# Case ID: 090318-01

## Accident Narrative

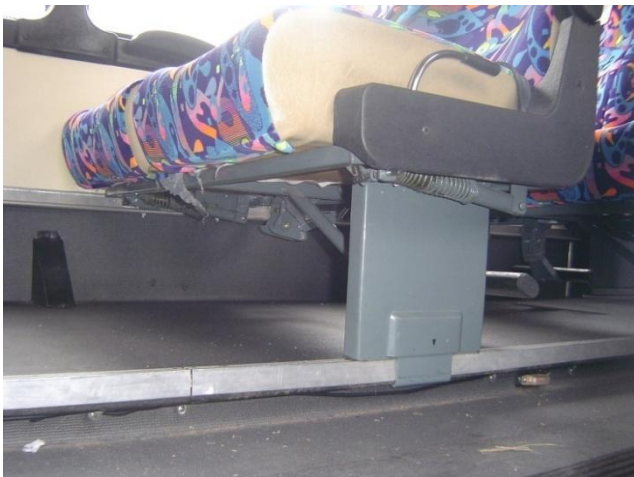
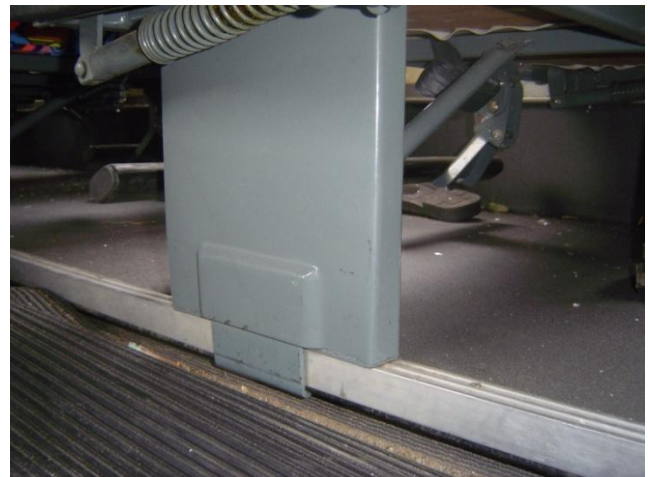
**Figure 3-4: Seat Installation**

From **Figure 3-3**, it can be seen that the lower deck is arranged into 5 parts including the driver cab, staff room, occupants compartment, luggage room, and engine box. Six set of passenger seats are installed in the occupants compartment, four on the right and two on the left. On the upper deck, the seating configuration of the bus consists of 12 rows. There are the seats only on the right side on the first, sixth and seventh rows, leaving space for the staircase on the left. The twelfth rows comprises of five seats connected to each other. Each set on the other rows are all individual but attached as a pair. The space between the seats is 85 cm. The seats are connected to the bus body by a pair of steel hooks, one attached to the floor while another one is attached to a side bar (**Figure 3-4**). However, only

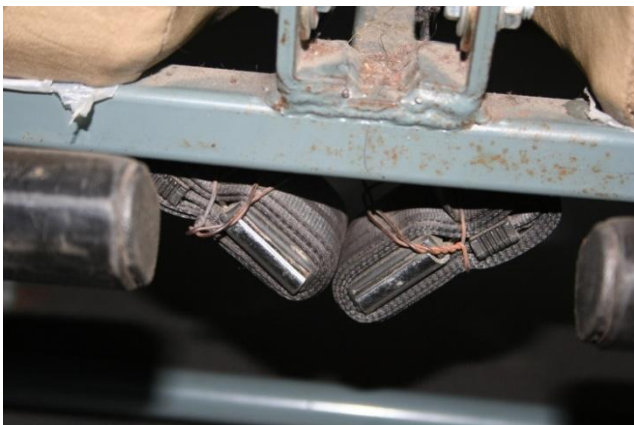
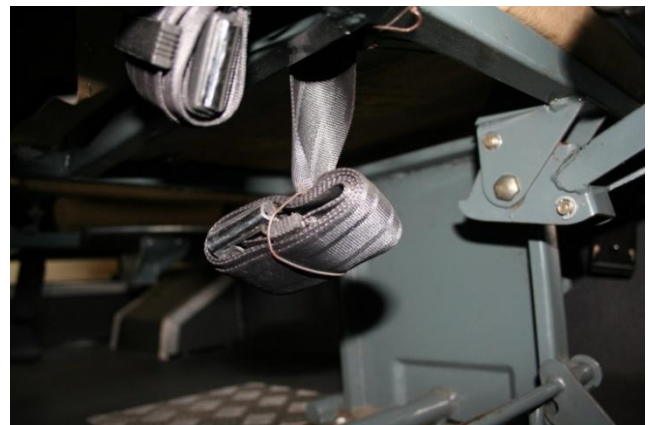
**Figure 3-5: Seatbelt**

the last row and three sets on the lower deck have seats installed on the bus floor by connecting bolts. All seats are equipped with a lap seatbelt. However, all of them were hidden and fasten at the back of the seats (**Figure 3-5**).

The most harmful event in vehicular collision is that of occupants hitting interior objects with other occupants. In this case, even though all passenger seats are equipped with the lap seatbelts they are fastened and kept hidden in the back of the seat. None of the occupants were using them. All four fatalities were found dead under the bus wreckage. One suffered severe cutting to the arms and legs.

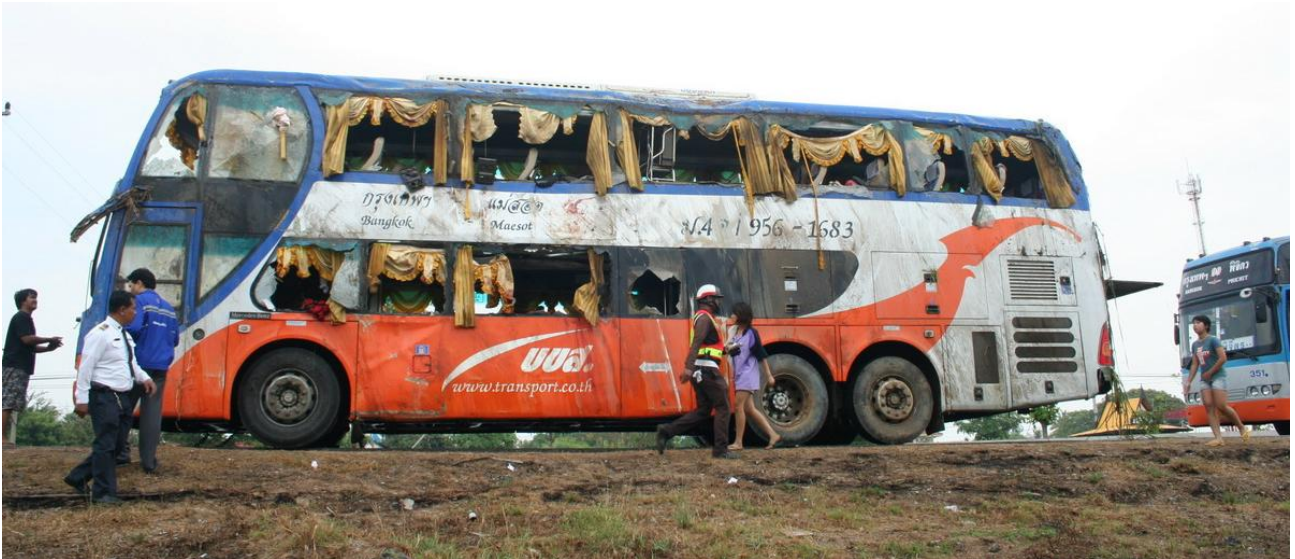
**Figure 3-6: Bus Damage on Left Side**

There was no major intrusion from the collision in this single vehicle crash (**Figure 3-6**). Since the bus stopped on its left side, there were scratch marks, mud, and grass entirely on this side. Almost all windows, except between second and third pillars, were shattered including the front windshield. The rear mirror on the left side was damaged.

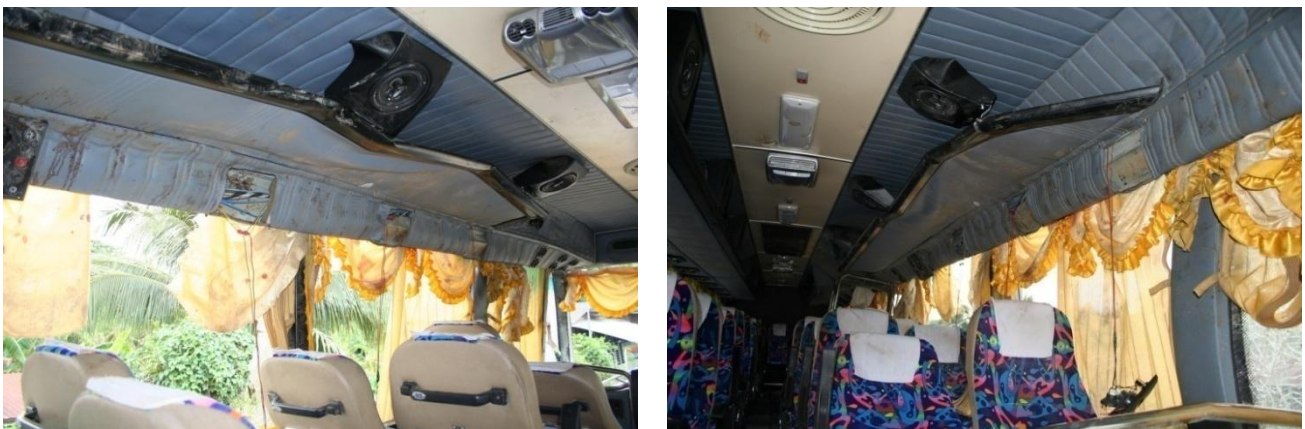
**Figure 3-7: interior Damage**

The interior damages showed a little deformation on the cabin luggage between the second and fourth and eighth and ninth rows (**Figure 3-7**). All passenger seats were intact.

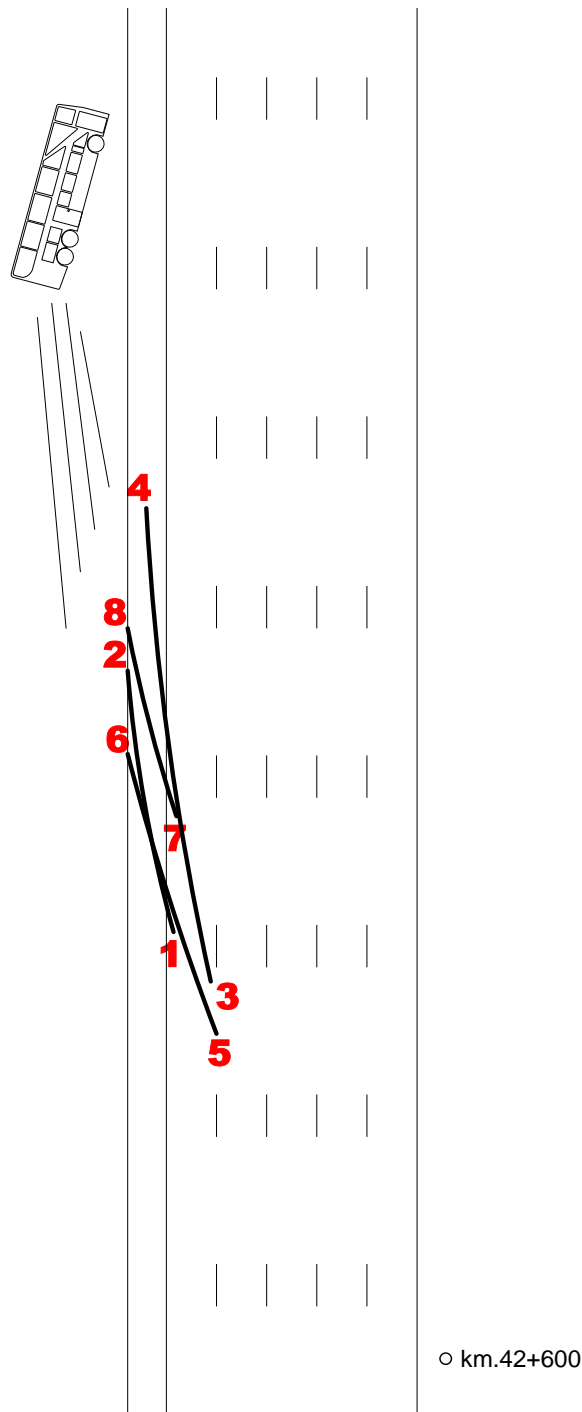
**Figure 3-9: Bus Tire Marks**

A set of wheel tracks were obviously seen, started from the third lane (counted from the median) and ended at the outer shoulder. The details of the tire marks are shown in **Figure 3-9** and **Table 3-2**. It was clearly shown that the bus started to yaw, or slide, in between the second and third lane. However, there was not enough space for the bus to recover on the traveling lane. The debris on the roadside, next to the shoulder, showed that the bus

overturned on the left side immediately after moving out of the road leaving no wheel tracks in this area. The bus finally stopped on the roadside ditch on its left side.

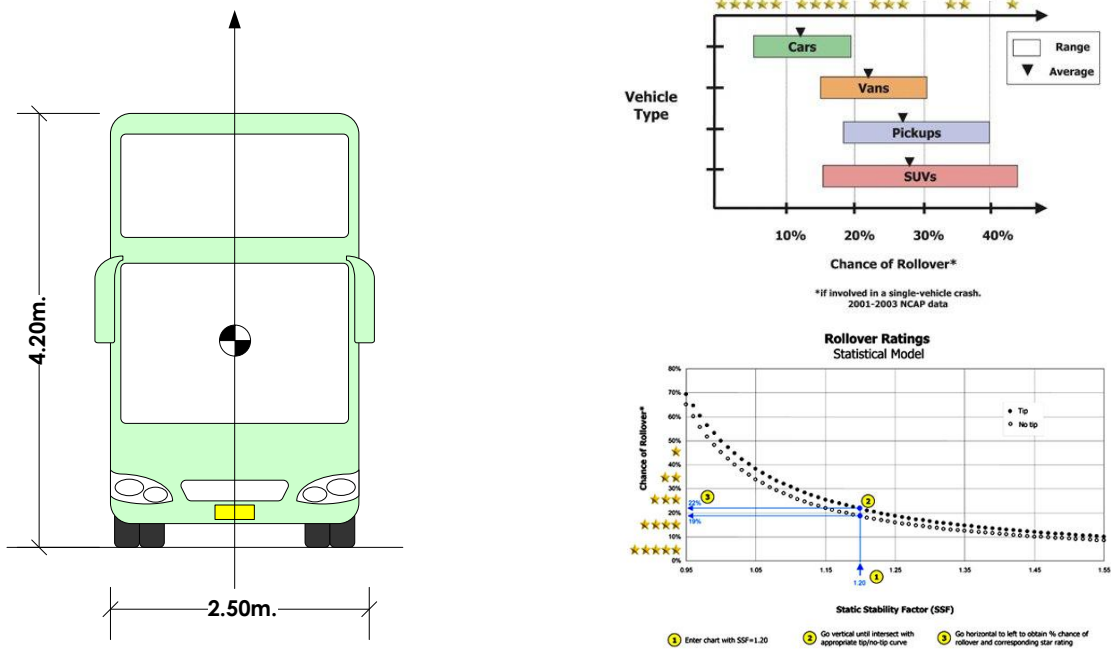
**Figure 3-11: High Rollover Risk Bus**

All of the cars in the United States are rated by using stars for the chance of rollover (**Figure 3-11**). Normally, the SSF of cars, vans, pickup, or SUVs are between 1.00 – 1.50. The bus, however, is calculated to be equal to 0.80 approximately. By applying the idea of statistical model used in medium cars, it is shown that a bus has a roll over risk 8 times higher than a car.
