Accident Narrative

At about 4:00 PM, on 3 July 2013, 7 peoples were returning back from Wat Nangnaithamigaram, Angthong to Doilan, Ayutthaya, in a pick up after attending their one of the relative's funeral. At about 4:17 PM, while travelling on a 4 lane Highway no. 329, between km 14+000 and km 15+000, the pickup (V1) hit a 24 wheeled trailer truck (V2) with its front at U-turn when the truck was trying to make a right turn towards its company gate. Based on the evidences found in the crash scene, the pickup was running over a painted median and when the driver saw a truck in front of it making a right turn, the pickup tried to maneuver left avoiding a truck but couldn't success and finally got collided with a truck. After the collision, the pickup moved few meters and stop on the roadway as shown in figure 2.

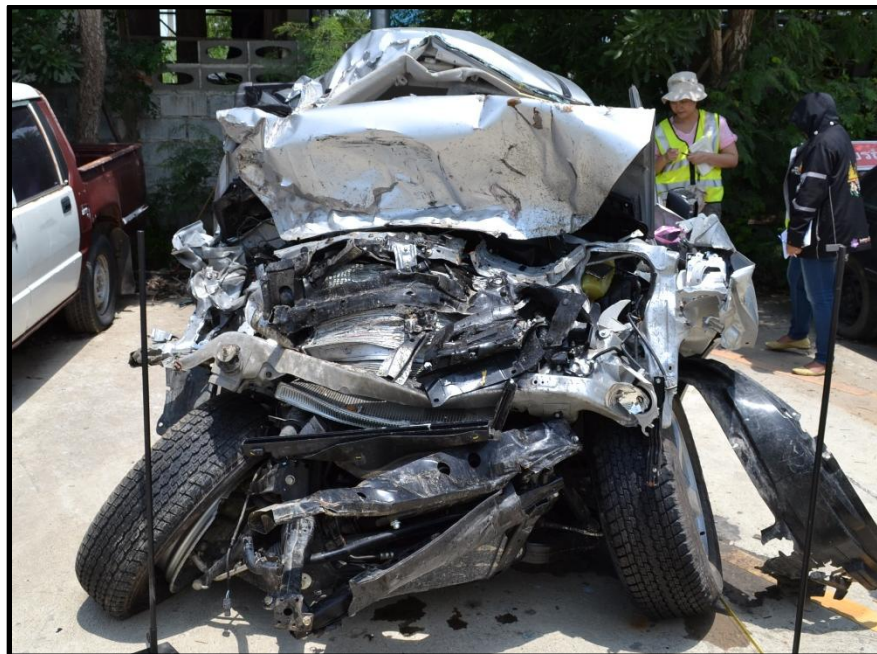
Figure 4 Damage of Pickup (Front Side)

The pickup had a massive damage on its front part as shown in figure 4. The hood was panned up and the pillars that support the roof was deflected from its original position. Similarly, the roof was also protruded at the middle and the front bumper was damaged entirely. As we can see from the figure 4, front-right tire swayed outside while the left tire swayed inside and the pickup body was found to be deflected downward it the middle. The rear window was broken totally and was intruded inside the compartment (Figure 7). Overall, we can say that the front-right part of the pickup was damaged heavily than left part (Figure 5) and the supporting pillars were intruded inside the passenger compartment especially on the driver's side (Figure 6). Figure 8 shows the deformed structure of the pickup from its original structure with high deformation at front right side (0.79 and 0.50 m). TRAC evaluated the Collision Deformation Code (CDC) for V1 as 12FDOAW6.

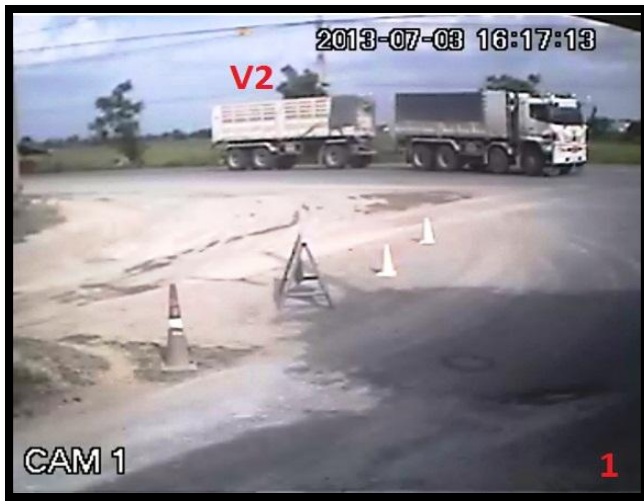
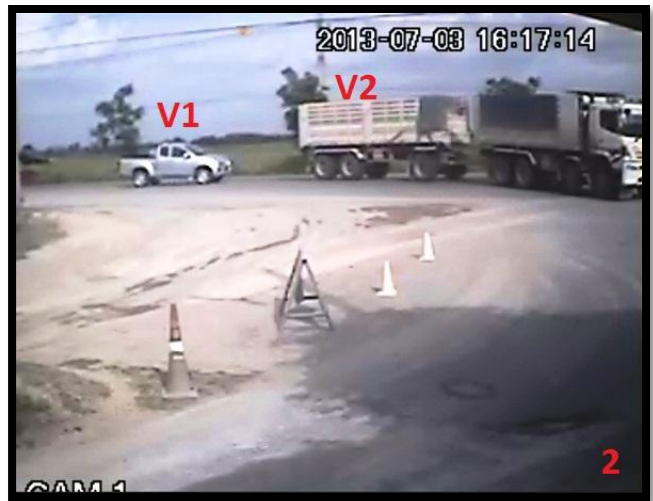
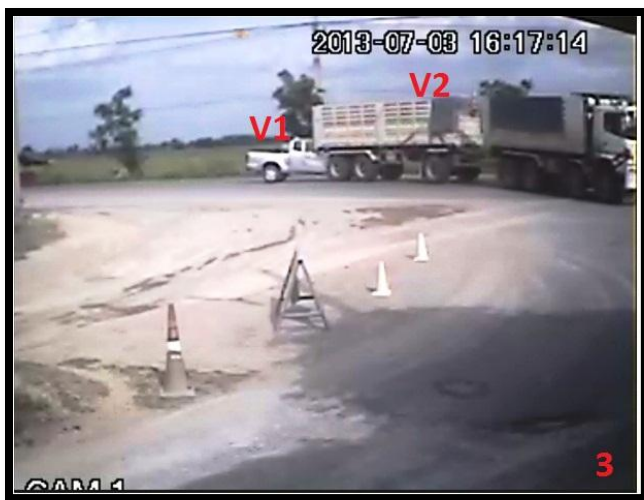
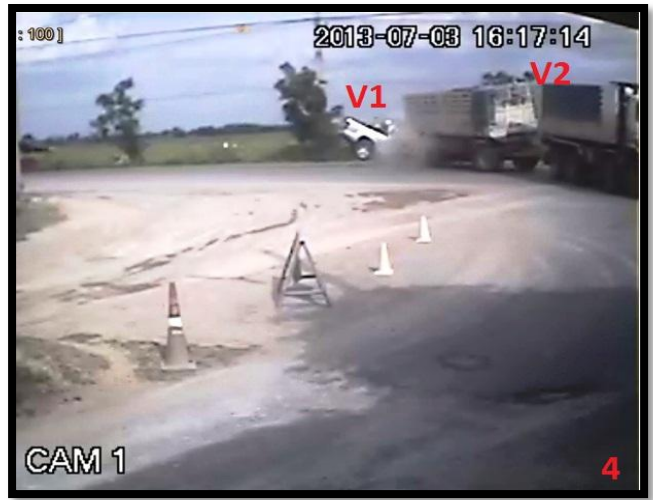
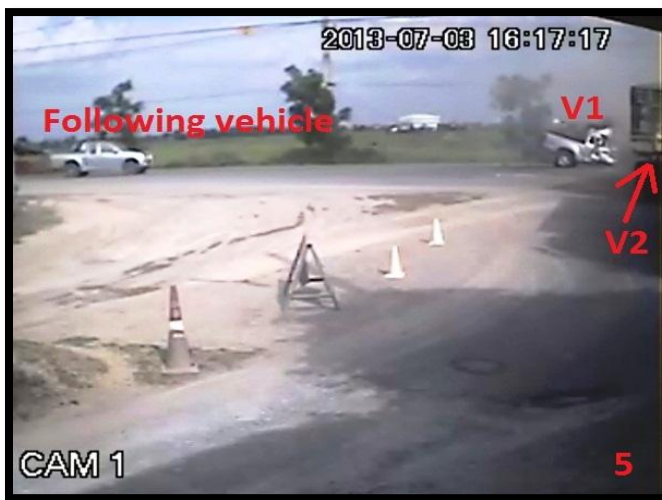
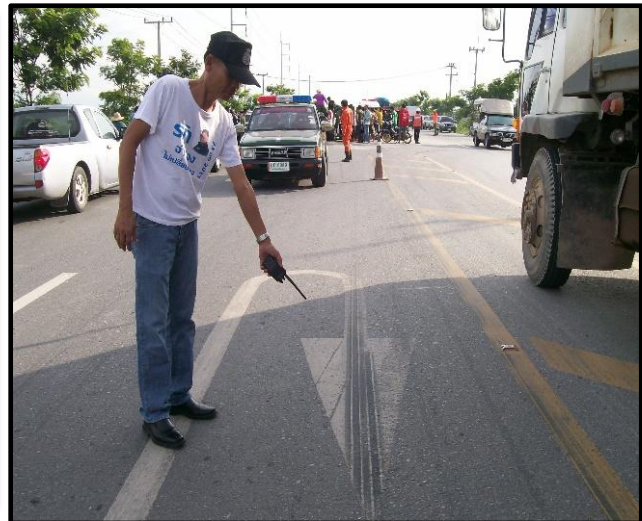
One of the most important evidence for guiding TARC team to investigate was 25 m long straight skid mark of the left wheel on the U-turn sign (figure 11), about 1m near to the median, which clearly shows that the right wheel of the pickup was running over the median. This evidence was supported by the CCTV footage. After the close examination of the footage it was found that the pickup might have overtaken another vehicle from the median and was unaware of the turning truck ahead, making a crash (figure 11).

Figure 11 Sequence of Crash (1 to 5) according to CCTV Footage and Skid Marks on the Road Surface.

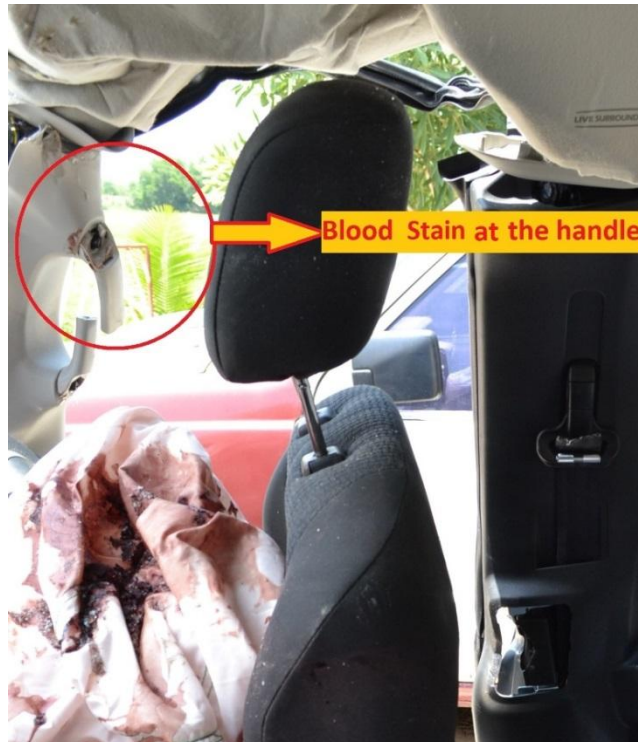
Figure 14 Blood Stains at the Handle

The evidences inside the crashed vehicle shows that the driver was using seat belt (figure 15) while the front passenger did not use the seat belt and rest of the passenger were sitting in the position where the seat belts were not installed. The interior damage at the front showed blood stains on the driver hand-hold fitted on the roof near the door (figure 14). Both the airbags were activated and were exploded as well (figure 15).

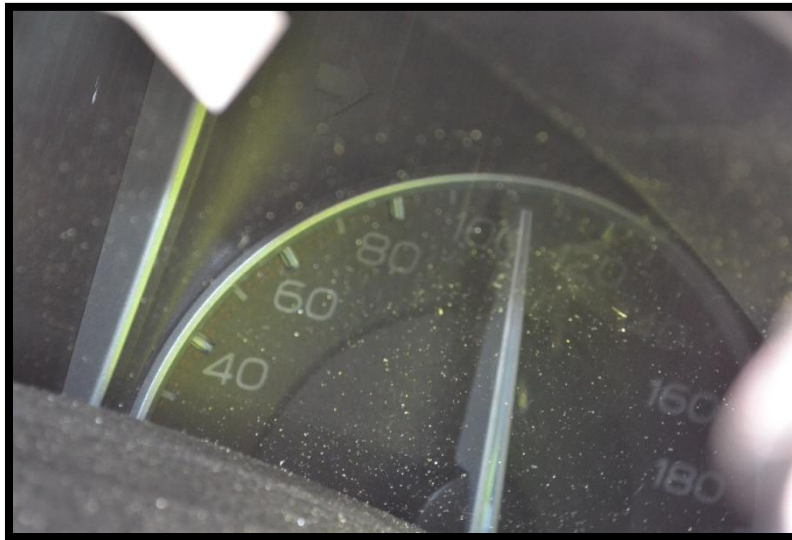
Figure 16 Reading of Speedometer Gauge during Impact

The speed limit of highway no. 329 is 90 km/h. However, from figure 16, we can see that the speedometer is showing the speed around 105 km/h during the impact and the speed is expected to be higher before braking. TARC performed the crash speed analysis to determine the pickup speed during the impact and before braking. Following steps are followed to carry out the crash speed and pre-crash speed.

From the calculation the speed during impact was found to be 107.83 km/h which is nearly equals to the speedometer speed, while the speed before braking was 118.86 km/hr. It means the speed of the pickup was more than the speed limit, which became one of the important factor for the accident.

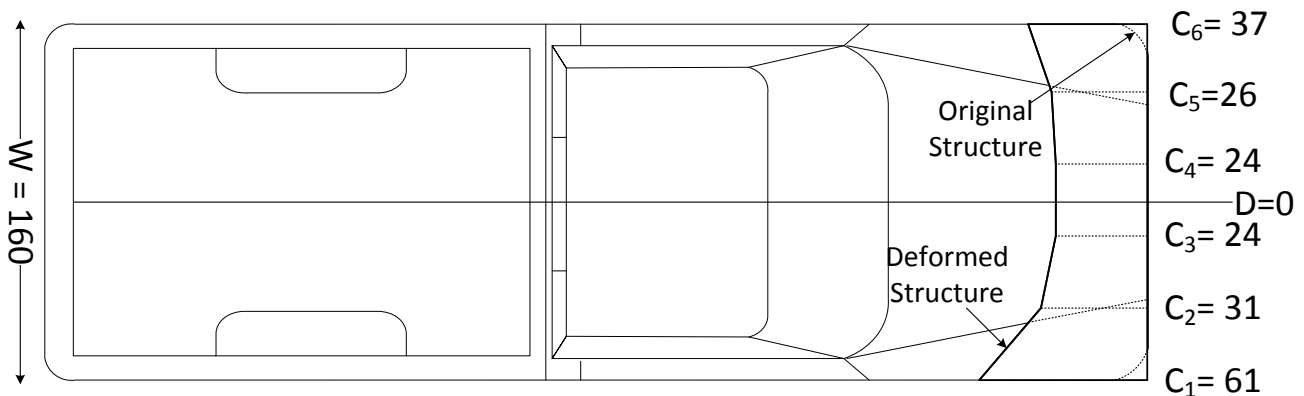
Figure 17 Dimension of Deformed Structure of the Pick up

$$V_{\text{impact}} = \sqrt{\frac{2gE_{\text{actual}}}{w}} \\ = 29.95 \text{ m/s} = \mathbf{107.83 \text{ km/h}} \approx 105.0 \text{ km/h (Speedometer reading)}$$
