Case ID: 081227-01

Accident Narrative

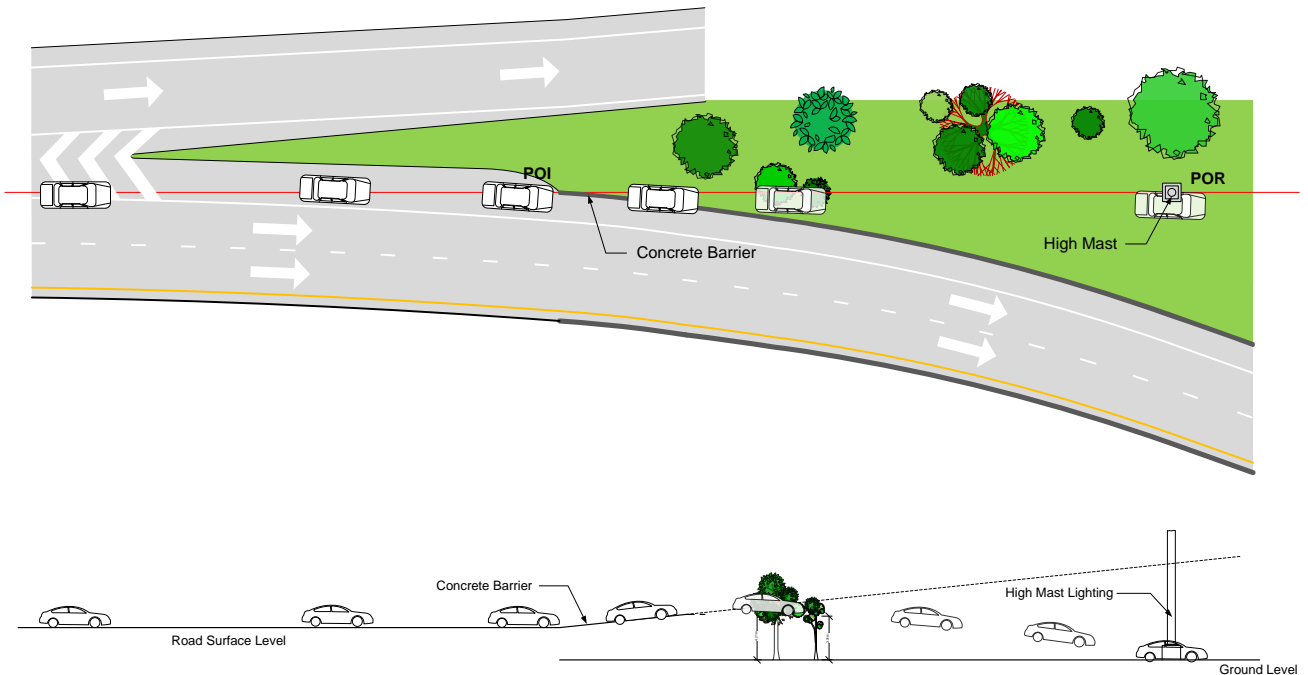
Figure 3-2: Collision Diagram

Based on evidences found on the crash scene (**Figure 3-2**), the vehicle was out of the travelling way while negotiating the curve. A tire print, which is left wheel tire was found on the footing of the New Jersey concrete barrier. The vehicle kept moving on the top of the

concrete barrier for some distance. The cut branches of the tree showed the vehicle movement path in the air. Finally, the top left part of the car landed on the concrete structure, resulting in the death of the six persons.

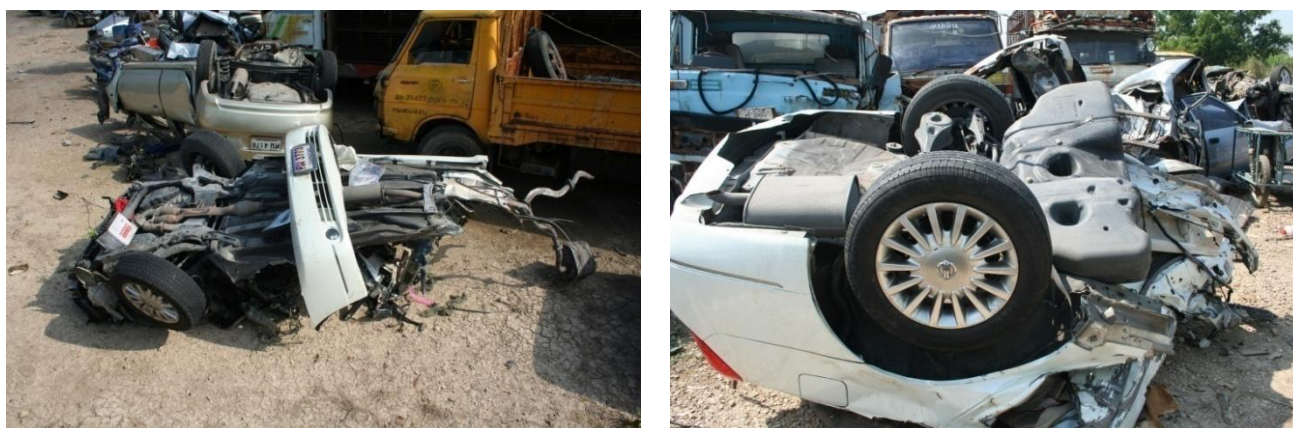
Figure 3-4: Vehicle Damages

The TARC team found that the car was dramatically damaged at the junkyard in the Klong 3 workshop. It was broken into two parts. The frontal part included the engine compartment, front seat row, and left doors. Other components, including the roof and right doors were to be found with the rear part. The cutting line was measured to be 2.00 m long from front bumper (**Figure 3-4**).

The evidences from the impact were mainly found in the rear part. The roof structure was compressed into a tiny piece, showing a rupture force from right to left. The curvature shape of the driver's door was the source of impact with a high mast column.

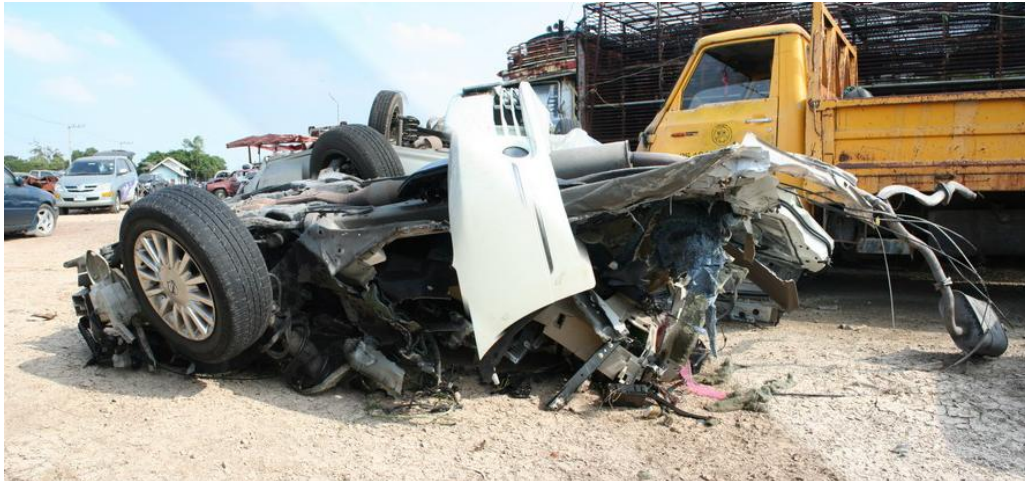
Figure 3-5: Frontal Part Damages

As for the front part (**Figure 3-5**), the left wheel was found damaged on the rim. The hood had disappeared. The interior inspection showed that the seatbelts remained their original positions and were found unused. The blood stained driver and front passenger's airbags were activated on the steering wheel and console, respectively. All control gauges, air condition control, and music player were massively destroyed. Blood splashed on the front passenger's door (**Figure 3-6**).

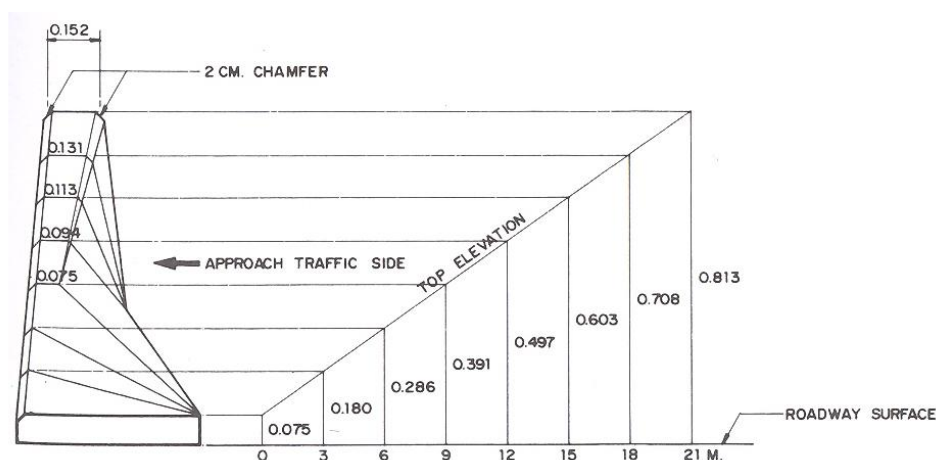
Figure 3-10: Standard Drawing of Approach Concrete Barrier Type B

At a distance of 65 m. from the diverging gore area, the concrete barrier is installed on the left side of the road. The beginning of the barrier is set up with the “Approach Concrete Barrier Type B”. The total length is 10.25 m. The details of the standard drawing of the approach barrier are shown in **Figure 3-10**.

The approach concrete barrier type B at the crash scene resulted in an adverse outcome regarding the safety for errant vehicles. This type of end , called sloped concrete end treatment by AASHTO or similar to a turned-down guardrail terminal, is intended to collapse

on impact and lead the vehicle to pass over the object without becoming unstable or airborne (AASHTO, 1996). However, AASHTO recommended using it in areas where the traffic speeds are lower than 60 km/hr. This treatment should be installed where the barrier is flared out beyond the clear zone or where the end-of impacts are not likely to occur. In this regard, the approach concrete barrier is not considered a sufficient treatment to protect an errant vehicle at this critical location.

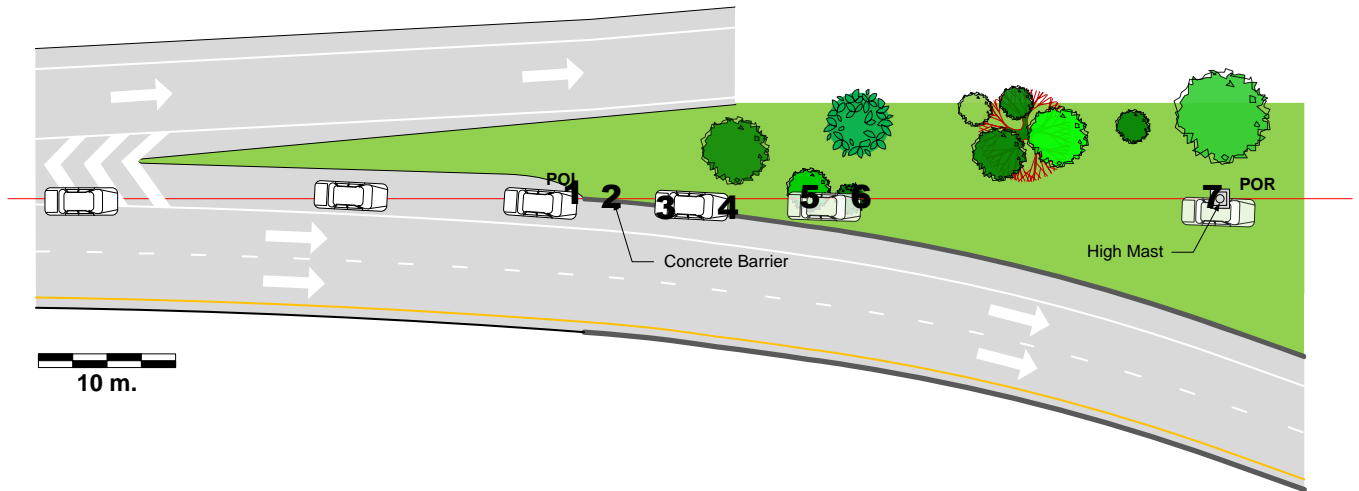
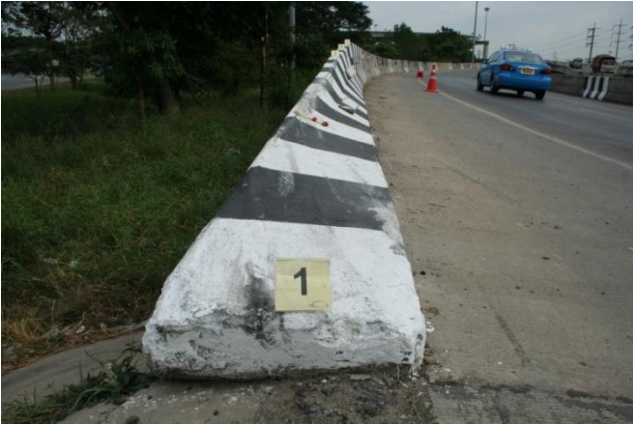
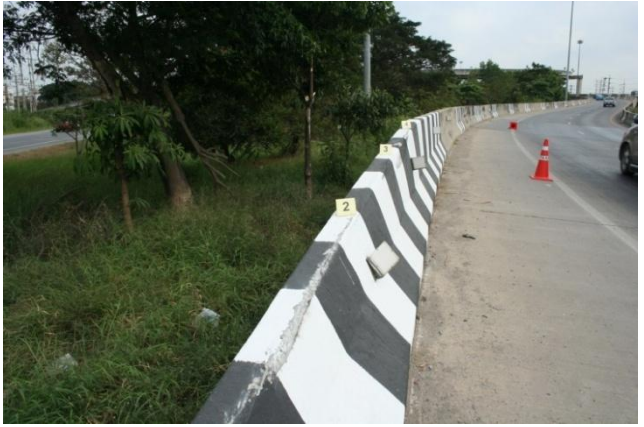
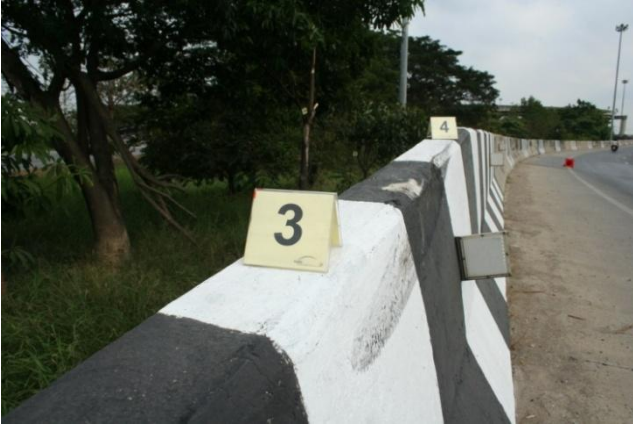
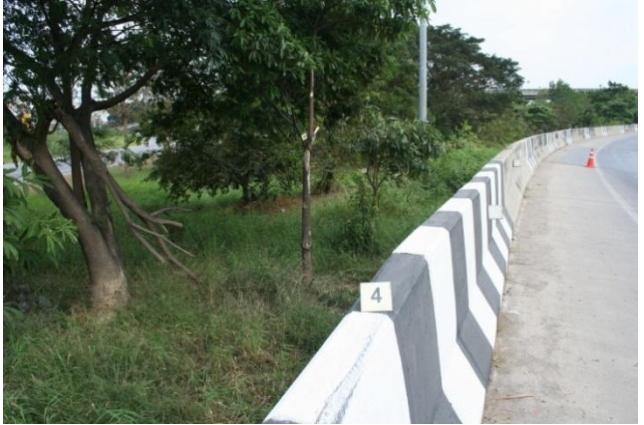
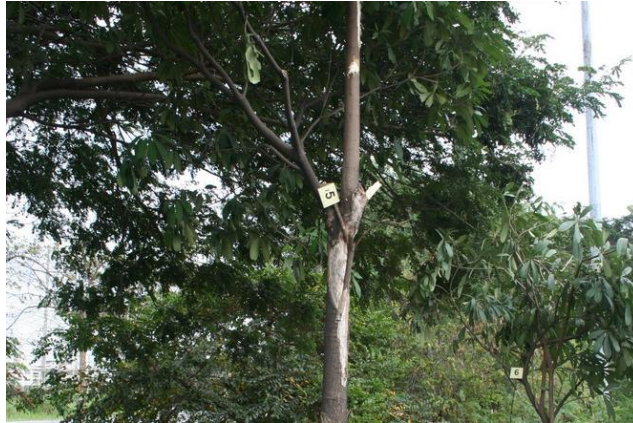
Figure 3-11: Set of Evidences Documented at the Crash Scene

The evidence found from the scene (**Figure 3-11**) began with a tire mark printed on the footing of the approach concrete barrier (**point no.1**). Within a further meter, there were plenty of scratch marks showing on the concrete surface on the top of the barrier (**point no.2**). 8.40 m from point no.1, a tire mark was printed again on the top of the barrier with 1.30 m in total length (between **points no.3** and **4**).

Another set of evidences were documented at the trees on the roadside where the branches of trees were broken. The first (**point no.5**) was found between 2.13 and 3.11 m above the ground. The next (**point no.6**), a broken branch, at a height of 2.20 m from the ground was found on the smaller tree which was located 3.03 m further away

The last evidence was located at the concrete foundation (**point no.7**) of the high mast lighting post, 46.35 m away from point no.1. It has to be noted here that there was no evidence found between point no.6 and point no.7 which means that it is highly possible that the vehicle flew from the concrete barrier at 6° over the trees and landed exactly at the concrete foundation without touching the ground.

A vertical distance is negative in this case since the landing point is below the takeoff point. Therefore, by using the above equation, the speed of the car at the takeoff point is equal to 137 km/h. In addition, while the car was traveling in the air, it had a relative effect of pitch and yaw movement that which made it land on the roof.
