Accident Narrative

At about 10:00 PM, on 14 July 2013, there is a report of car crash accident at Pathumwilai Intersection across Pathumthani City Hall in Pathumthani City. The car was reported to be crash into a light pole in the raised median. Based on the evidences, the left side of the car hit into the median street light pole. The car driver was only one casualty and he has only minor injury.

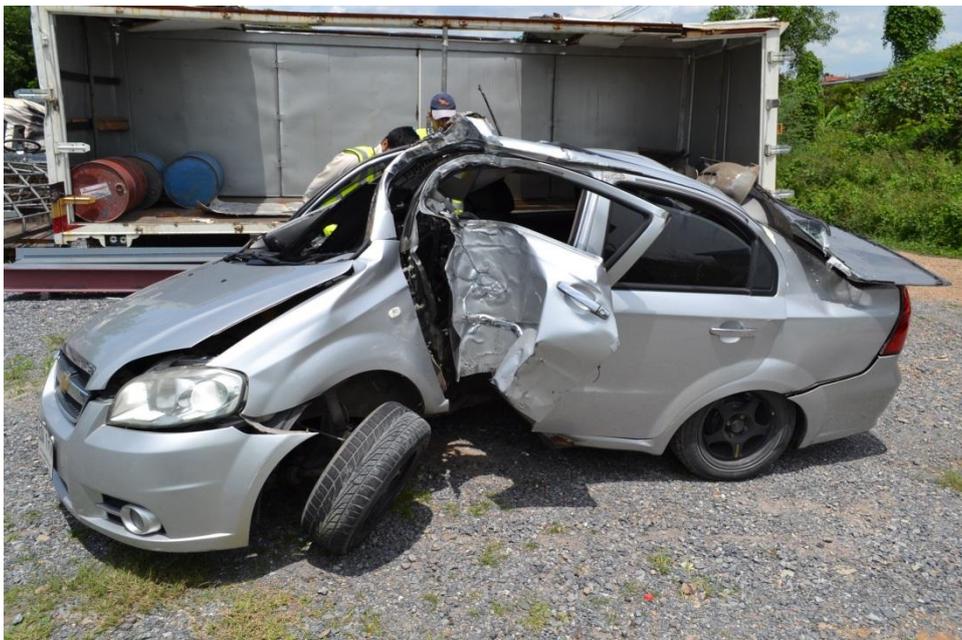
Figure 3 Vehicle Damage (Left Side)

The pickup had a massive damage on its left part as shown in figure 3 to 5. Left part of car was deformed up from the frame of the left door to the front left passenger seat. Also, front part of the car was bent back due to the force of impact. Front left wheel swayed outside from its axle and front right wheel tire was burst. In contrast, right side of the car received only a minor damage due to the structural deformation from its left side. Rear right door can still be opened. TRAC evaluated the Collision Deformation Code (CDC) for V1 as 10LP1AE3.

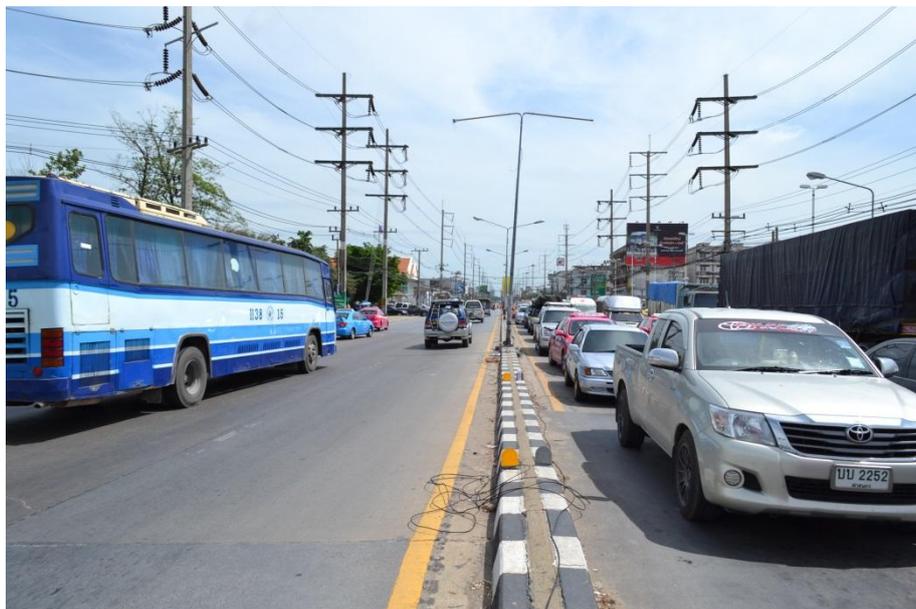
Figure 9 Crash scene (Northward)

The surrounding area of Pathumwilai Intersection can be considered as a downtown area of Pathumthani Province. Across accident scene, there is a Pathumthani Government Center on the west, Tesco Lotus Supermarket on the east and surround with many important places including Pathumthani Hospital, Pathumwilai School and entrance to Fresh Market on the east. Therefore, heavy traffic volume can be observed throughout the day time. According to the investigation, a distortion in pavement surface was found before the crash site. Also, 5-meters length yaw mark and a scratch were observed in the raised median.

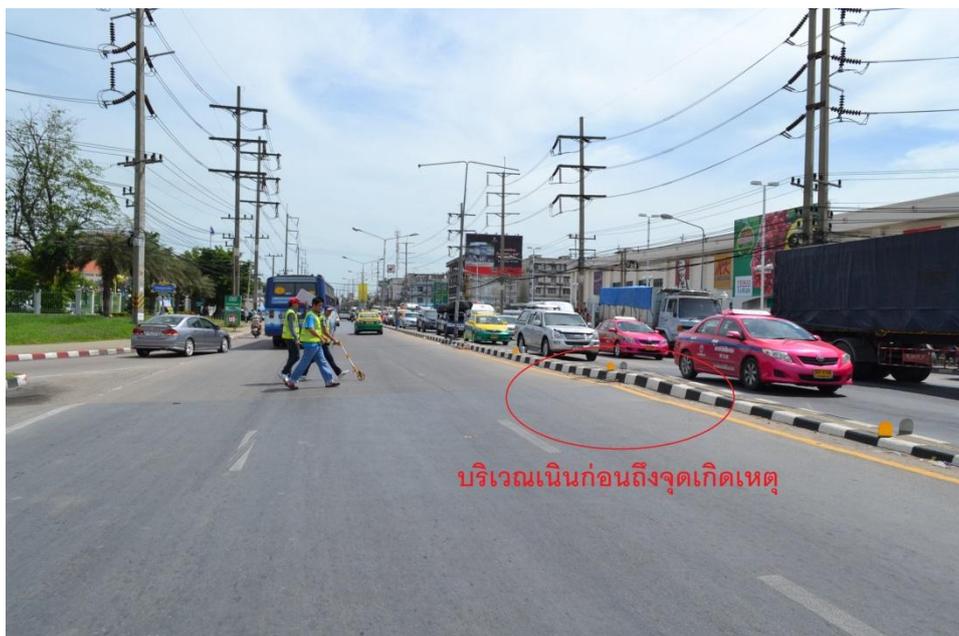
Figure 10 Pavement distortion before reaching crash area

Before reaching the resting point of the crash, a distortion of pavement surface can be observed. According to information from the locals, that area used to be a small canal but had been filled for street widening and distortion in settlement produce uneven road surface. Suspect that the car can lose its control when running across a hump.
