Case ID: 051117-01

Accident Narrative

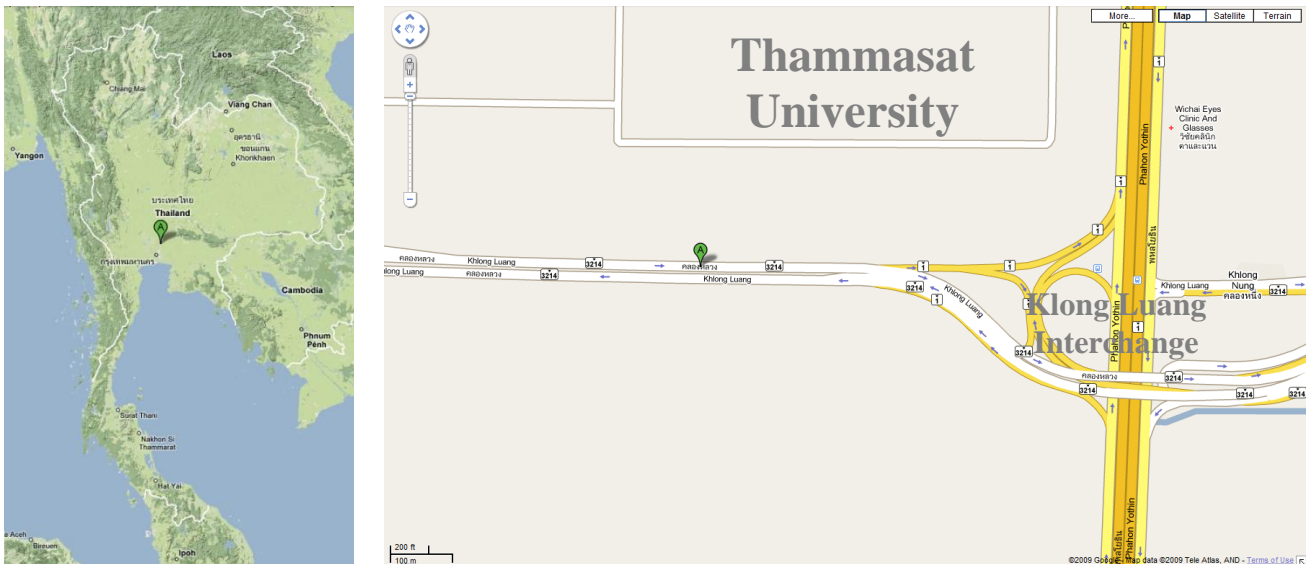
Figure 3-1: Crash Location

On 17 November 2005, in the very late night of the “Loy Kra Tong” festival, a passenger car hit four pedestrians and later hit the sign post on Highway No.3214 at KM.4+500, near the Thammasat University. Four persons were reported to be fatally injured and two other were seriously wounded. The injured persons were admitted to Thammasat hospital.

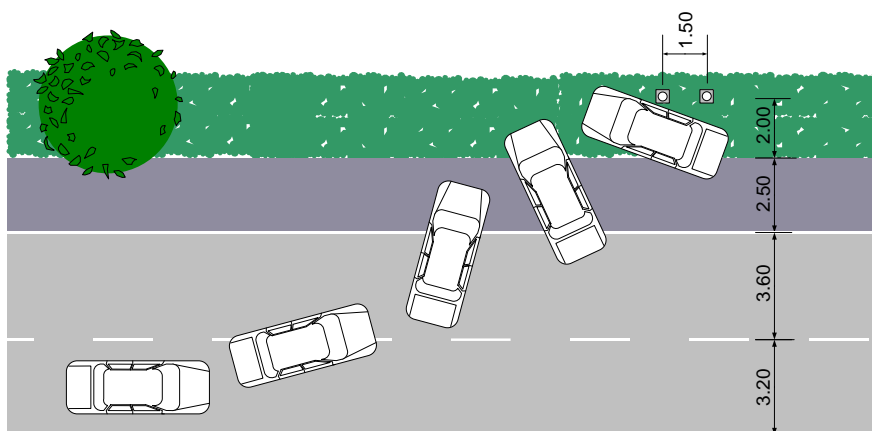
Figure 3-2: Schematic of the Crash

After picking up the passenger at around 4:15, the journey started. The female driver and her passenger agreed to settle their misunderstandings related to their friendship inside the car. She was driving very fast as the passenger claimed, in the inner lane of Highway No. 3214. Suddenly, she swerved into the left side and hit four pedestrians. Later the car was found struck with the post of the overhead directional sign with its right side of the passenger compartment. Three pedestrians and driver were killed instantly and the passenger and one pedestrian suffered serious injuries.

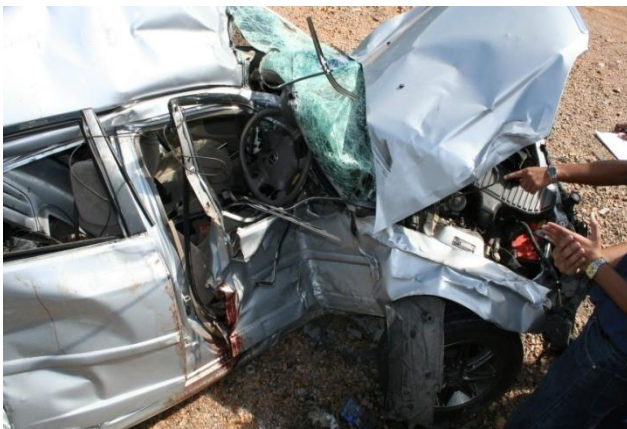
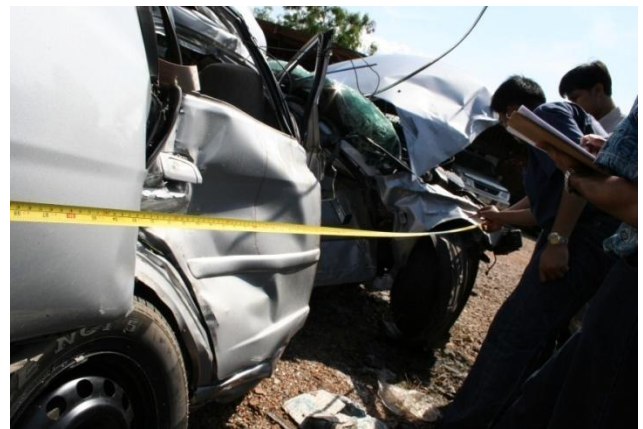
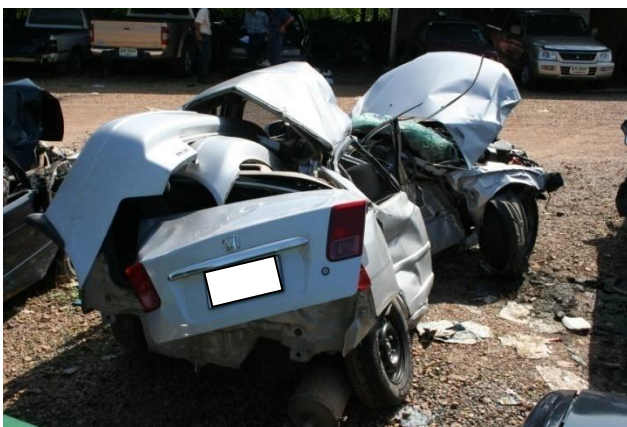
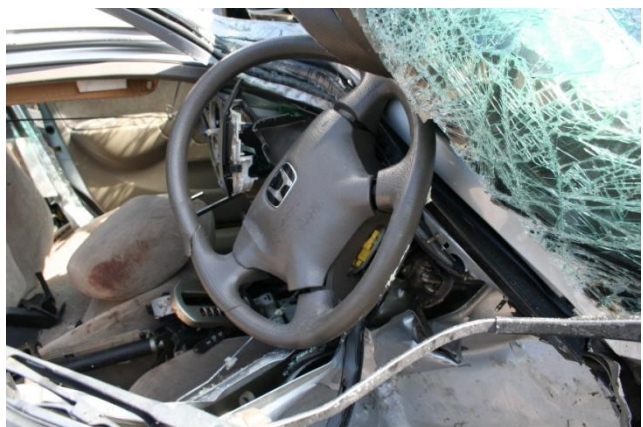
Figure 3-3: Damages to the Passenger Car

The right part of the passenger compartment directly struck with the concrete foundation and steel member of the sign post. The marks on the steel member which struck with the A-pillar of vehicle were measured at 1.90 m. and near the C-pillar 1.75 m. high from the ground. This satisfactorily matches the height of the deformation of the roof panel. The roof panel was also pushed to the left side from the impact with the steel member of the post.

The width of direct damage along the passenger compartment was measured to be 1.89 m. However, the center-to-center spacing of the concrete foundation was 1.50 m. Moreover, the induced damage was measured to be 2.88 m. long.

The space of the driver's position was compressed from the right side impact from the combined effect of the concrete foundation and steel member. The direct intrusion came from the right door panel being pushed inside of the compartment. The steering wheel was found to indicate a left turn and the windshield was broken.

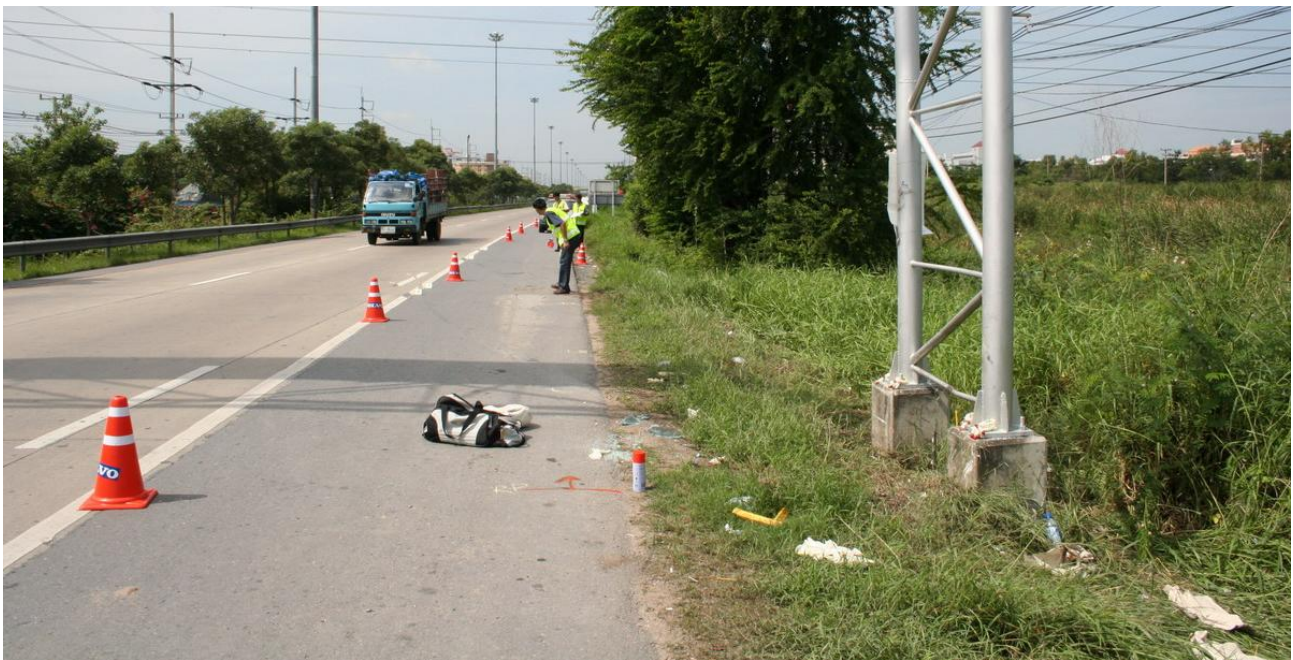
Figure 3-4: Evidences on Crash Scene

The yaw marks were printed on the road surface, starting from the inner lane extending up to the left shoulder. The chord length of the yaw mark was measured to be 28.8 m. and the middle ordinate 0.6 m. prior to the impact. The location of the pedestrians hit by the vehicle can be estimated from the vehicle movement path.

The left post of the sign post foundation was located at 2.0 m. from the edge of the left shoulder. The 40x40 cm² rigid concrete foundation had a height of 50 cm. The end to end distance of the concrete foundation was 1.90 m. The blood stain at 4.15 m. from the edge of left shoulder was found on the vegetation along the roadside indicating the rest position of the one of the deceased pedestrians. However, the traces of the other two pedestrians were also flown to 9.20 m. from the edge of the left shoulder on the marshy area along the roadside vegetation.

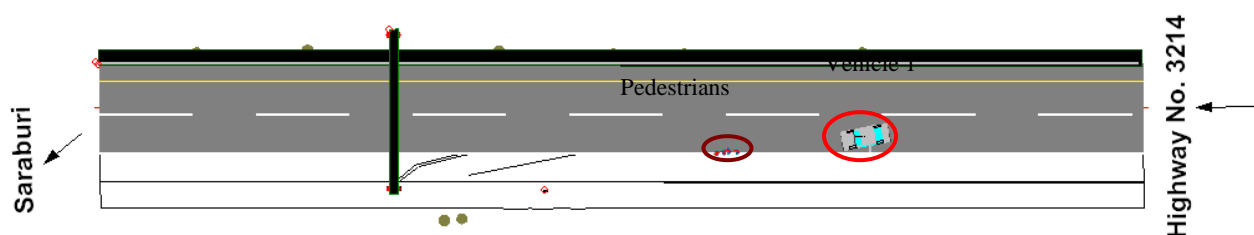
Figure 3-5: Plan View of the Crash Scene

After getting the data of chord (C) and middle ordinate (M), the radius (R) of the curve can be determined to be 173.1 m. The coefficient of friction of the road surface and the shoulder measured at the scene were 0.76 and 0.72 respectively. As a result, the traveling speed at the onset of the yaw can be obtained from the speed-radius relation and found to be 129 km/h.

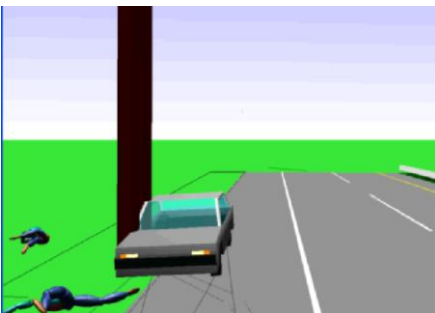
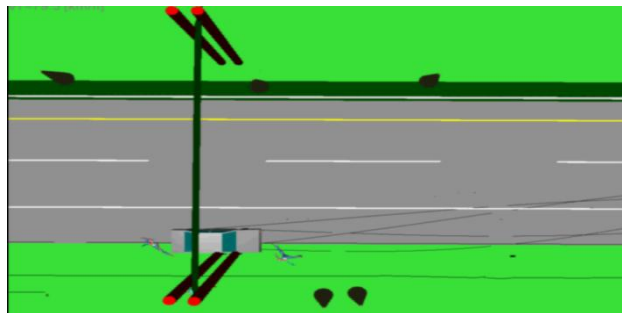
(4) Rest Position after hitting with Steel Post

The 40x40 cm² concrete foundation, with a steel structure, double post is quite strong—without any protection surrounding this assembly. No major damage on this post was found during the investigation. The “Forgiving Highway” concept can be taken as an issue to reduce the severity of crashes; regardless what the cause of this crash is.
