Case ID: 080915-01

Accident Narrative

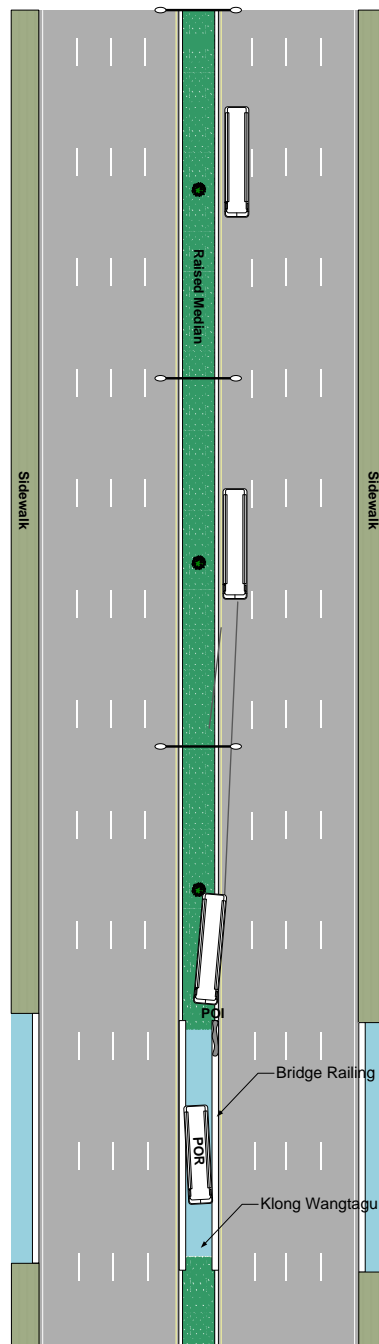
Figure 3-2: Schematic of Crash Scene

Seven persons including the driver lost their life, while another 44 and 20 suffered serious and slight injuries, respectively. It was reported that there were numbers of standing passenger because of the peak hour. Identifying the seating position of the victims was impossible.

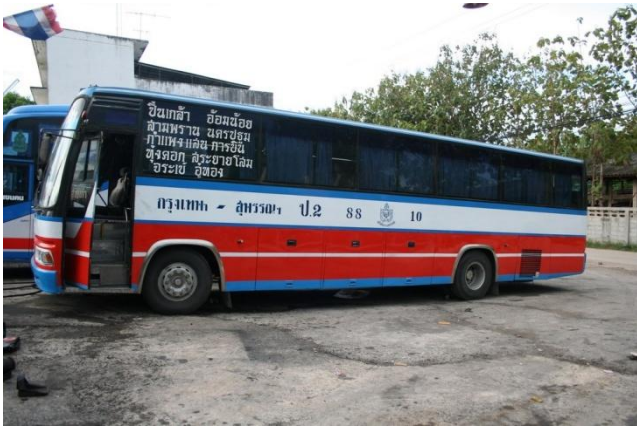
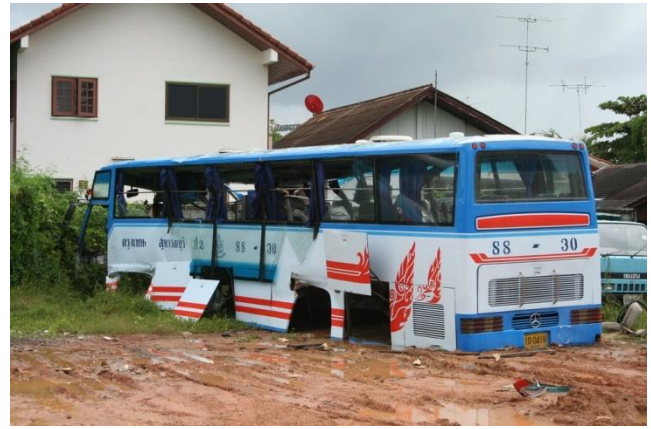
Figure 3-3: Comparison between Original and Damaged Buses

The exterior damage of the bus shows on the front. The front and rear axles departed the body structure. A-pillar on the driver side was pushed backward, causing massive damage to the driver's door. The frontal impact destroyed the body structure on the front left corner. The stairs were missing. The collapse of five pillars, including the A-pillar, on the right side caused a deformation of the roof structure. All windows were shattered. **Figure 3-4** describes the deformation on the frontal part of the bus.

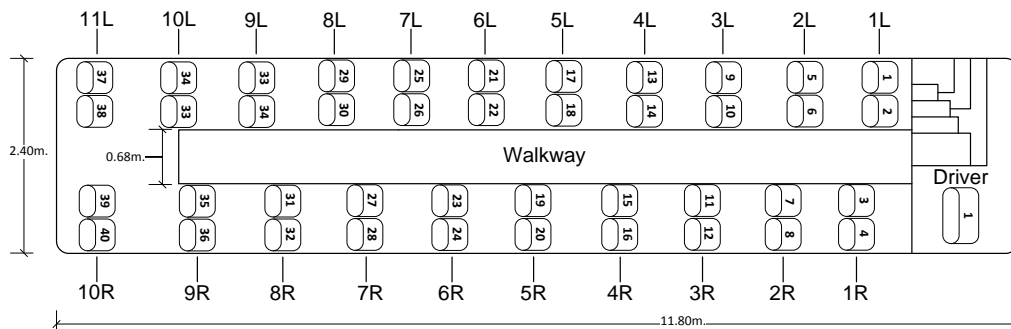
Figure 3-5: Seating Configuration

The seating configuration of the bus was arranged as 11 rows of 4 seats (**Figure 3-5**). The passenger's seats were all individual but tightly attached r as a pair. The seats connected to the bus body by a pair of steel hooks, one attached with the floor while another one was attached to a side bar (**Figure 3-6**). However, only on the last row the seats were installed to the bus floor by connected bolts. It was documented that 6 seats departed their original position, including 1L (left), 2L, 3L, 4L, 6R (right), and 8L.

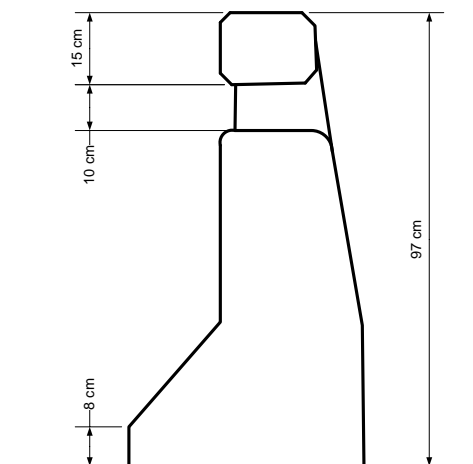
Figure 3-7: Bridge Railing Dimension

A 27 m length bridge is constructed over Klong Wangtagu at km.63+052. The height from the water to the pavement was 4 m. The concrete barrier acts as bridge rails connected with the median curb. The distance between the yellow edge line and the bridge rail is the same as with the curb. The height of the bridge rail was measured to be 97 cm from the pavement surface. According to the design, there is a 10 cm notch located 15 cm under the top of the barrier (Figure 3-7). However, the end-treatment on both sides of the rail is not applicable.

The major impact on this crash occurred where the front part of the bus collided with the bridge railing. It caused massive damages to the bus. According to scene documentation, the 97 cm concrete barrier stands about 30 cm away from the traveling way without any protection.

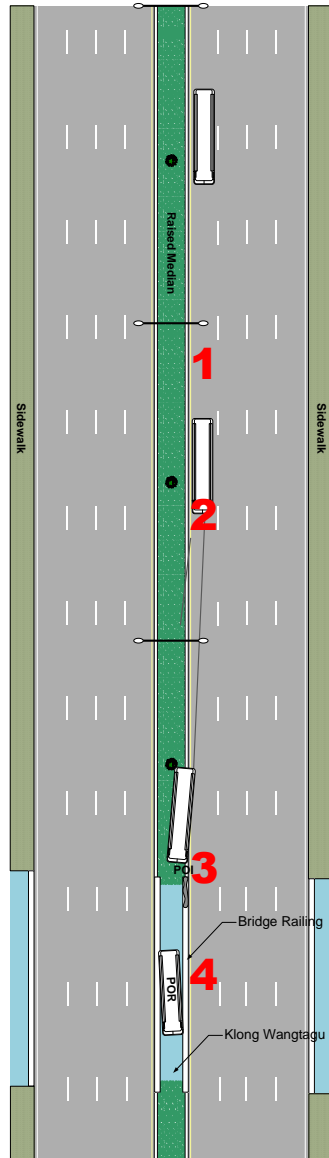
Figure 3-8: Evidences on the Crash Scene

Measurement conducted on the evidences found at the scene shows that the bus left the traveling way at a point 45.5 m. from the bridge end, showing a tire mark on the median curb (1). About 10 m. before the bridge, there was a scratch mark on the median curb showing the impact with the bus' underneath structure (2). There was no end-treatment installation preceding the bridge structure (3). The 97 cm. height concrete barrier had a minor damage on the top, measuring about 14 m. from the beginning of the bridge (4), as shown in **Figure 3-8**. Two electric poles installed on the bridge railing were hit by the bus.

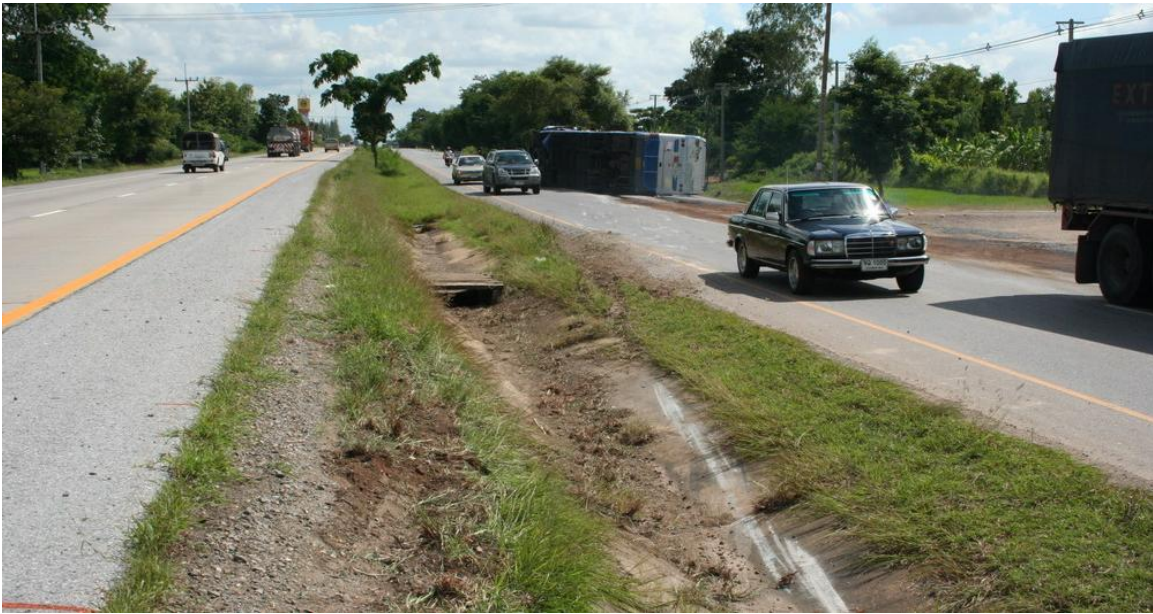
Figure 3-9: Possible Scenario if No Bridge Railing

Another issue which has been raised regarding this crash is that if there had not been any bridge railing, where would the bus have gone? In case the driver could not return the bus into the ongoing traffic, it would run into the opposite traffic and cause other unpredictable collisions with other moving vehicles, pedestrians or roadside buildings. As a result, the issue of roadside curb needs to be discussed in Chapter 5 in details.
