Case ID: 081010-01

Accident Narrative

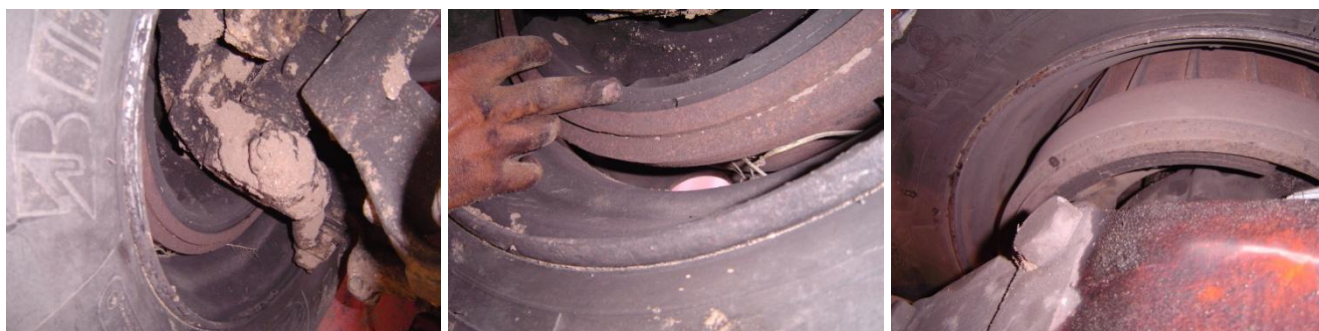
Figure 3-4: Suspension and Brake System

1. Brake pads were in good condition. The spaces between pad and wheel were normal. Only at the middle axle the space was bigger than the other wheels, about 2 mm (**Figure 3-4**).
2. Steering rod was damaged due to the crash.
3. The driving gear was in the 3rd position.
4. Before this trip, two sets of air suspension were replaced.

Driving on a long distance of mountainous section requires high skills of driving maneuver, especially for heavy vehicles which are equipped with an air brake system. Generally, the mechanism of air brake system starts by taking filtered air from the atmosphere, compressing it, and keeping it in high-pressure reservoirs. When applying the brakes, this high pressure air is routed to the operating cylinders on the brakes, which actuate the braking hardware and slow the vehicle (Wikipedia, 2009). The air brake system used for heavy vehicles is separated into two parts, the supply system and the control system. While the engine is working, the compressed air is routed through the air compressor system and stored in the reservoir. When the driver presses on the brake pedal, the supply line from the trailer brake circuit receives air from the air tank. However, when applying the brakes more frequently, it is possible that the engine could not supply the compressed air into the tank as it used to and cause a shortage of air in the system. In this case, the bus traveled on the hilly section for about 30 km before the bus driver found the error in the brake system while on the downhill section. The driver controlled the bus using the lowest possible gear. The mechanical inspection showed that the driving gear was in the third position. Accordingly, all of braking pads were in good condition without burns from the scratching with the rotating wheels.

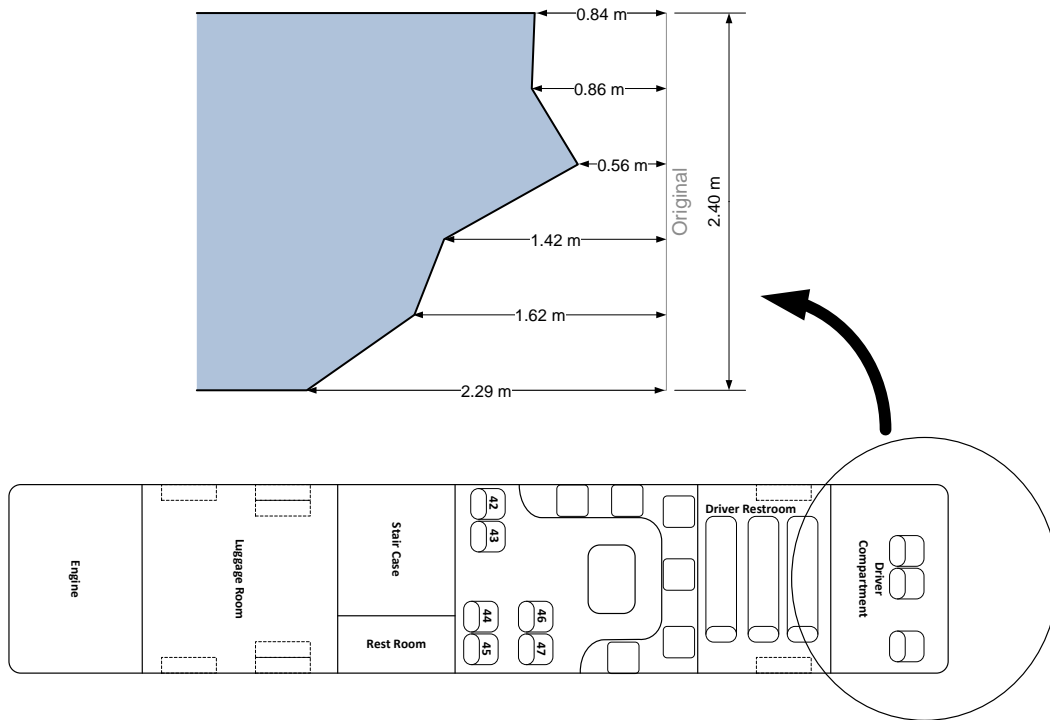
Figure 3-5: Frontal Deformation

The bus was deformed entirely on the front part due to the impact with a hillock. The driver compartment starting from the A-pillar intruded into the bus staff room and occupants

compartment. The driver and passengers' doors and console were crushed. The front axle was also bent. However, the damage on the roof as seen on the photo occurred during the post crash evacuation.

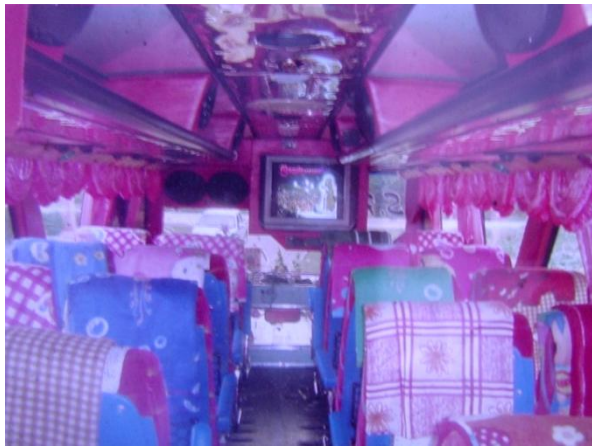
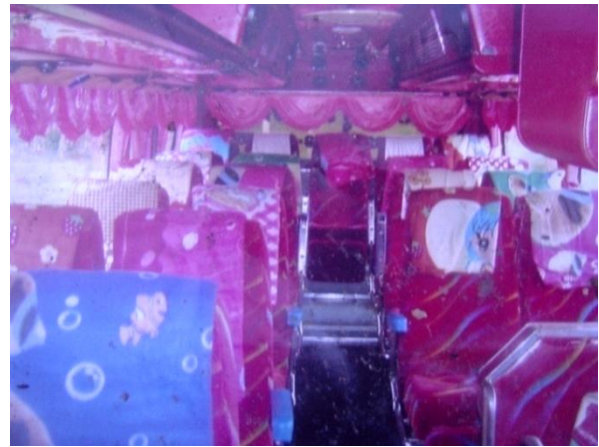
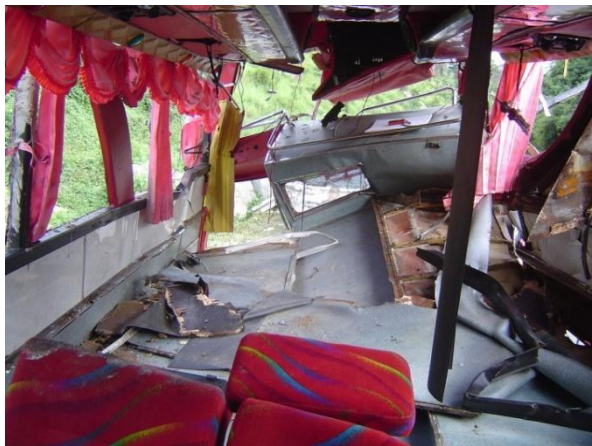
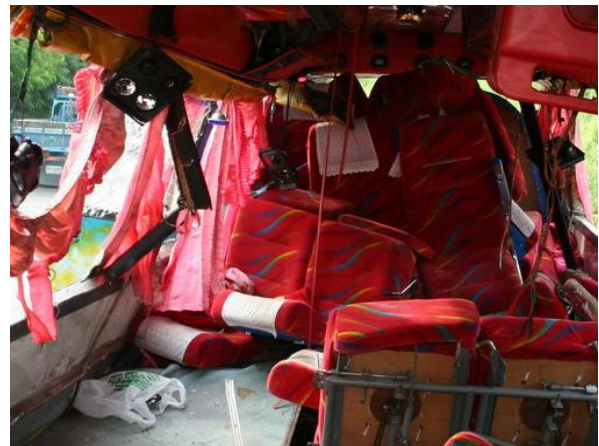
Figure 3-9: Seating Configuration Before and After Crash

Due to major damage to the front part, the intrusion extended to the occupants compartment on the upper deck. The first and second pillars were displaced while all of the passenger seats were separated from their original position. **Figure 3-9** presents the comparison before and after the crash. **Figure 3-10** and **Figure 3-11** show the seating dimension and the hook connecting the seats and the bus body as mentioned.

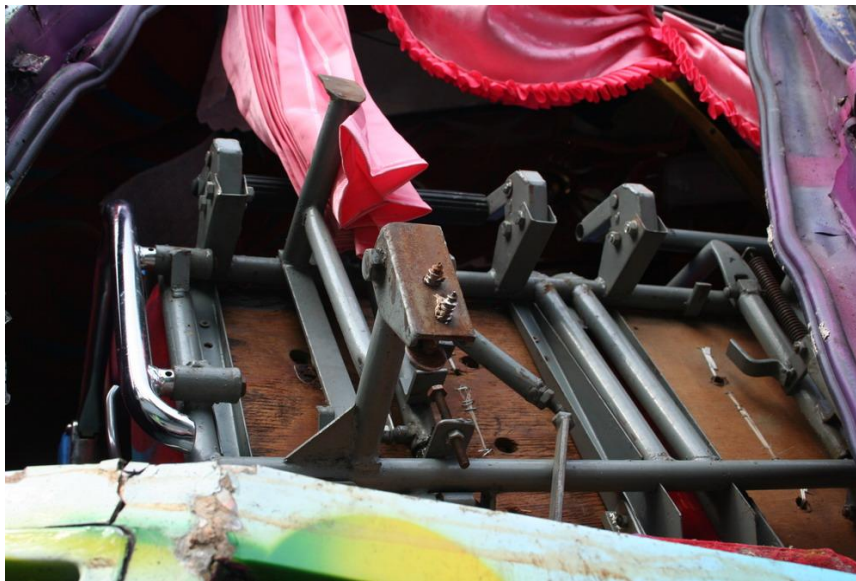
Figure 3-12: Lower Deck Seat

Three seats on the lower deck (Seat No.42-47) were installed to the floor with connecting bolts. There was only one set in place, while the other two were missing. **Figure 3-12** shows that the bolts were still firmly screwed to the steel structure.

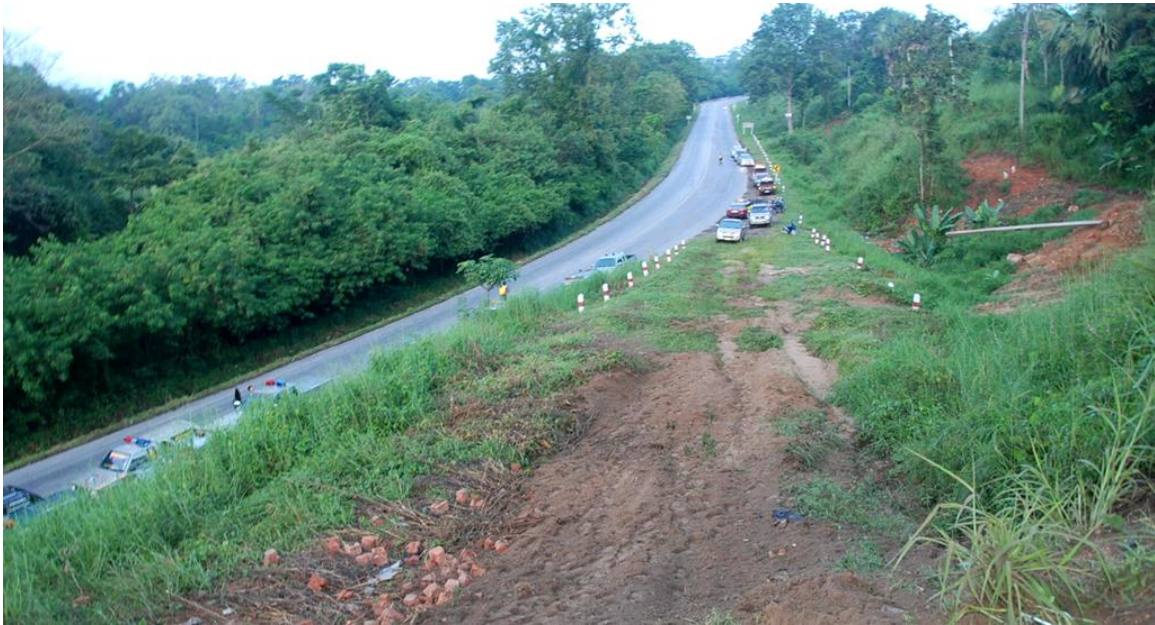
Figure 3-16: Ramp Condition after Crash

After examining the crash scene starting from the previous curve to the crash scene, no distinct marks showing the bus movement, evasive maneuver or tire marks, prior to approaching the emergency exit were found. The condition of the ramp, however, was modified during the time the TARC team performed its investigation. Therefore, some information of the ramp relied on the photos from local news reporters. As clearly seen from **Figure 3-16**, there were no sliding wheel tracks printed on the ramp, even between the wheels and grass nearby.

A speed-distance calculation was performed to determine the ability of the emergency ramp to reduce the speed. Fixing a coefficient of friction equal 0.6 on 6.7% grade uphill as measured from the scene; the speed drops only by 9-10 km/hr if entering a speed between 51-58 km/hr. The efficiency of the ramp is possibly reduced by the natural compaction of the gravel pavement over time. It was revealed from relevant agencies that this exit has been improved the roughness condition monthly. However, the soil was easily compacted again after pouring of the falling rain.

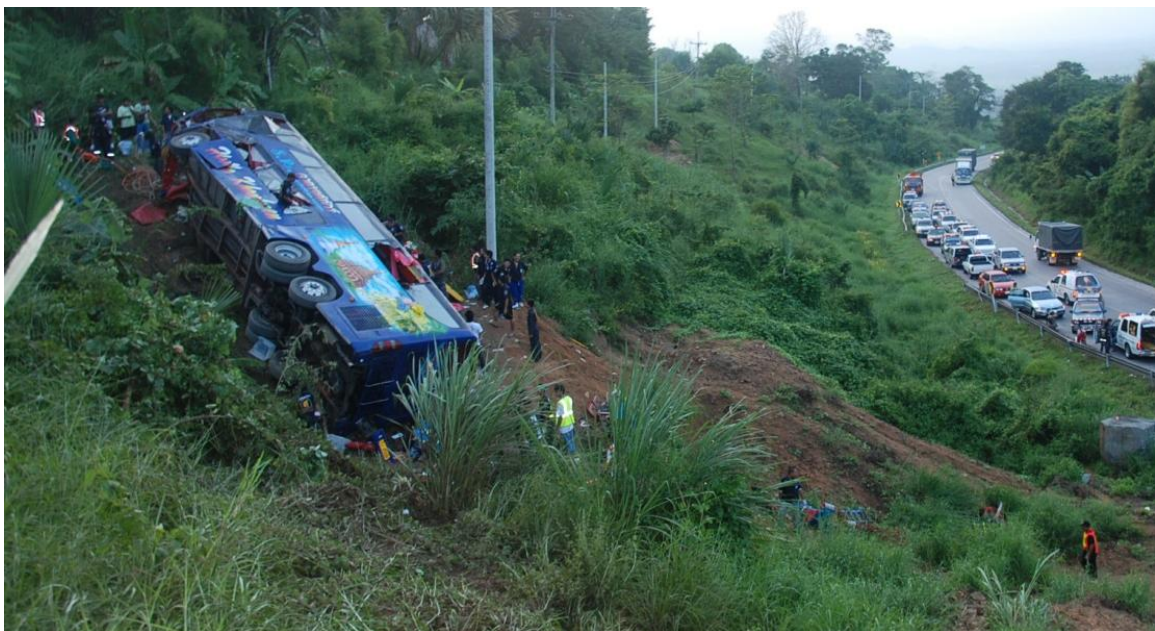
Figure 3-17: Point of Rest

After the bus reached the top of the hill, it suddenly fell into a 24% downhill hillock and hit the embankment with its front, considered as Point of Impact (POI). The bus overturned and kept moving for some distance and stopped on its left side (**Figure 3-17**). The total distance the bus moved from the top to POR was about 40 m. (inclined distance) as shown in the moving diagram in **Figure 3-18**.

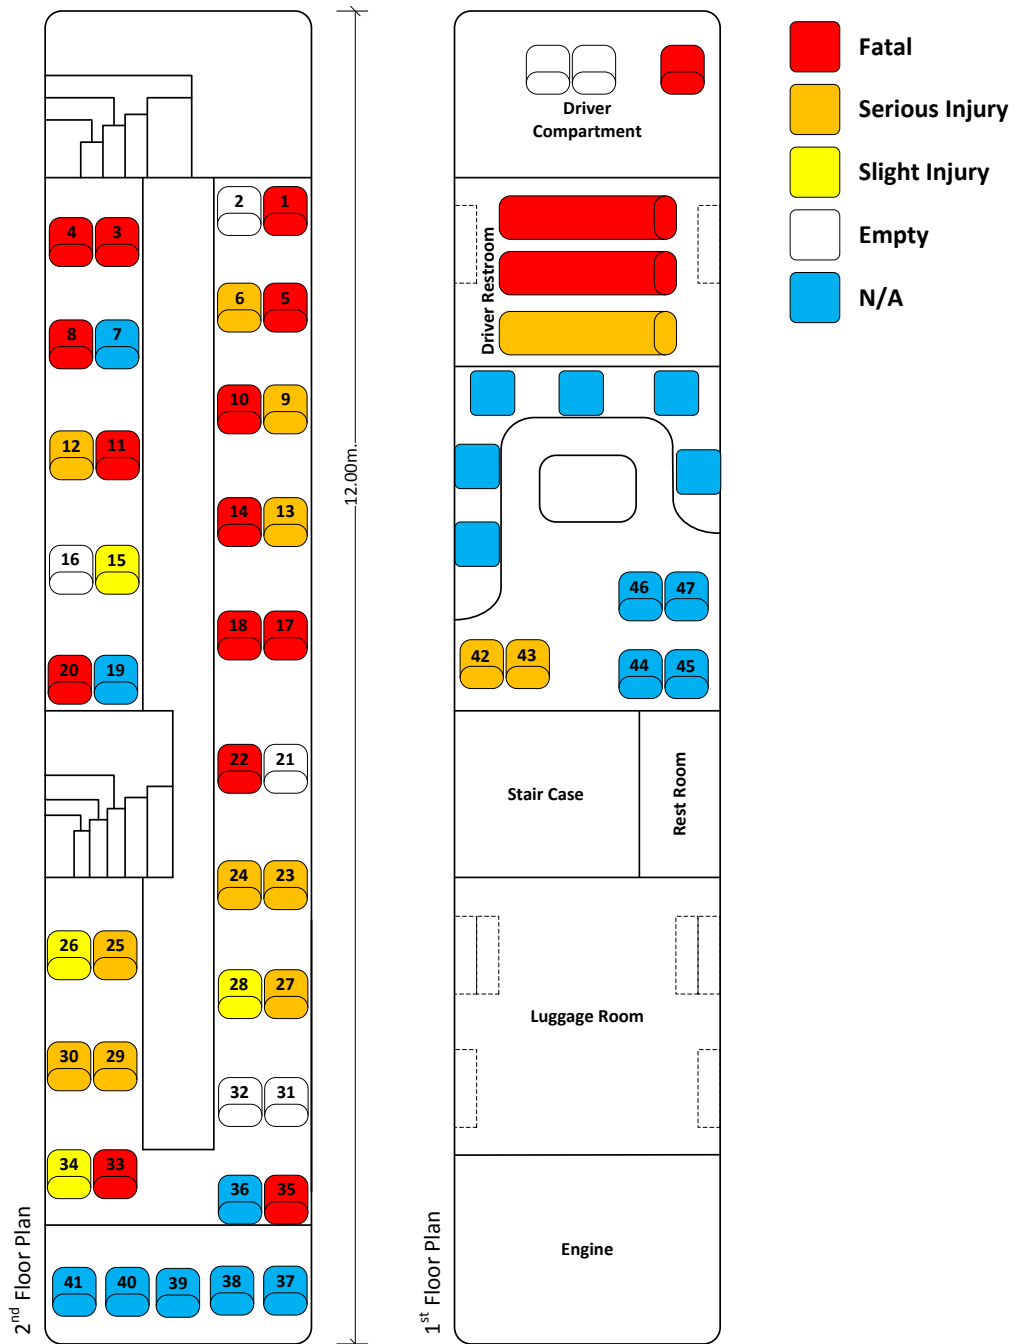
Figure 3-19: Seating Positions of Occupants inside the Bus

There were 21 fatalities, 17 serious injuries and 10 slight injuries reported from this crash. **Figure 3-19** shows the diagram of seating position of the occupants by severities. The red shows fatalities, orange the serious injuries and yellow the slight injuries. Unspecified occupants are shown in blue. The detail of injuries information is shown in **Table 3-5**.

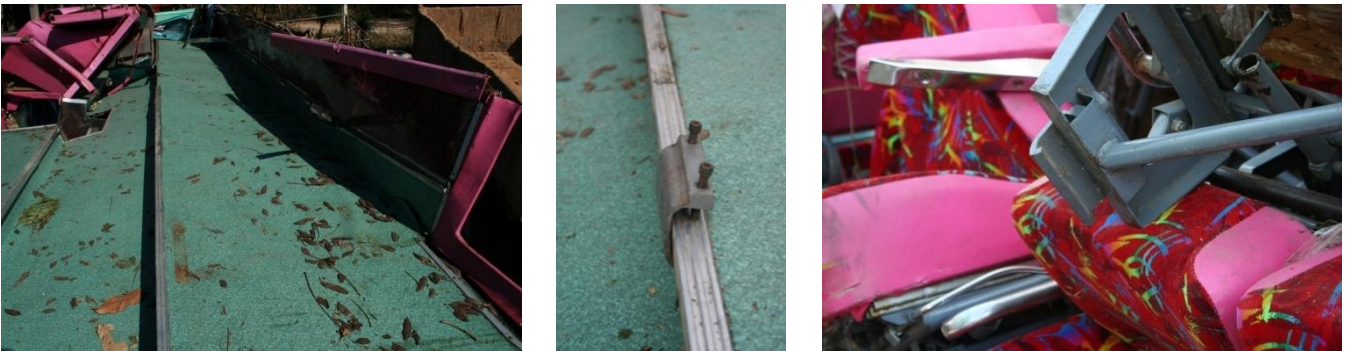
Figure 3-20: Detached Seats of the 19 January 2007 Bus Crash

People bouncing on each other and the seats detaching from their position caused harm to the occupants during the event of crash, according to victims statements. The crash consequences were reminiscent of another bus crash which happened on Highway No.304 in Doi Saket, Chiang Mai, where 17 passengers died. At that time, the seating on the upper deck detached from the body, as in this crash. It was documented that the fixing system was almost the same, where the hook fixed the seat on the bus body near the walkway, while another set of bolts was fixed into the sidebar. However, in Chiang Mai, the bus overturned more than 720 degrees, while the bus turned 90 degree after frontal impact in this crash. It was revealed from the bus manufacturer that this installation is preferred by the bus companies since it requires less time and power to rearrange the seating configuration compared to fixing the seat on the bus floor. This issue is still not addressed in the Land Traffic Act or Land Transport Act.
