# Case ID: 081212-01

## Accident Narrative

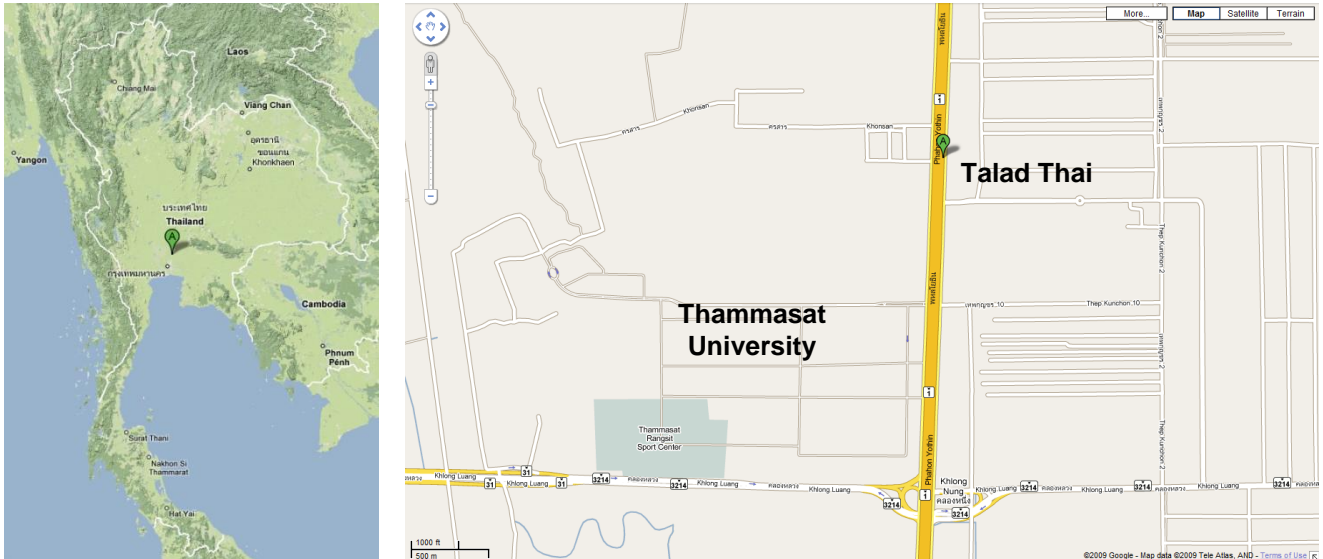
**Figure 3-1: Crash Location at km. 43+000 on Highway No.1**

At about 04:00 on 12 December 2008, a ten-wheel truck lost control on Highway No.1 (Paholyothin Road) at KM. 43+000 (**Figure 3-1**) and hit a traffic sign, causing the entire structure to collapse. The driver suffered light injuries with no hospital treatment needed.

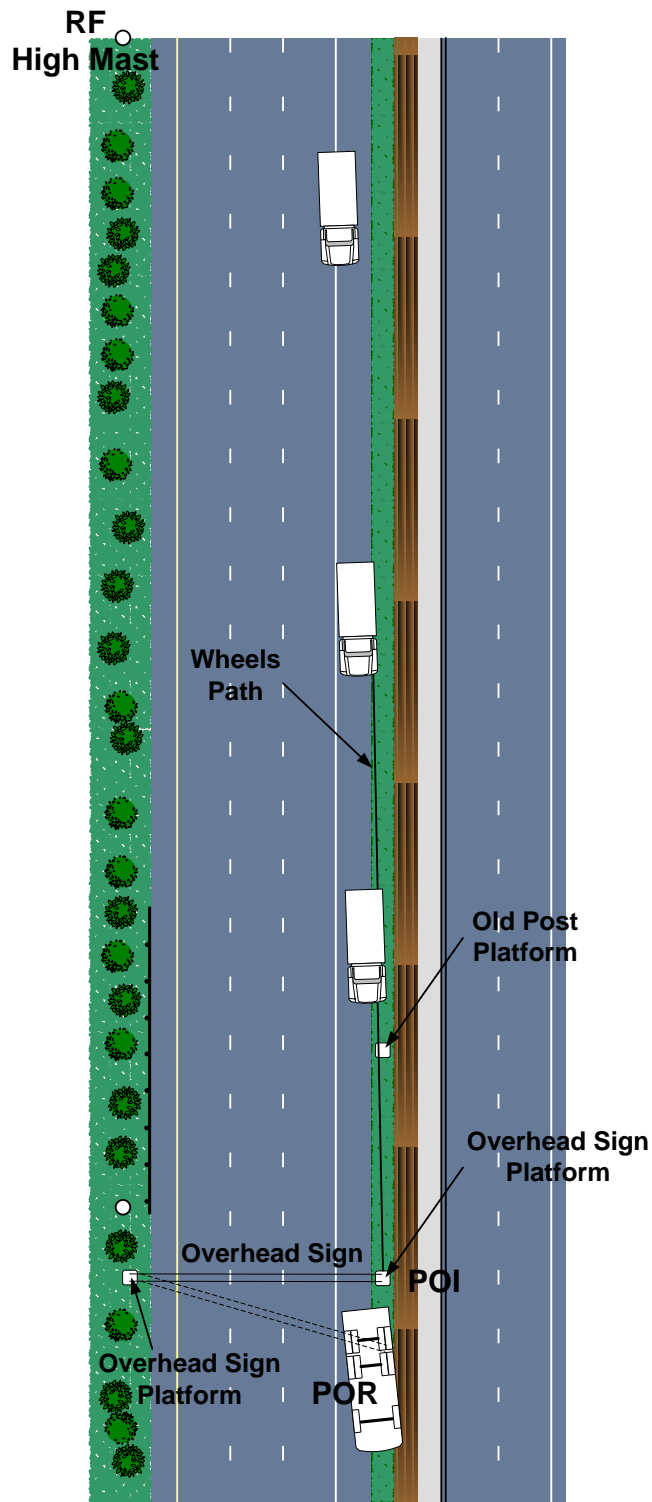
Figure 3-2: Crash Diagram

The truck, contained plastic seeds from Lopburi. As usual a stop was planned in Samut Prakarn. However, after travelling for one hour the driver admitted that he fell asleep while at a speed of about 60 km/hr. After leaving the roadway, the vehicle fell into a roadside ditch (**Figure 3-2**). It continued moving and hit a traffic sign pole. The foundation structure of the pole almost collapsed following the impact.

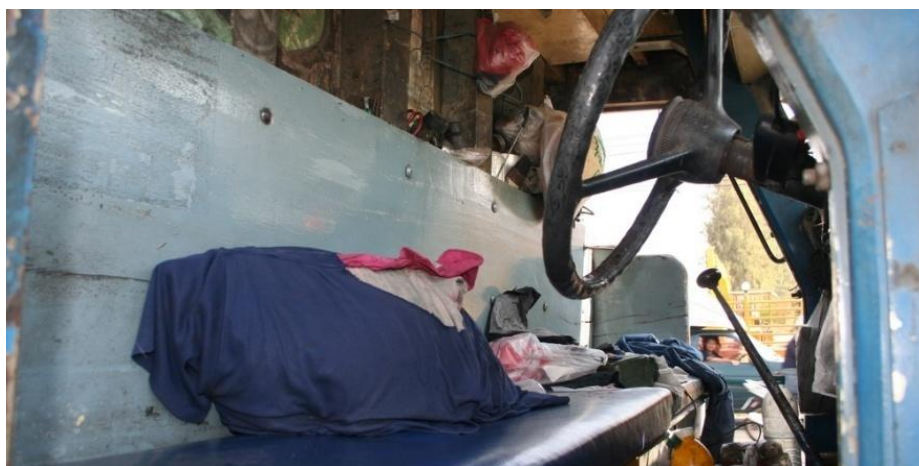
**Figure 3-4: Occupant Seat**

The driver's seat was a long wooden bench with two seating pads in the occupant compartment. No seatbelt were installed. No doors were fitted on either side of the compartment.

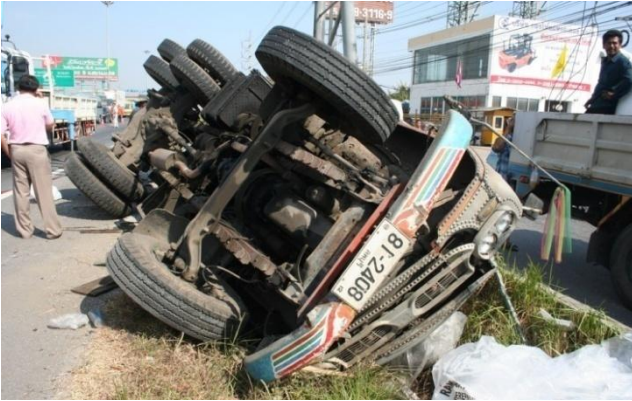
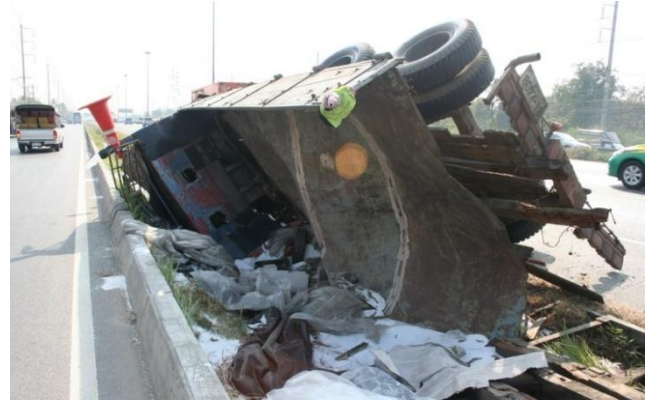
**Figure 3-5: Exterior Damage**

After closely examining the truck, it was found that the major structure of the truck was totally damaged (**Figure 3-5**). It was in the overturn position. The vertical structure and the roof were deflected and tilted to the right while frontal body was separated from its original position. A steel floor in the pickup bed was deformed by the impact during the overturn. The entire wooden seat structure was missing.

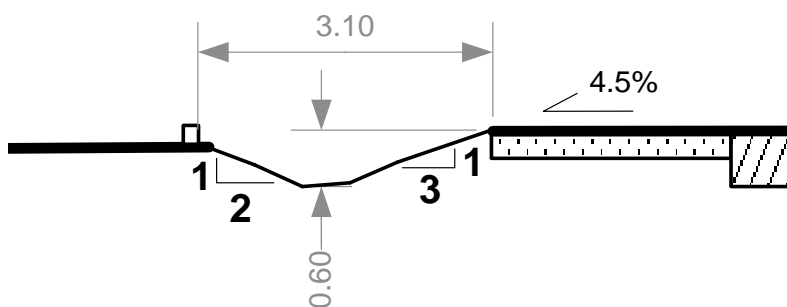
**Figure 3-8: Ditch Profile**

A waterless 3.1 m. wide roadside ditch is located next to the outer shoulder, covered with grass and small plants. A 0.6 coefficient of friction was measured. A cross section of the ditch shows a depth of 51 cm. at the middle of the canal. A 19 cm. high roadside curb is installed on the opposite side of the canal, the frontage road (**Figure 3-8**).

The overhead sign and the ditch are located along the roadside without any protection from errant vehicles. This small ditch with a slope of 1:3 was steep enough to overturn the truck, as mentioned. The level of severity was increased when the truck collided with the strong fixed overhead sign. However, the speed calculation based on the crush energy approach could not be performed in this crash since the stiffness coefficient of this late body design truck is not available.

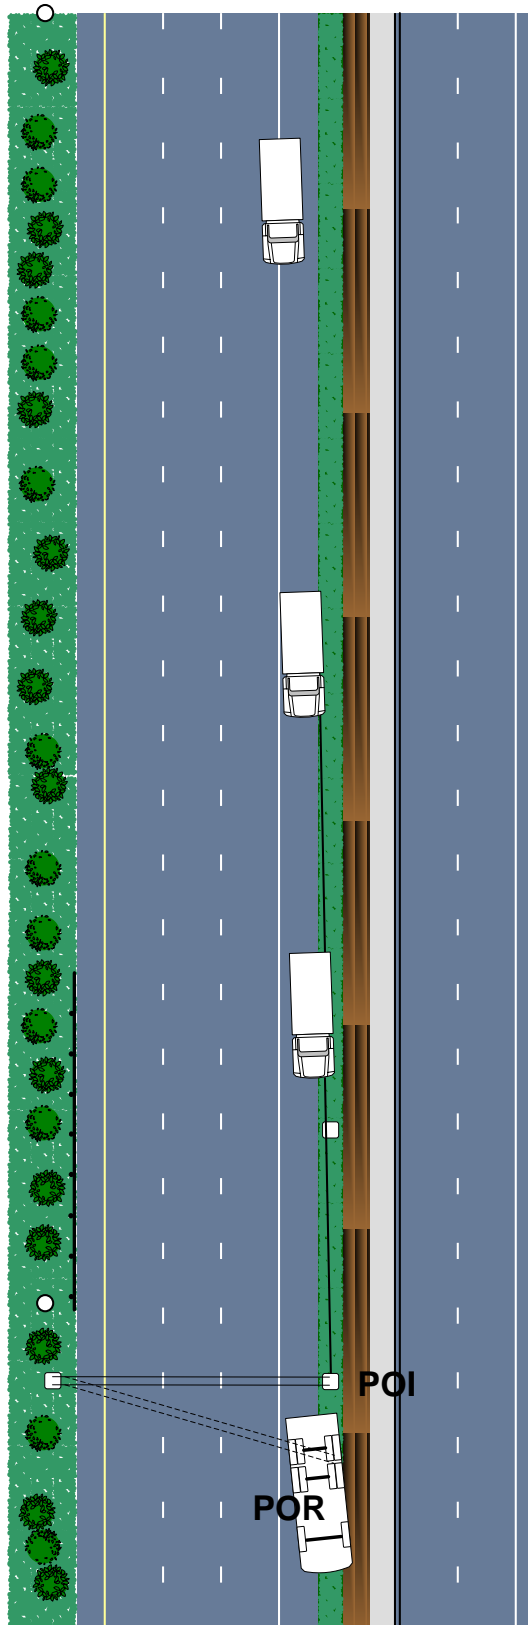
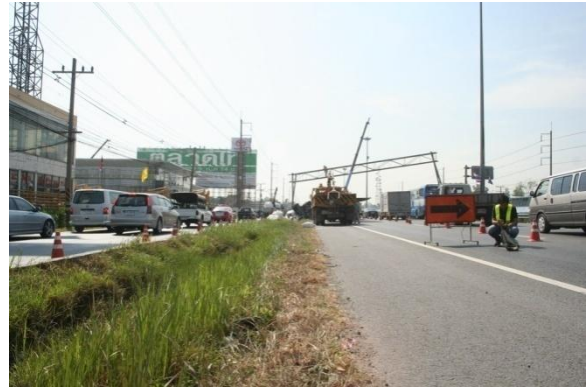
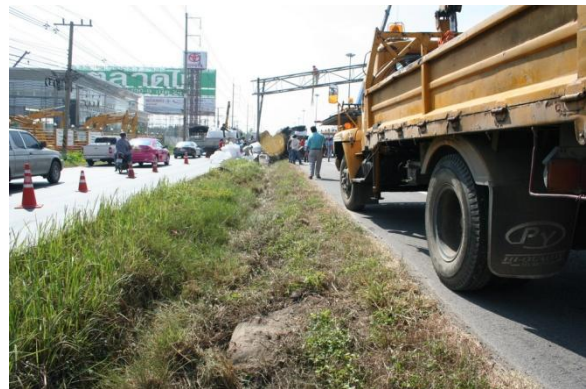
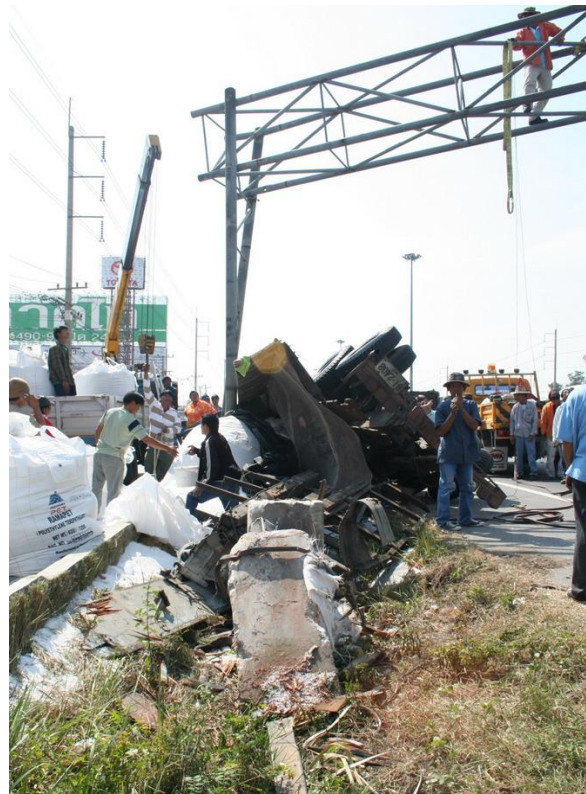
Figure 3-9: Major Events from Evidences

After examining the crash scene (**Figure 3-9**), it can be clearly seen that the wheel tracks ran out of the road into the roadside ditch. The tracks which are likely to be the left wheel showed that the truck gradually left the outer shoulder 61.7 m. before the overhead sign.

The truck then kept moving with its remaining speed and started to overturn on its left. At Point of Impact (POI), it hit the overhead sign steel column on the left side, and pushed the steel columns about 7 m. forward. During this event, the deflected concrete column was damaged and the connecting bolts disappeared. It was marked here that the truck moved past an old concrete column hit by a previous crash located about 27 m. before this damaged sign.

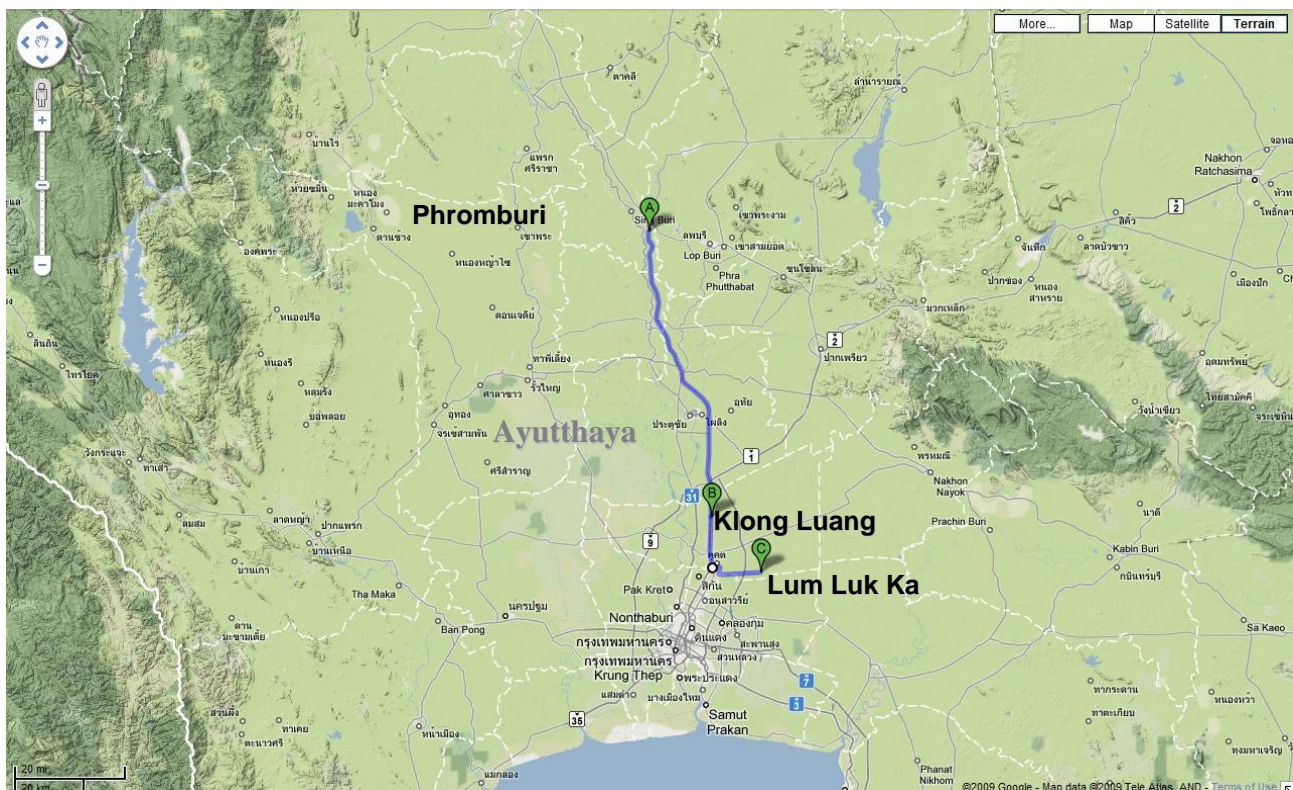
Figure 3-10: Traveled Route

The driver admitted to the TARC team that he fell asleep before the truck left the roadway. However, the distance from the point of origin to the crash scene was not a noticeably long, only 90 km. approximately. He also stated that he slept 4.30 hours the night before. Nevertheless, after leaving Highway No.32, there is no other conflict point for the traffic on Highway No.1 (**Figure 3-10**). This means that he stayed on this widen road section which is about 10 km. in length without being interrupted by any geometric changes. Likewise, according to scene documentation, there were no marks or evidences on the pavement showing the movement of the vehicle prior to leaving the roadway. No other traffic involvement prior to the crash was reported.
