# Case ID: 090213-01

## Accident Narrative

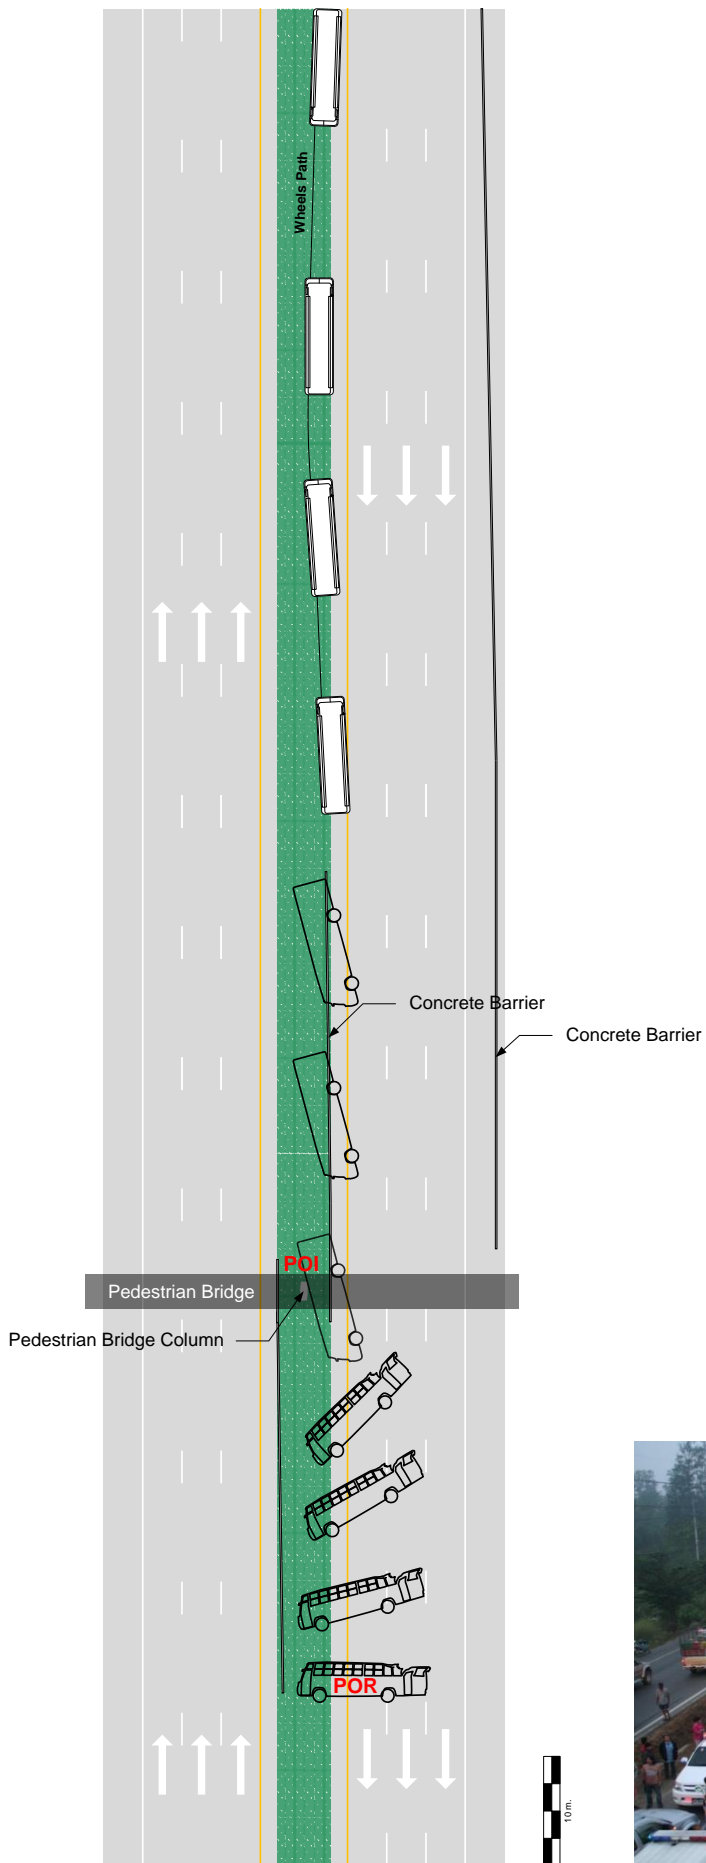
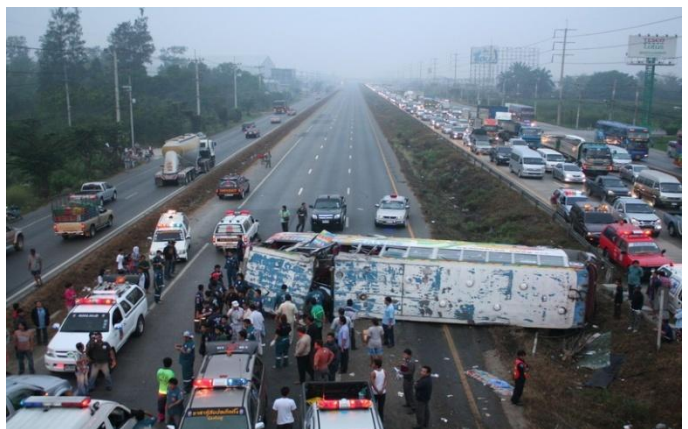
Figure 3-2: Crash Diagram of 090213-01

In the early morning of 13 February 2009, a bus driver started his routine trip from Saraburi planning to take passengers, are factory workers, to Pratunam Pra-In, Ayutthya. At about 05:50, while traveling on the right lane of Highway No.1 at KM. 62+000 (**Figure 3-1**), the bus suddenly left the roadway on the right side and ran into the depressed median. The driver tried to recover the bus back into the roadway but the bus fell down on its right side after hitting the approach concrete barrier. The main impact occurred when the bus overturned and scratched the top of the barrier. It hit a pedestrian bridge column with its roof and stopped 26 meter further away on the travelling way (**Figure 3-2**).

According to the details of the scene documentation the bus left the roadway 170 m before the approach to the bridge. The concrete barrier was unable to prevent the main impact, between the bus and the bridge column. It caused 3 fatalities, 6 serious injuries and 19 light injuries. Two fatalities were located at the seat where the roof of the bus hit the column.

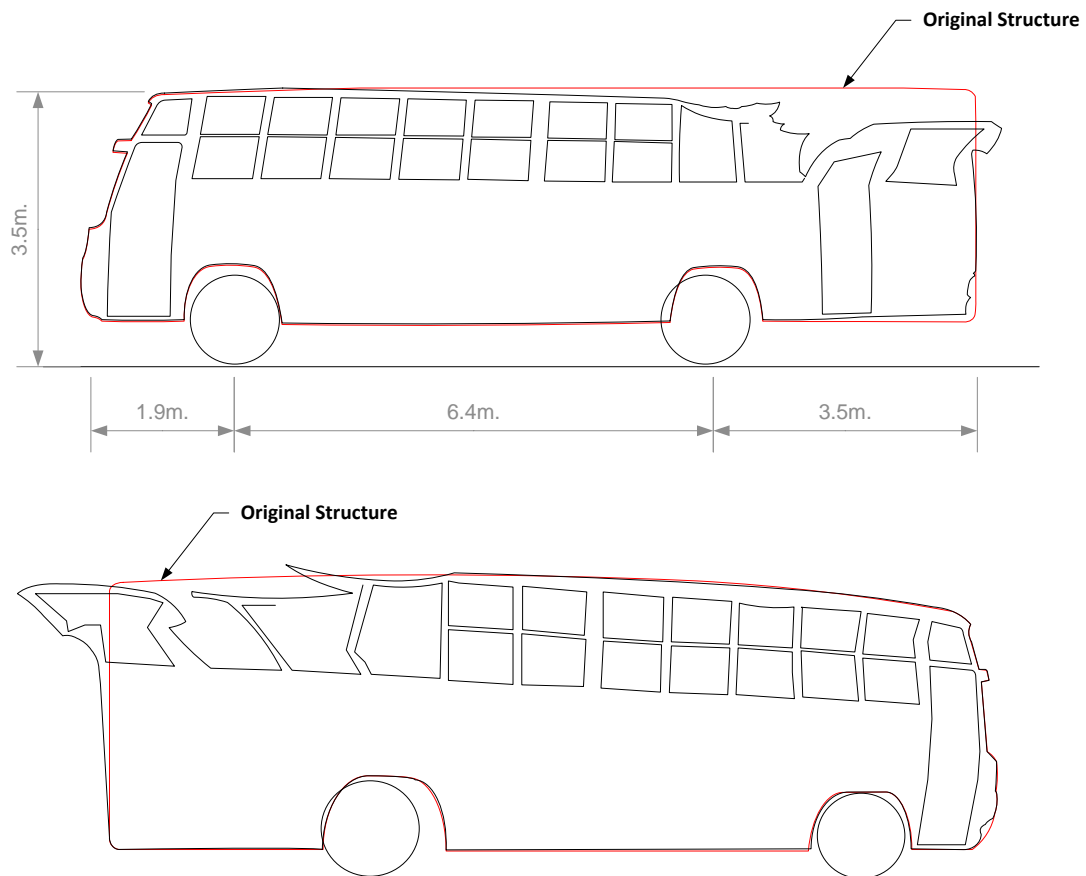
**Figure 3-5: Damage Pattern**

The major damage to the bus occurred on the roof at the position of the eleventh and twelfth rows, 9.10 m from the front (**Figure 3-5** and **Figure 3-6**). The impact force split the roof and the structure on the luggage case. Blood stains are shown at this position. There was a rupture damage with 0.80 – 1.40 m in width. The intrusion pushed and skewed the pillars on the rear part backward, causing shattered windows starting from the ninth pillar.

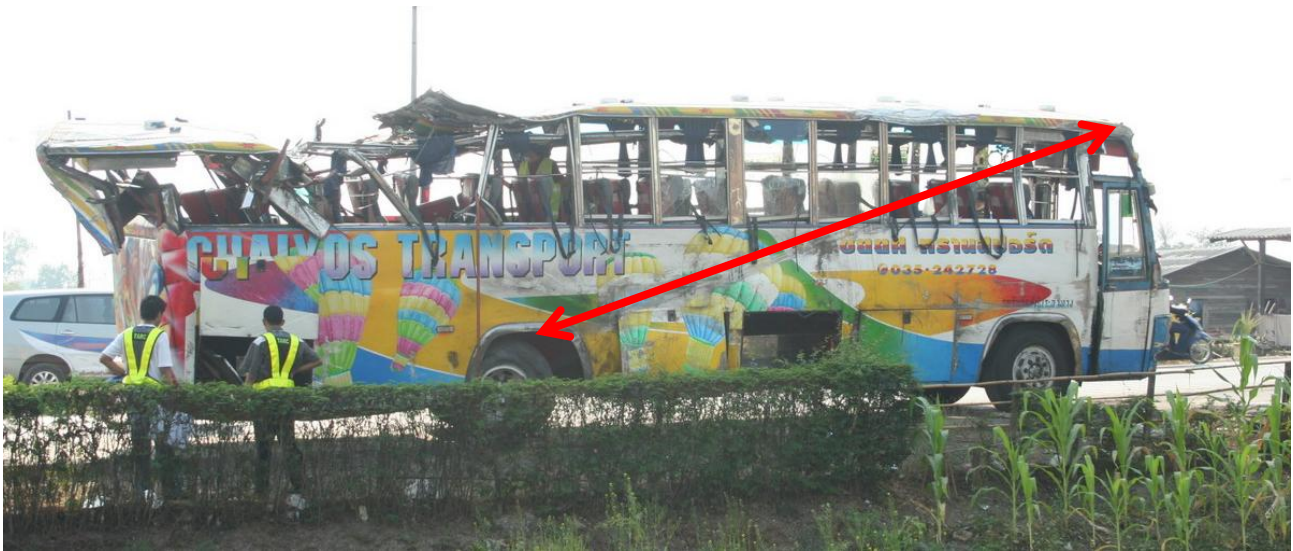
**Figure 3-7: Damage Pattern on the Right**

Another damage pattern was located on the entire right side of the bus since it stopped on the left side at point of impact. All windows were shattered. An obvious scratch mark was printed diagonally from the upper corner down to the rear axle at about 70 cm (**Figure 3-7**) from the ground. The bent rear right wheel was pushed from its original position and the rim deformed. A light damage occurred on the roof between the fourth and fifth pillars.

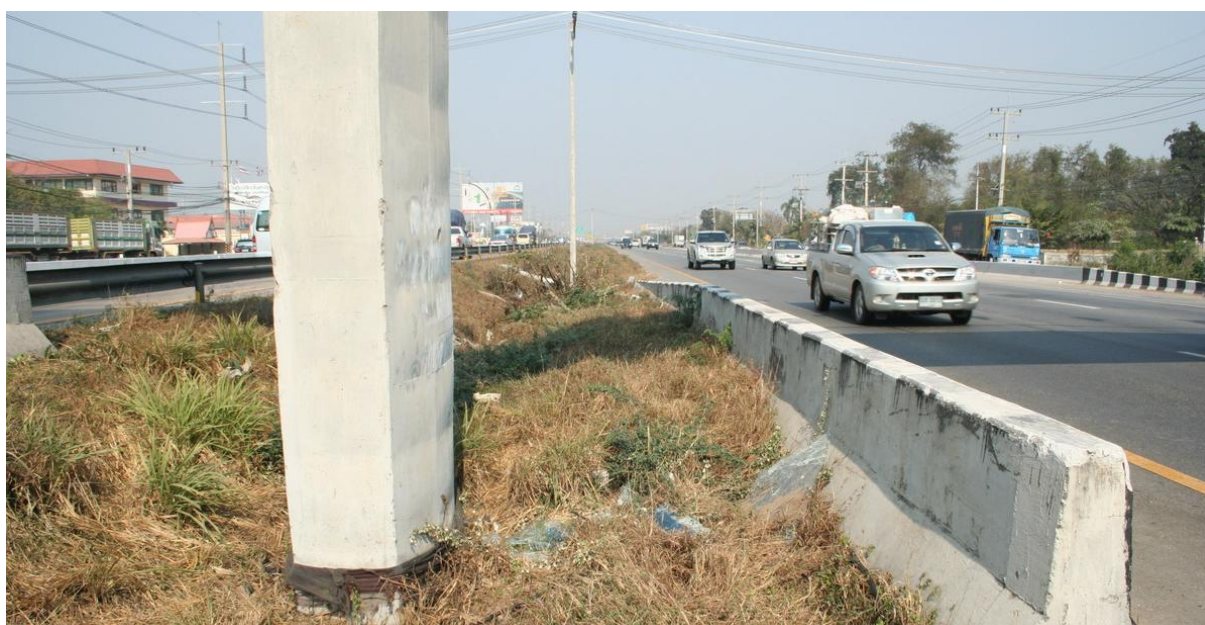
**Figure 3-9: Pedestrian Bridge Column at the Depressed Median**

A pedestrian bridge is located at km.60+300. Two 47 x 164 cm. concrete columns stand on each side of the road with another similarly sized column supporting at the depressed median. All columns are shielded by a concrete barrier, located 2.9 m. away from the columns and a continuous w-beam guardrail on the north approach only (**Figure 3-9**).

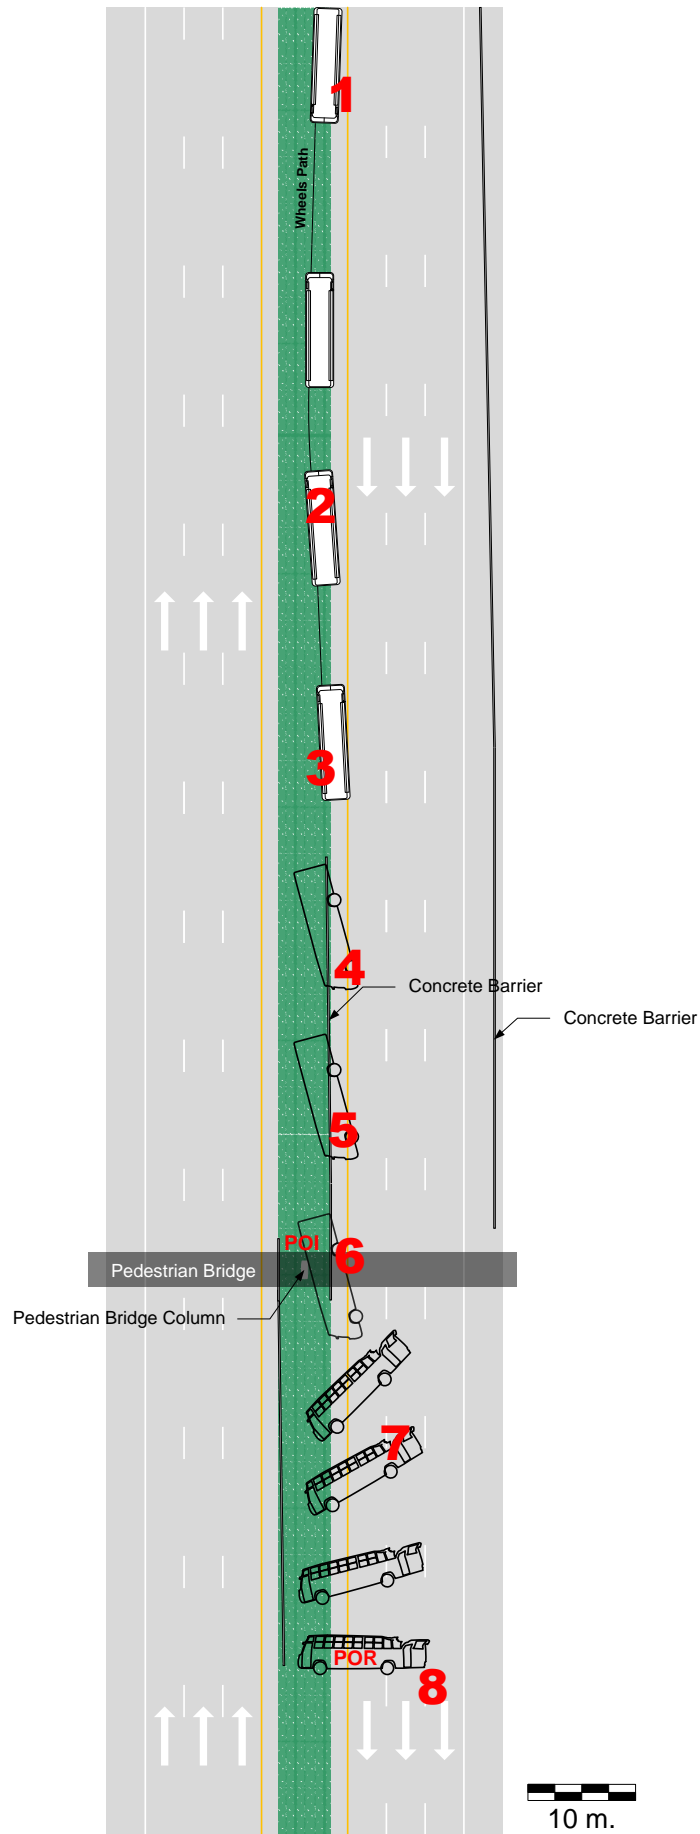
Figure 3-10: Evidences at the Crash Scene

The evidence found at the crash scene (**Figure 3-10**) showed that the bus left the roadway 170 m from the pedestrian bridge's column (**point no.1**). It started with a wheel track printed on the grass next to the inner shoulder with a tiny angle. The bus kept moving on the depressed median for about 87 m. The track then started to return to the roadway (**point no.2**). However, it collided with the concrete electric pole in the next 38 m, breaking it into three separate parts (**point no.3**).

The 14 m long tire mark was to be seen on the pavement 5m further away, next to the beginning of the approach concrete barrier (**point no.4**). The sliding tire mark printed exactly on the footing of the approach concrete barrier (**point no.5**). Within several meters further away, a continuous scratch mark was printed on the top of the concrete barrier until reaching its end. In addition, at the pedestrian bridge column, the collision debris were noted from the ground to a height of 3.5 m (**point no.6**). The Point Of Rest (POR) (**point no.8**) was located about 25 m further away from the pedestrian bridge's column. Between them, there were several landing furrows on the pavement (**point no.7**).

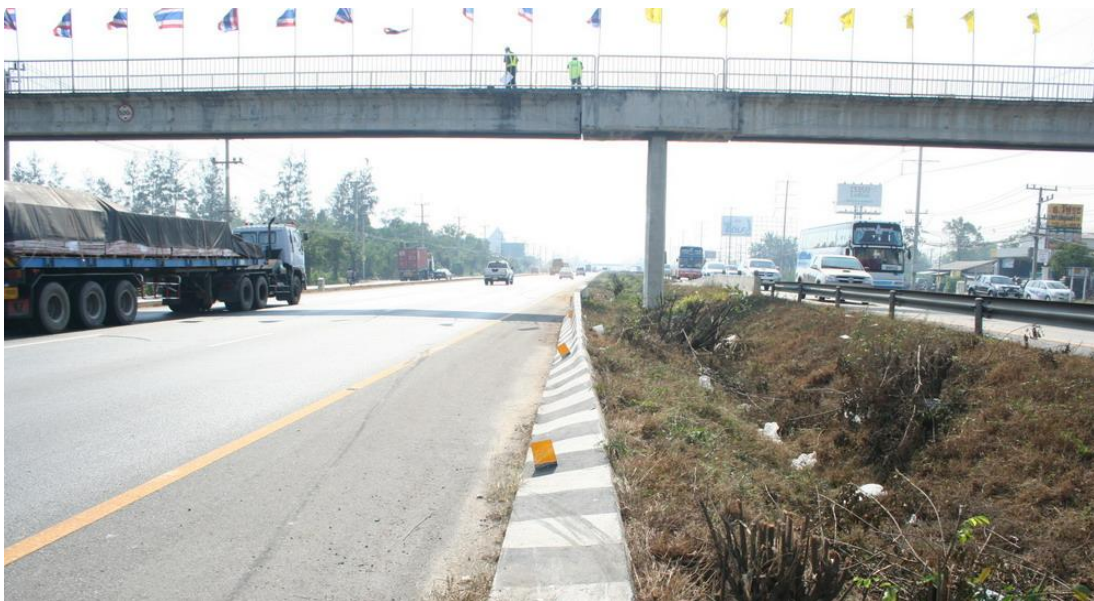
**Figure 3-11: Approach Concrete Barrier**

The approach concrete barrier (**Figure 3-11**) is installed about 38 m ahead in order to protect an errant vehicle from colliding into a pedestrian bridge's column. Nevertheless, according to the mentioned evidences found at the crash scene it resulted in a negative outcome. The marks printed at points no.4 and 5 showed that the barrier prevented an evasive maneuver by the bus driver. It made the bus to rollover onto the top of the barrier, as supported by the matching scratch marks on the right side of the bus. The situation became worse when the bus hit the column, causing massive split damage to the roof structure and fatal injuries.

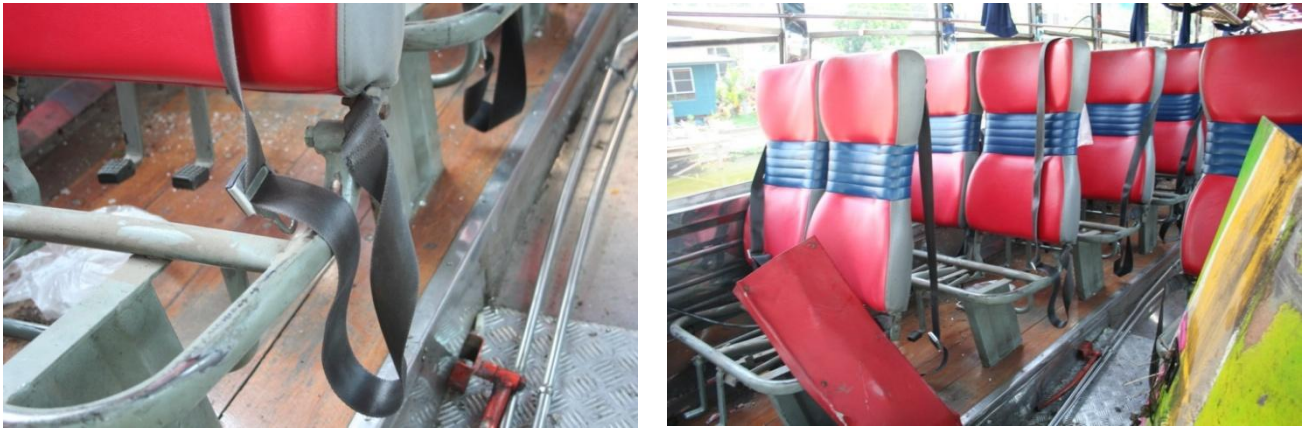
**Figure 3-12: Seatbelts**

Even though all seats were equipped with seatbelts (**Figure 3-12**) none of the occupants were reported wearing them. Similarly to other bus crashes, the level of severity of the consequences regarding occupants' injuries is increased by the collision between the occupants themselves. However, the issue of occupants' protection inside the bus was not been rose. The Land traffic act requires seatbelt usage only for the driver and front passenger.
