Case ID: 060816-01

Accident Narrative

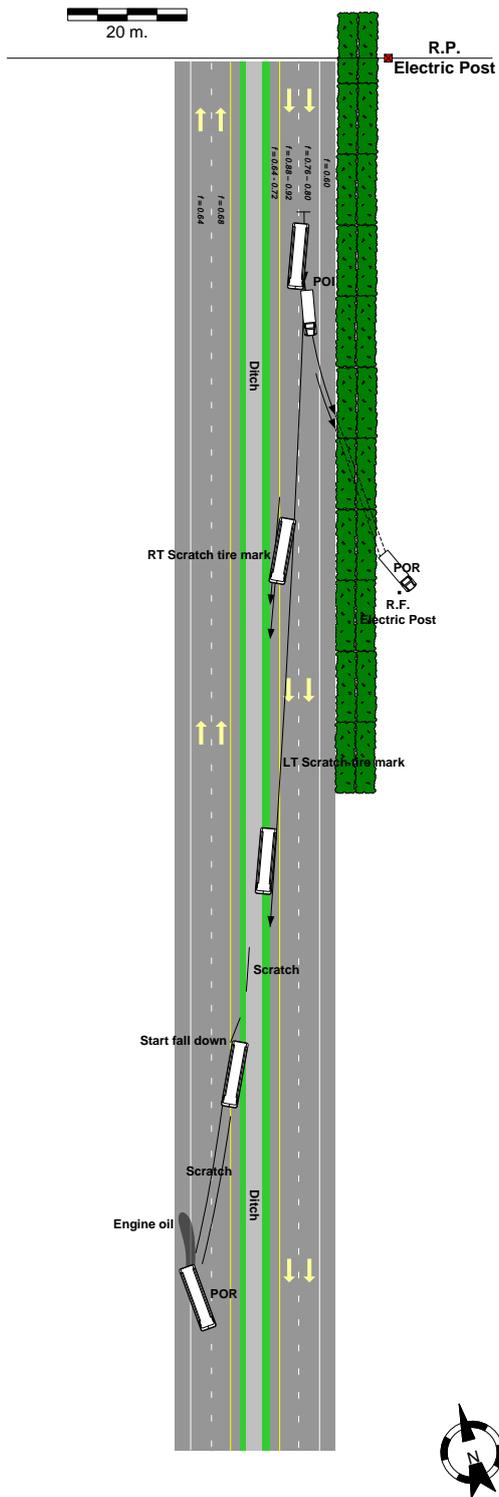
Figure 3-2: Schematic of Accident Scene

According to the bus staff, the bus left Bua Khaow, the trip's origin, at about 8:10. It stopped at Phon Tong and Roi Ed which are routine stops at around 9:10 and 10:15, respectively. Most of the passengers told the TARC team during an interview that the bus was not travelling fast, some even insisted that it was too slow for them. One passenger summarized that before crash, the bus was travelling along the 1st lane, the inner lane. After that, the driver moved to the 2nd lane, the outer lane, allowing one passenger car to take over. The crash occurred when the bus tried to come back onto the inner lane to overtake a truck in front of it but could not manage and hit at the right-rear end. The major events of the crash are shown in **Figure 3-2**.

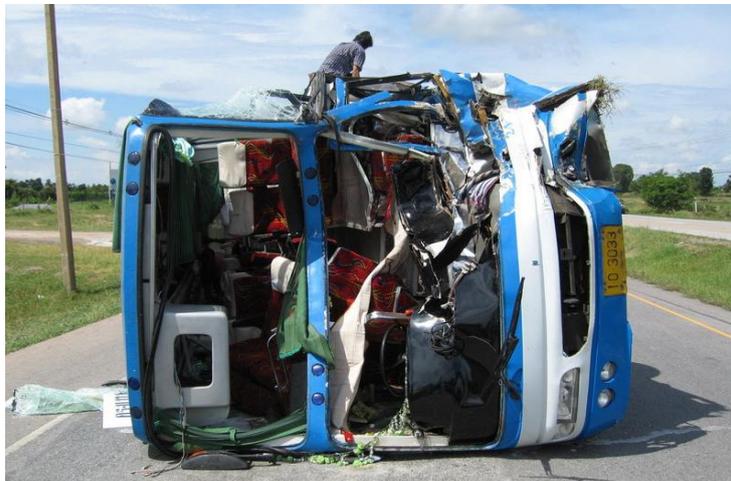
The bus rolled over on its right at the rest position. The bus sustained frontal crush and the damage extended to the exterior on the right. The windshield was missing. The windows on the right side were shattered while the first windows on the right were damaged. The front left corner showed a massive crush. All pillars on the right side were intact, while the left A-pillar (the first one), front bumper and front left door were pushed inward. The crush extended into the interior compartment. The bus staff's seat, beside the driver's seat, was displaced. Seats number 1 AB, 3AB, and 4AB detached from their position. **Figure 3-3** and **Figure 3-4** show the extent of damages to the bus.

Figure 3-3: The Bus at Point of Rest

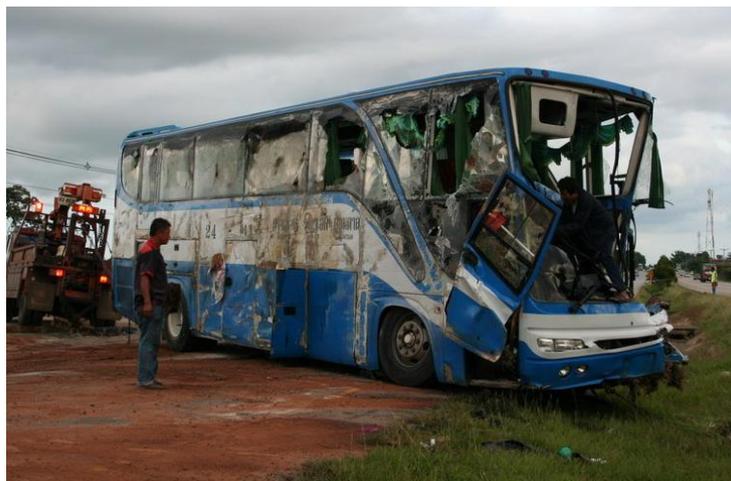
Figure 3-4: Extended Damages on the Right of the Bus

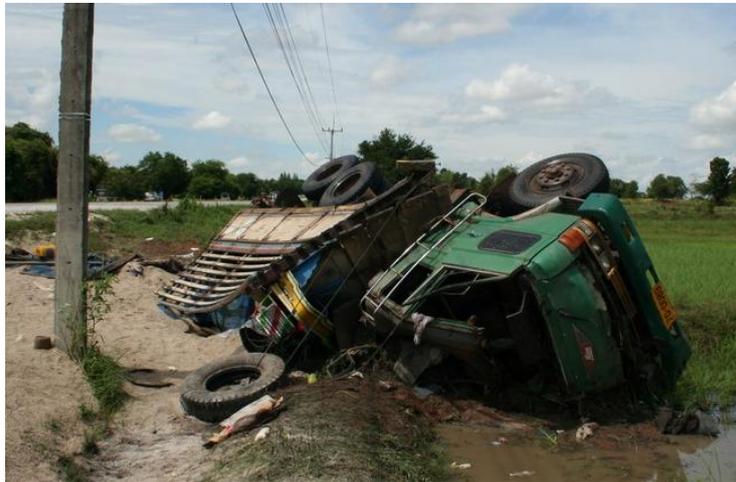
Vehicle number 2, the ten wheel Hino truck, contained a full load of salt in a wooden cargo compartment. It was green in color. During the investigation, the car was in an about 225 degree roll over. The roof was deflected downward damaging the front pillar supporting the roof. The right wooden trunk had been separated, causing the cargo material to be ejected and scattered all over the place at the truck's rest position. **Figure 3-5** and **Figure 3-6** show the extent of damages to the truck.

Figure 3-5: The Truck at Point of Rest

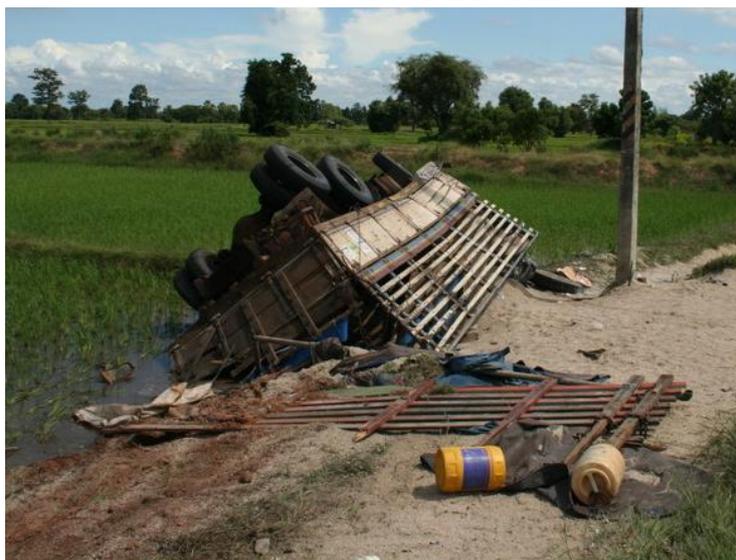
Figure 3-6: The Damage from Rollover

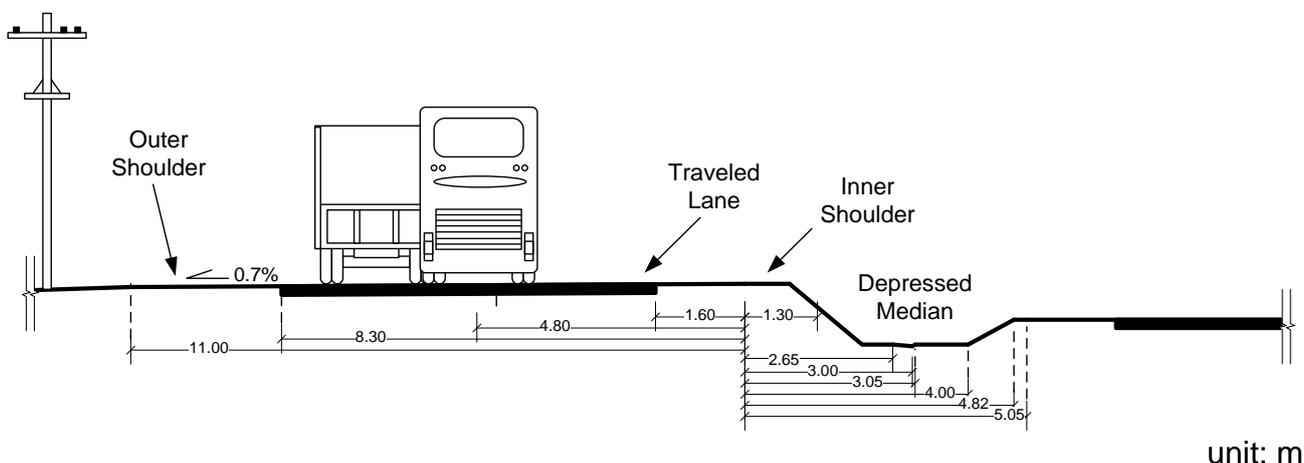
Figure 3-8: Depressed Median at Crash Scene

The depressed median was asymmetric in design since there was a roughly 0.65 m. difference in elevation of the roadway. The total width of the southbound road edge was 9.4 m. A short length of concrete open channel was installed inside the median and about 7.4 ms long scratch marks were found in the sloped open channel. The cross section of the roadway at the crash scene is shown in **Figure 3-8**.

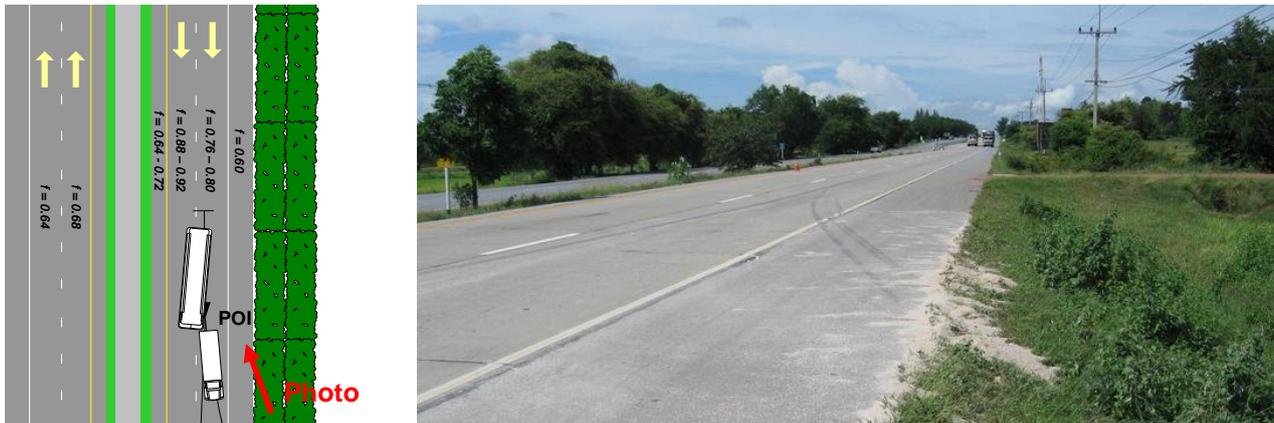
Figure 3-9: Crash Scene at the Point of Impact

At the point of impact, two obvious tire marks, single mark and double mark printed on the 2nd southbound lane, two diverging tire marks were found followed by an about 11.8 ms long single tire marks. They moved almost in the same path before separating in a Y shape as shown in **Figure 3-9**.

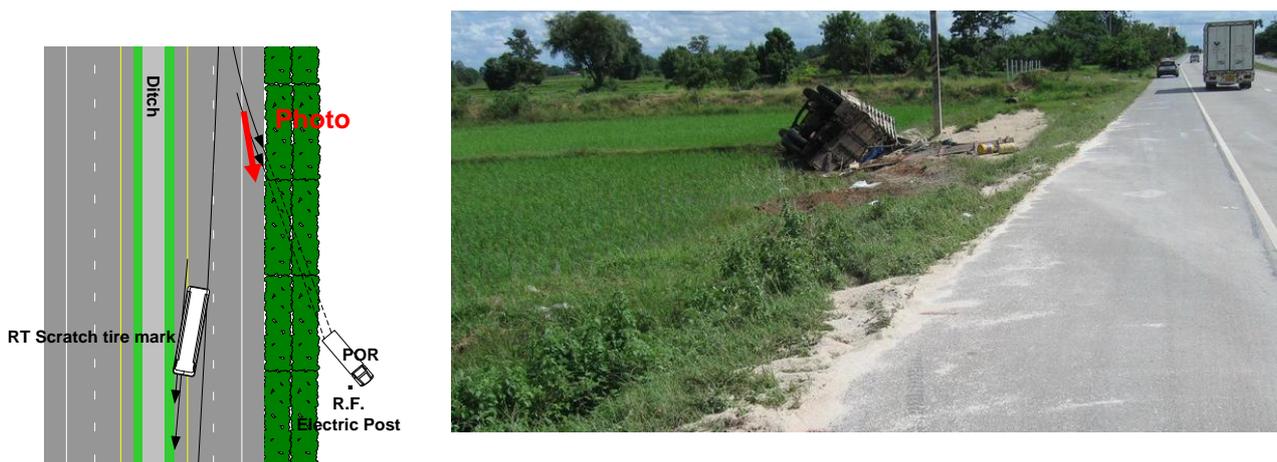
Figure 3-10: Crash Scene at the Truck's Point of Rest

The truck left the roadway after a tire mark length of about 24.7 m. from the diverging point the of Y-shape. Then it went into the grassy roadside and traveled about 13.4 m. and an additional 10-15 m. on the marshy plane before it rolled over. There was one mark showing the tire print on the soil, indicating the roll over path of the truck on its right. The salt cargo had been ejected after the vehicle left the roadside for 10 - 15 m. The vehicle stopped at the embankment near the rice field close to an electric pole. It travelled a total of about 48 to 53 m. from the point of impact, as shown in **Figure 3-10**.

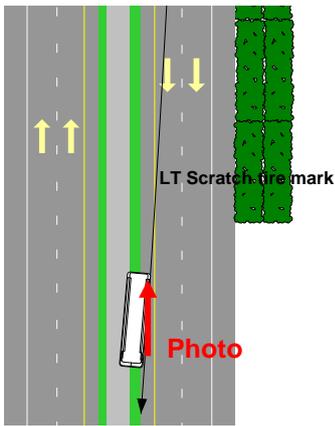
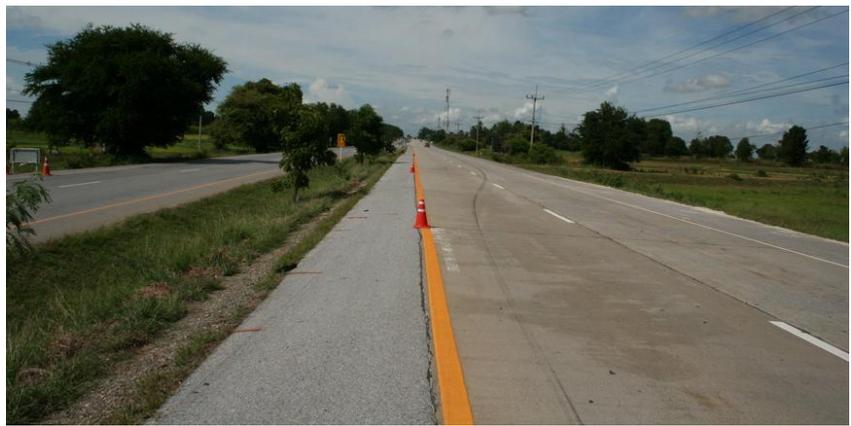
Figure 3-11: Crash Scene showing Bus Travelling Path after Collision

While the truck left the roadway, the bus still travelled about 116 m. after the diverging point of the Y-shape before leaving the shoulder. After a travel of 32.5 m., the bus swayed to the right into the 1st lane and continued to the right shoulder as found by the mark of left tire (**Figure 3-11**).

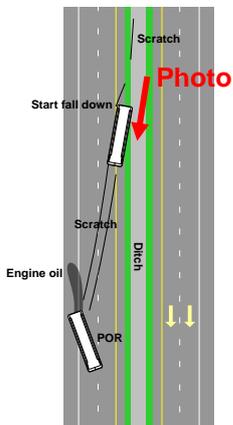
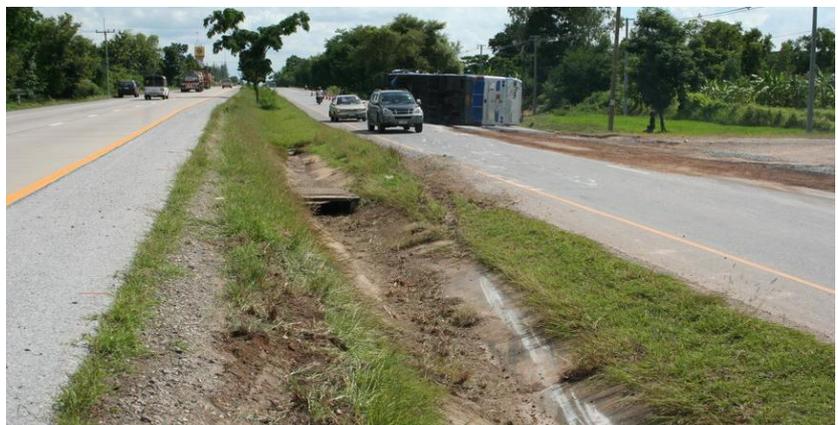
Figure 3-12: Crash Scene at the Bus's Point of Rest

Immediately after leaving the roadway, the bus started to roll over clockwise, according to the scratch mark on the concrete open channel. It kept moving on its right into the northbound lane and stopped in the rest position as shown in the **Figure 3-12**. The bus had moved about 49 ms after falling into the concrete channel to its rest position.

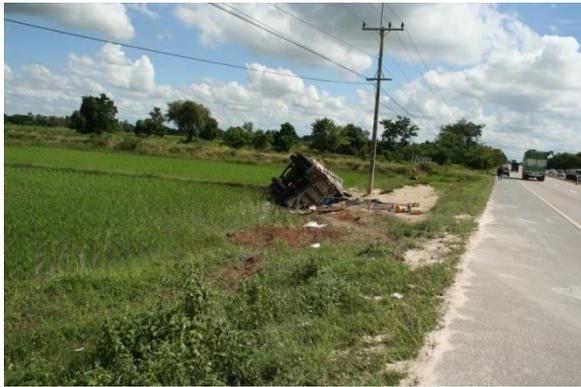
The truck was found rolled over on a roadside paddy-field, the left side of the traveled road, on its right making 0.375 turns about its longitudinal axis. From the point of impact, the truck traveled 48 – 53 m. consisting of on-road and shoulder and off-road, until it stopping in the rest position. On the other hand, the bus was found rolled over on the opposing traffic lane, right side of the traveled road, on its right making a 0.25 turn about its longitudinal axis. The total travelling distance after the crash was about 217 ms up to its rest position.

Roll-over of 10-Wheel Truck (0.375)

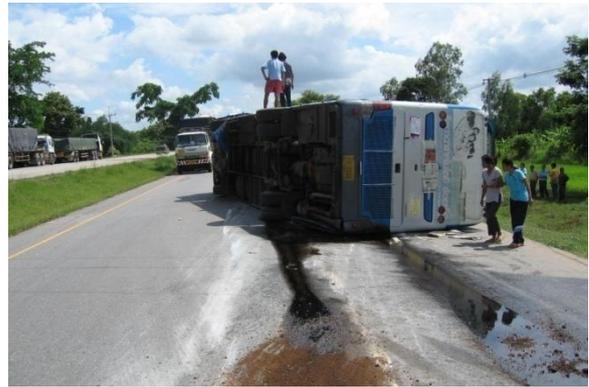
Roll-over of 6-Wheel Bus (0.25)

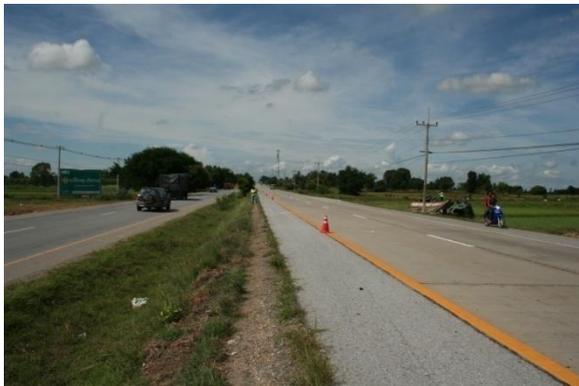
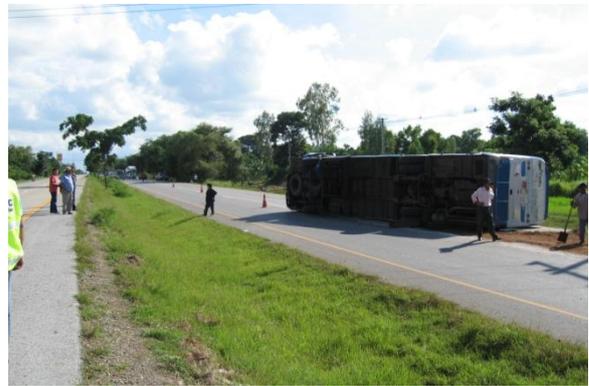
Figure 3-15: Unsafe Roadside Slope-Median

Median: There was a difference in elevation of the inbound and outbound road. The 4-lane 2-way road was separated by a depressed median of 5.05 m. (on average) wide. **Figure 3-15** shows the cross section of the highway at the crash location.

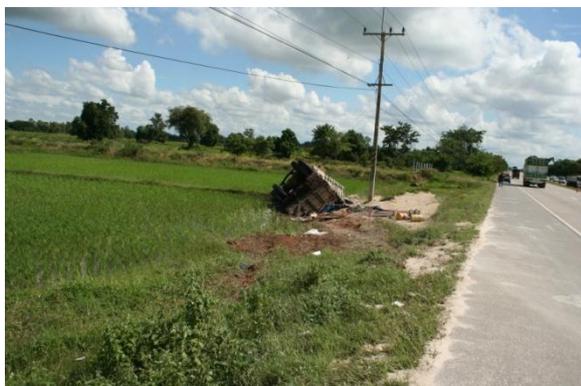
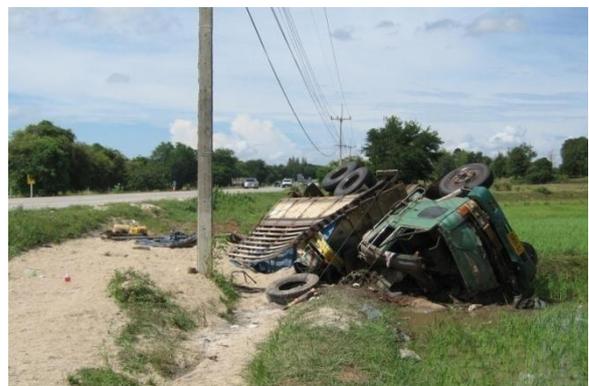
Figure 3-16: Unsafe Roadside Slope-Roadside Embankment

Roadside Embankment: On the other hand, the roadside embankment on the left side of the traveled road was not 'errant friendly' for the heavily loaded 10-wheel truck particularly the uneven road softened due to presence of a paddy-field.
