Case ID: 080929-01

Accident Narrative

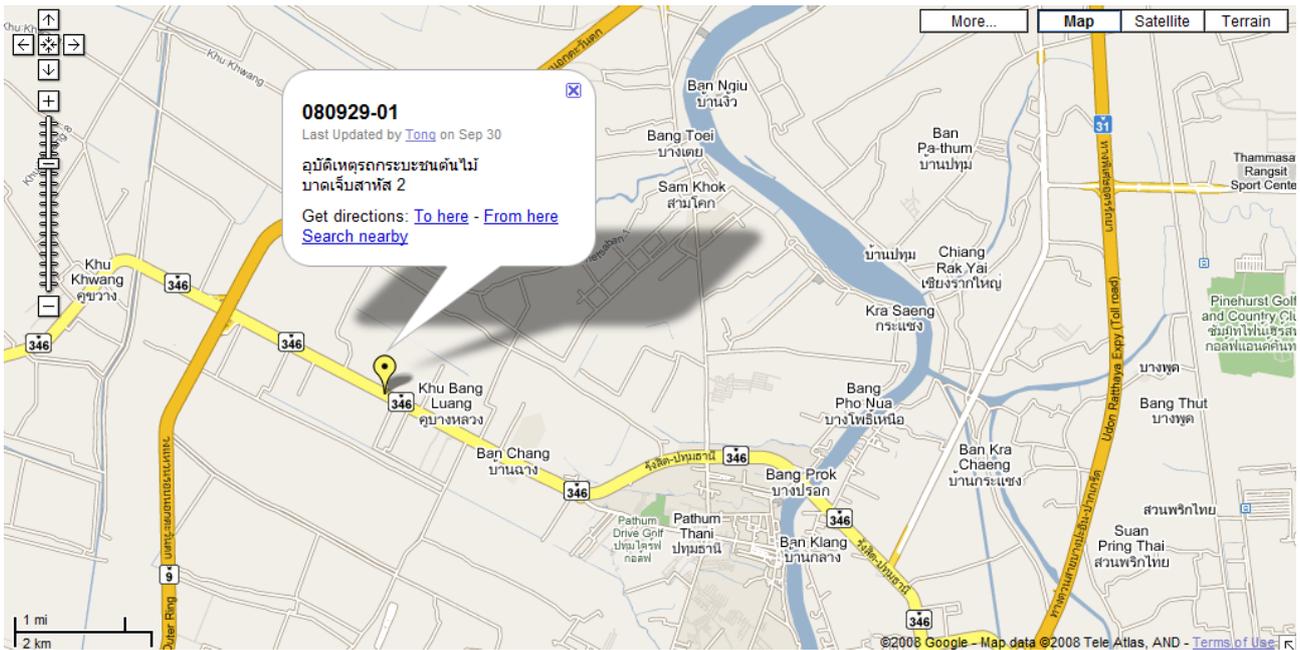
Figure 3-1: Location of Crash Site at KM. 17+500 on Highway No. 346

On a rainy 29 September 2008, a couple took a routine trip from their home in Lad Lum Kaew, Pathumthani, on Highway No. 346. At KM.17+500 (**Figure 3-1**), while traveling on the outer lane, the driver lost control of his vehicle. The pickup ran into the adjacent raised median. The vehicle then hit a Palm tree. The palm tree was broken into two parts by the impact while the vehicle was broken into three parts. The driver and passenger suffered serious injuries.

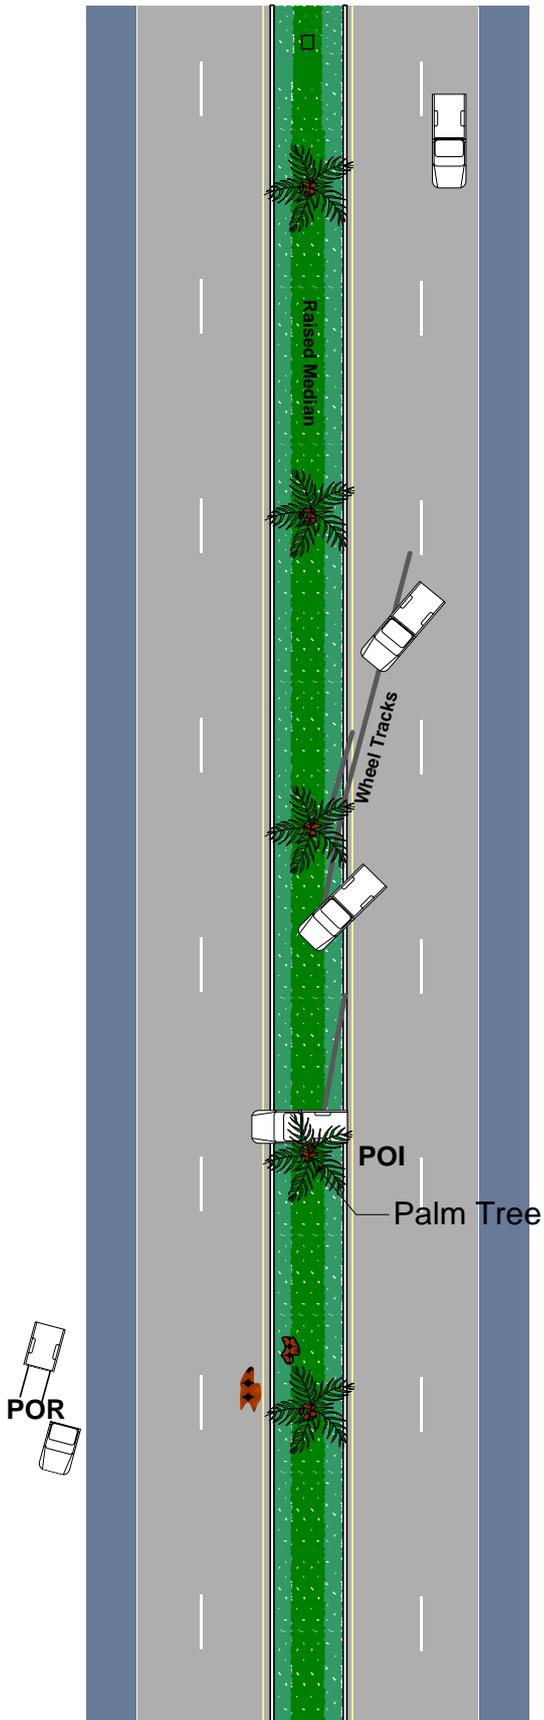
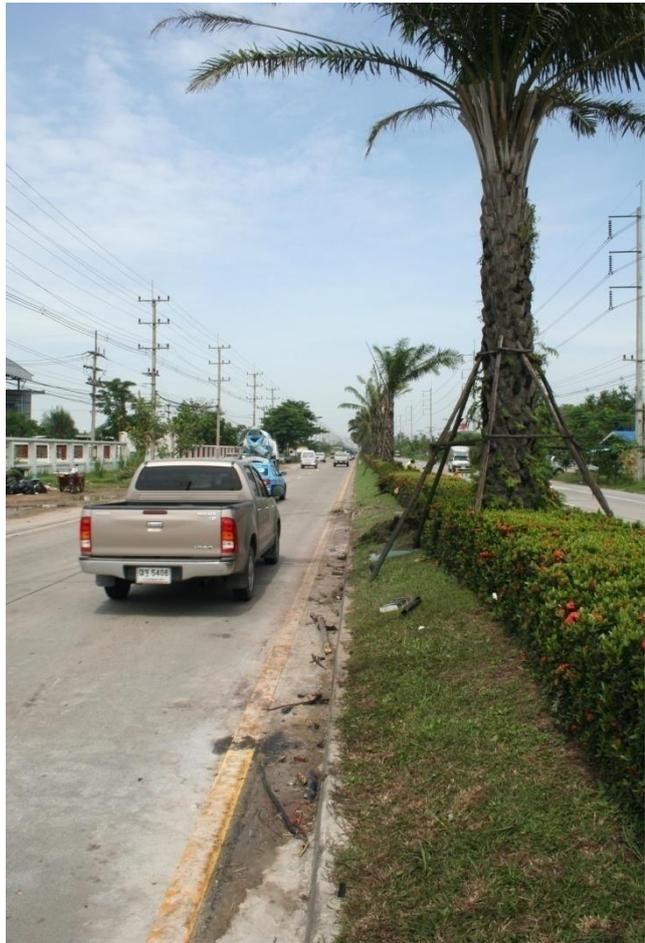
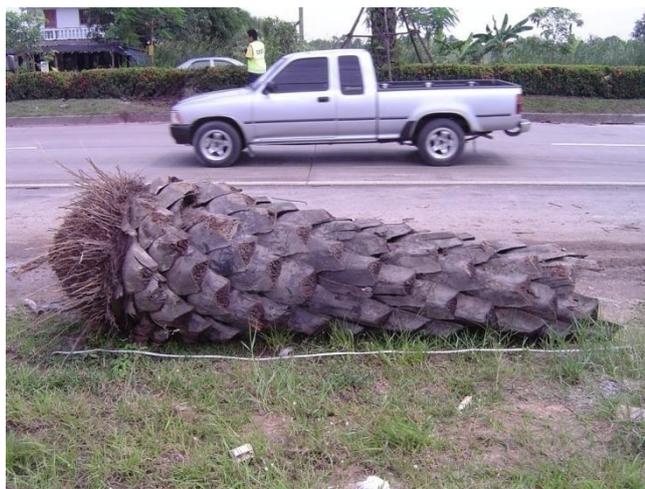
Figure 3-2: Collision Diagram

The couple had taken this route as normal for their business. They were going to take a fresh beef at Klong 1, Pathumthani, to Talad Thai (Thai Market). It was a rainy day at the time of the crash. While traveling on the outer lane, the driver found it difficult to control the pickup. It then started rotating and ran up into the raised median. It hit the palm tree by its left, causing huge damage on the pickup bed. The driver and passenger suffered serious injuries and were hospitalized at Pathumwet Hospital.

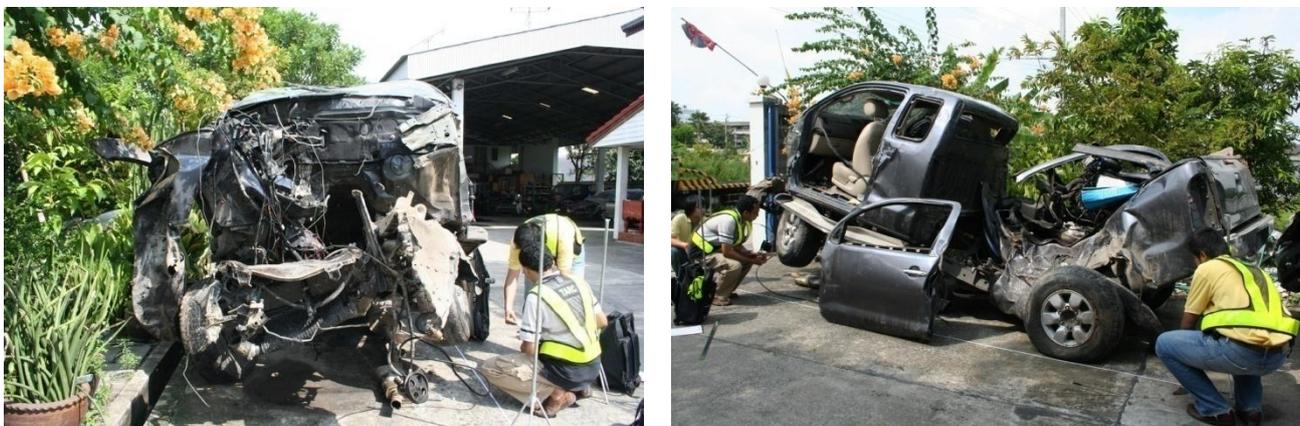
Figure 3-3: Deformed Pickup Bed

After the crash the pickup was separated into three parts; occupant compartment, pickup bed, and engine. Evidence found from the pickup bed showed that the major impact with the tree occurred on the left side, at the location between the C-pillar and the rear axle (**Figure 3-3**). It intruded into the pickup bed. The frontal body was substantially damaged. However, it was likely from the ejection of the engine as a consequence of the collision. The connected joints between the main longitudinal bars and the occupant compartment were missing.

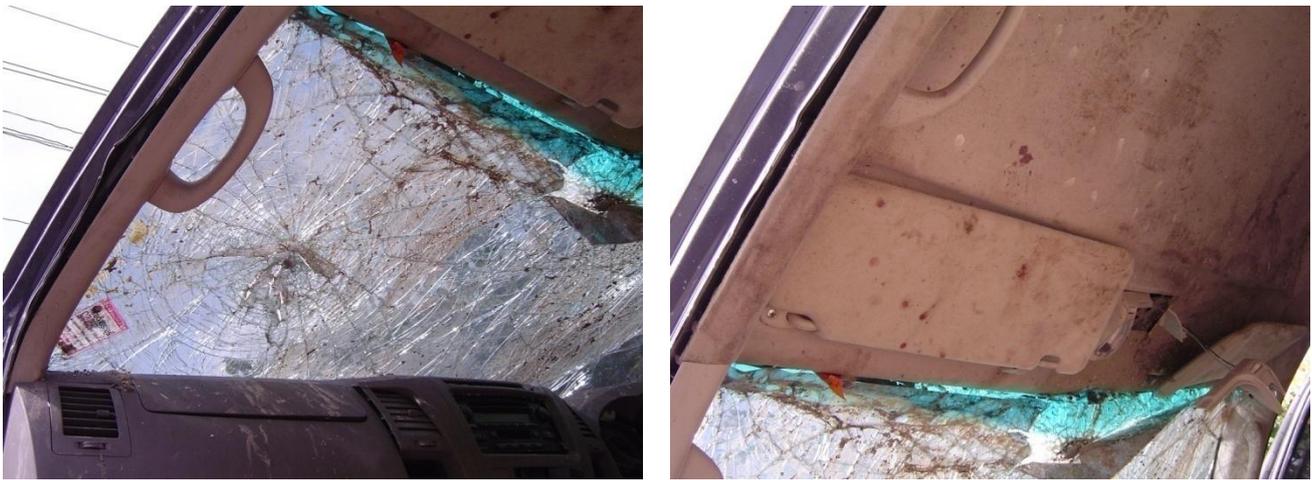
Figure 3-4: Blood Strain

The interior evidence showed a blood stain on the roof and near the door on the passenger side. Likewise, there were two damage marks on the windshield (**Figure 3-4**).

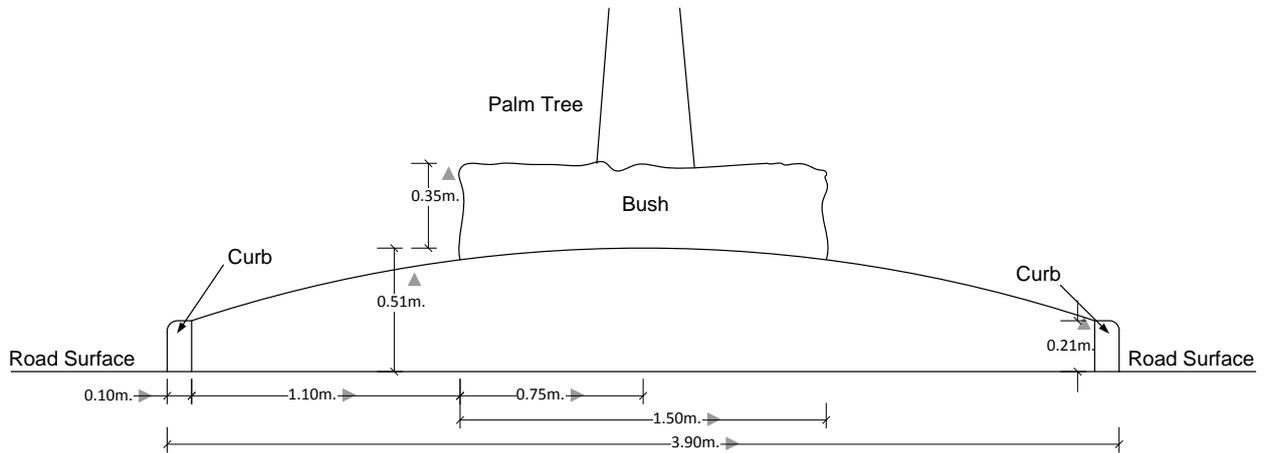
Figure 3-6: Cross Section of Crash Scene

Highway No. 346 connects Phanom Thuan, Kanchanaburi and Thanyaburi, Pathumthani. It is about 112 km. in total length. In the area of the crash, the 4-lane road and concrete pavement is divided by a 3.7 m. width grassy median. Each side of the median ended with 20x10 cm. concrete curbs. West Indian Jasmines, about 65 cm. in height, are planted at the middle of the median. The lane and shoulder width were 3.3 m. and 2.7 m., respectively. Cross section of the road in the area of the crash is shown in **Figure 3-6**.

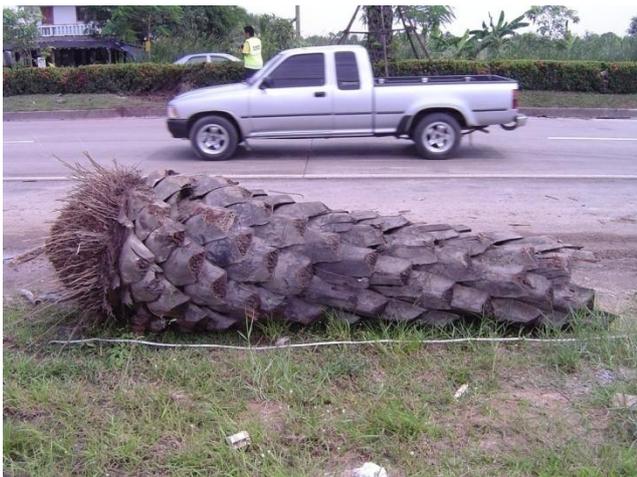
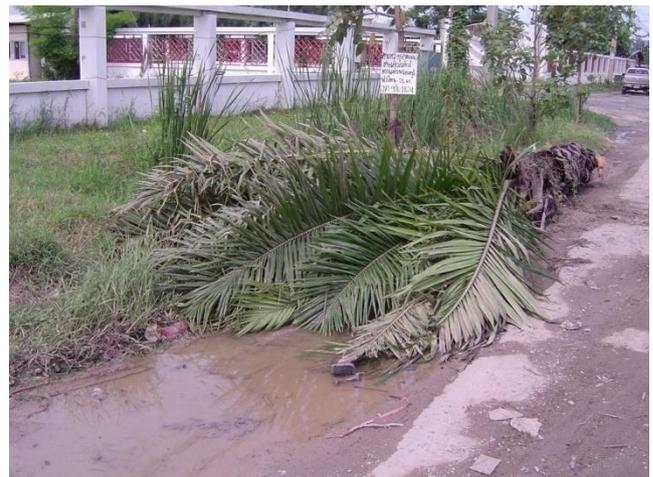
Figure 3-7: Palm Tree

The palm tree with a 10 m. height and 28 cm. diameter was planted on the median without any protection. The stem formed an elongated cone covered with the projecting remnants of the former leaves or marked with circular scars indicating the position of those leaves which had already fallen away. The space between each palm tree is about 18 m. It was found that the roots of the tree were not firmly implanted into the soil since it was not originally grown here.

The palm tree was located at the middle of the median without protection. According to the designation of raised median curb on divided highways, the median barrier, i.e. guardrail or concrete barrier, is not required. The tree is considered as hazardous object since its diameter is bigger than 10 cm. However, it had been recently removed from a farm and re-planted, so the roots were not firmly implanted thus reducing the impact force between the collided parties. However, its strength was still high enough to split the pickup into three parts.

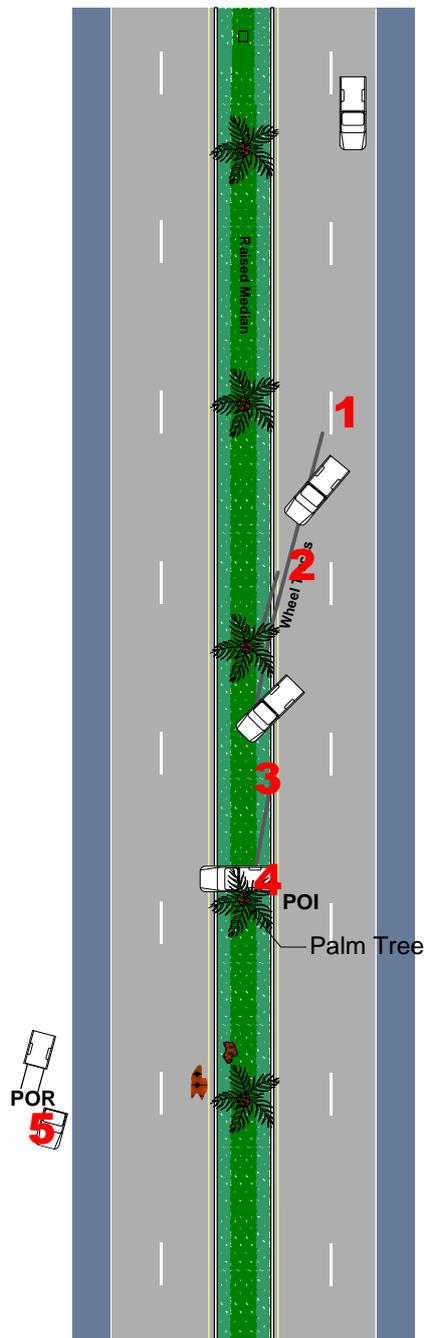
Figure 3-8: Major Events

One of the important evidence showing the movement of the pickup in this case are the yaw marks (**Figure 3-8**). They obviously started from the right lane, 28 m from the 17+500 kilometer post (1) and directed into the raised median. The scrub marks made between the front right tire and the concrete curb were printed 10 m further (2) where the pickup started moving on the median. At about 47 m from POI it showed the movement of the pickup over the West Indian Jasmines with another wheel track on the grass (3). At a point situated 60 m away from POI, the pickup hit a palm tree by its left and landed about 14 m further ahead. Three parts of the pickup separated; the engine, occupant compartment, and pickup bed (5).

The major event occurred when the pickup lost control on the wet surface. The victims and witnesses revealed that the rain had just stopped and the sight distance was quite clear at the time of the crash. While driving on the left lane, the pickup drove over a water splash. The driver then applied the brakes which resulted in the pickup spinning over the vertical axis. This kind of event is highly possibly an effect of hydroplaning.
