# Case ID: 090318-01

## Accident Narrative

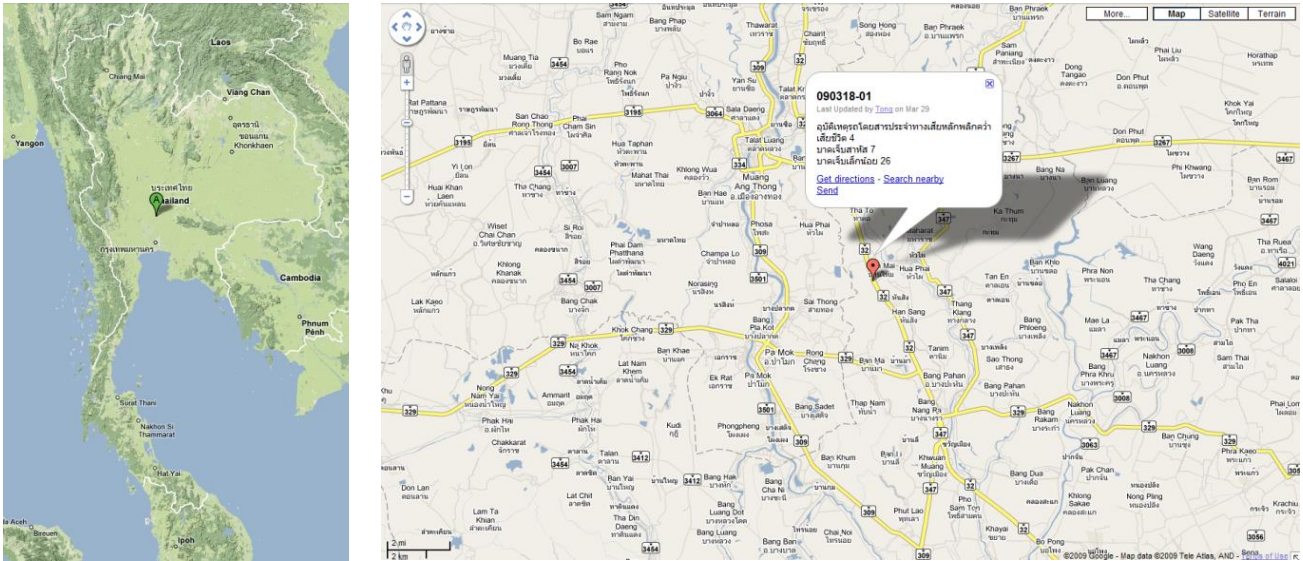
**Figure 3-1: Crash Location**

At about 09:00 on Wednesday, 18 March 2009, the double decker intercity bus, service between Bangkok and Mae Sot, lost control on a wet pavement surface while traveling on Highway No. 32 at KM. 42+600, Bang Pahan, Ayutthaya (**Figure 3-1**). It fell into a roadside slope and overturned. Four passengers out of a total of 37 on board died instantly. Another 7 and 26 suffered serious and light injuries, respectively.

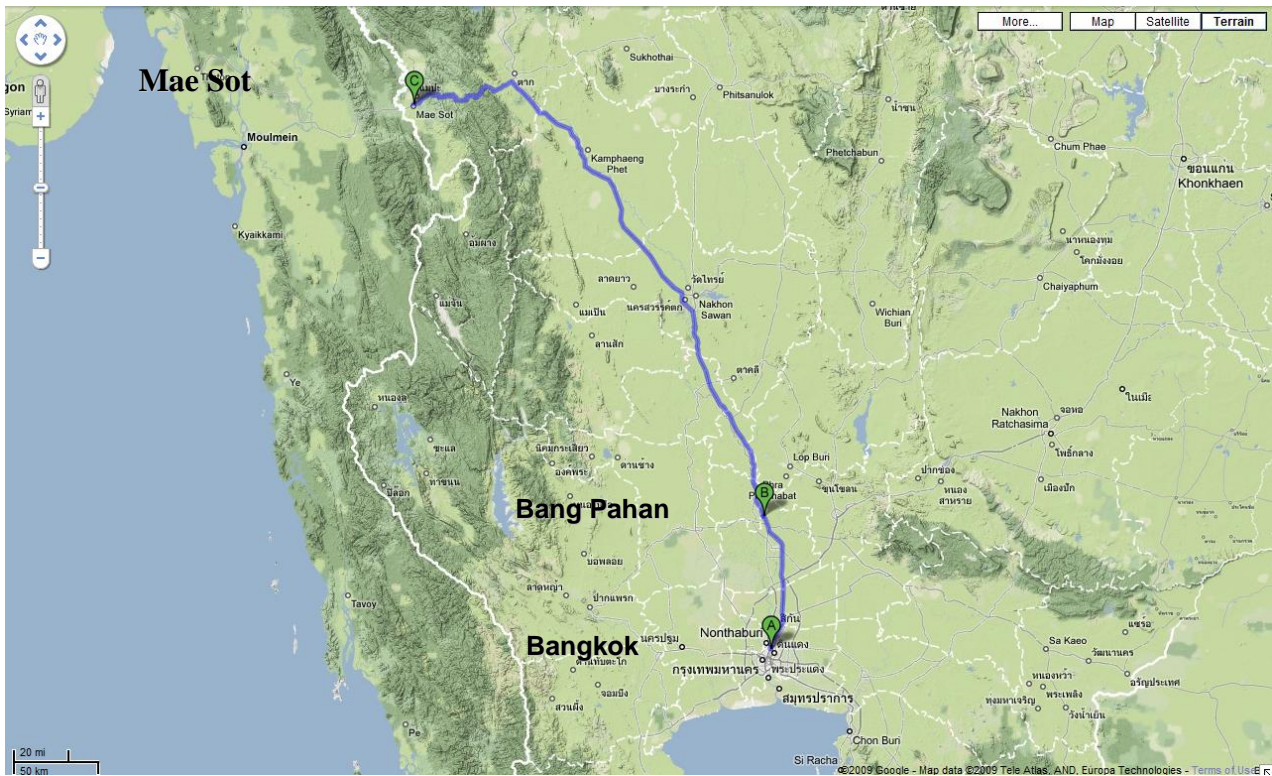
Figure 3-2: Bus Route

This morning trip started from Mo Chit 2, Bangkok bus terminal station, at about 08:15. It traveled on Highway No.1 and turned right into Highway No.32 in Bang Pa-in, Ayutthaya, planning to arrive in Mae Sot at 17:00. The bus route is shown in **Figure 3-2**. It was slightly raining and the windshield wiper was on. The bus started losing its control at KM.42+600 and swung left from the middle lane. The bus swayed two or three times, according to the witness passengers. The bus turned on its right immediately after departing the roadway, causing the subsequent injuries as mentioned.

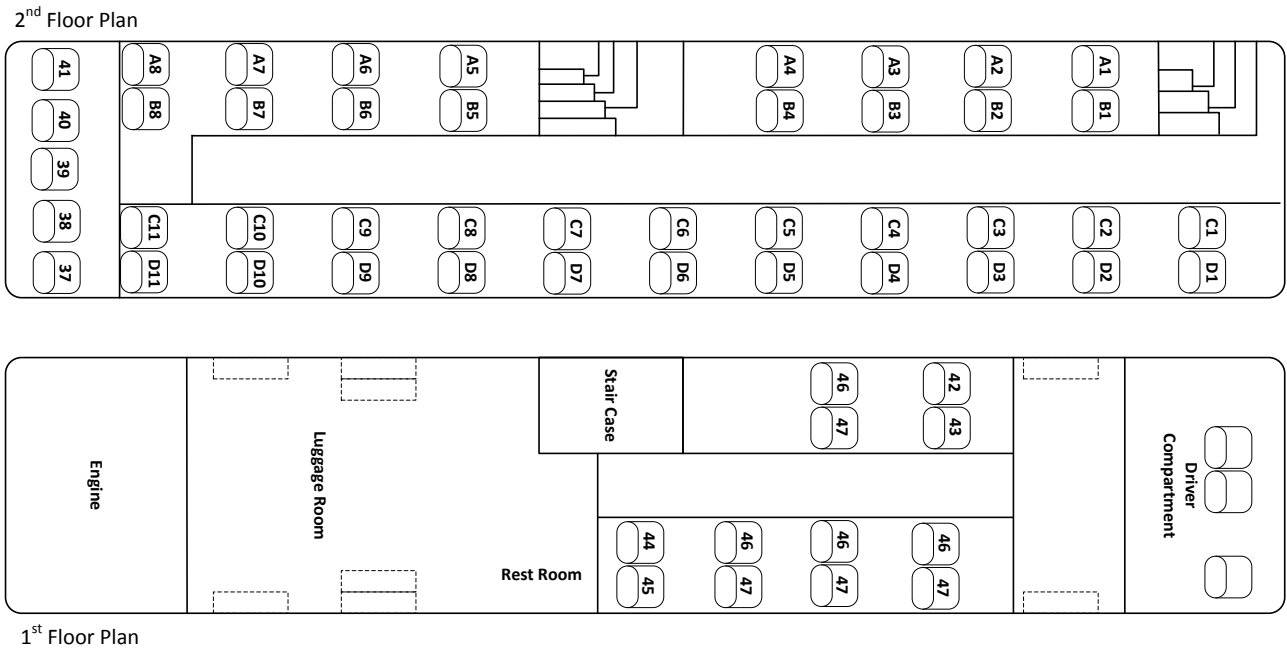
**Figure 3-3: Seating Configuration**

From **Figure 3-3**, it can be seen that the lower deck is arranged into 5 parts including the driver cab, staff room, occupants compartment, luggage room, and engine box. Six set of passenger seats are installed in the occupants compartment, four on the right and two on the left. On the upper deck, the seating configuration of the bus consists of 12 rows. There are the seats only on the right side on the first, sixth and seventh rows, leaving space for the staircase on the left. The twelfth rows comprises of five seats connected to each other. Each set on the other rows are all individual but attached as a pair. The space between the seats is 85 cm. The seats are connected to the bus body by a pair of steel hooks, one attached to the floor while another one is attached to a side bar (**Figure 3-4**). However, only

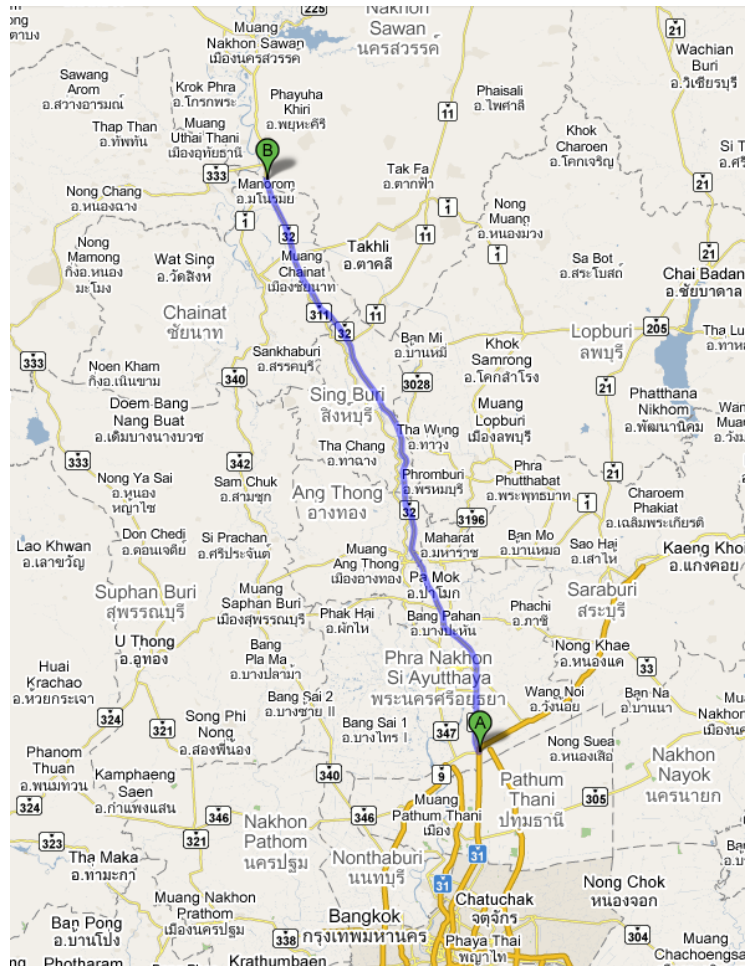
**Figure 3-8: Highway No.32**

The crash occurred on Highway No.32 (unofficially called “Asia Route”) at KM. 42+600 in Bang Pahan, Ayutthaya. Highway No.32, 151 km long, serves as a Northern corridor, starting from Highway No.1 at Bang Pa-In, Ayutthaya running through the provinces of Ayutthaya, Ang thong, Singburi, and connecting again at Manorom, Chainat (**Figure 3-8**).

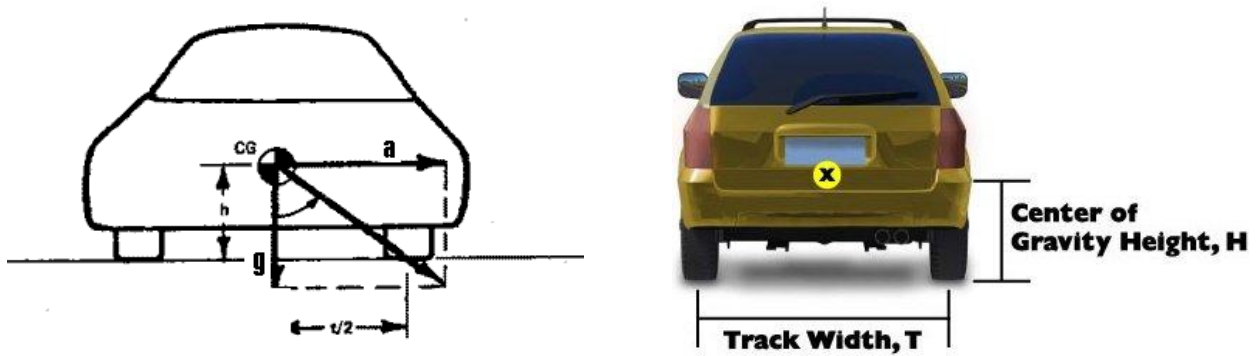
**Figure 3-10: Static Stability Factors**

Vehicle dynamic is likely to be an important factor in this crash. In Thailand, a static measure to determine the Static Stability Factors (SSF) has not yet been performed. The theory of SSF defines that the vehicle rollovers if the sum of the lateral forces on the tires, divided by the weight of the vehicle, is greater than T/2H for a sufficient length of time (Gillespie, 1992). SSF is defined as the track width divided by twice the center of gravity height, meaning that  $SSF = T/2H$  (TRR, 2002) (**Figure 3-10**).
