Accident Narrative

At about 4:00 PM, on 3 July 2013, 7 peoples were returning back from Wat Nangnaithamigaram, Angthong to Doilan, Ayutthaya, in a pick up after attending their one of the relative's funeral. At about 4:17 PM, while travelling on a 4 lane Highway no. 329, between km 14+000 and km 15+000, the pickup (V1) hit a 24 wheeled trailer truck (V2) with its front at U-turn when the truck was trying to make a right turn towards its company gate. Based on the evidences found in the crash scene, the pickup was running over a painted median and when the driver saw a truck in front of it making a right turn, the pickup tried to maneuver left avoiding a truck but couldn't success and finally got collided with a truck. After the collision, the pickup moved few meters and stop on the roadway as shown in figure 2.

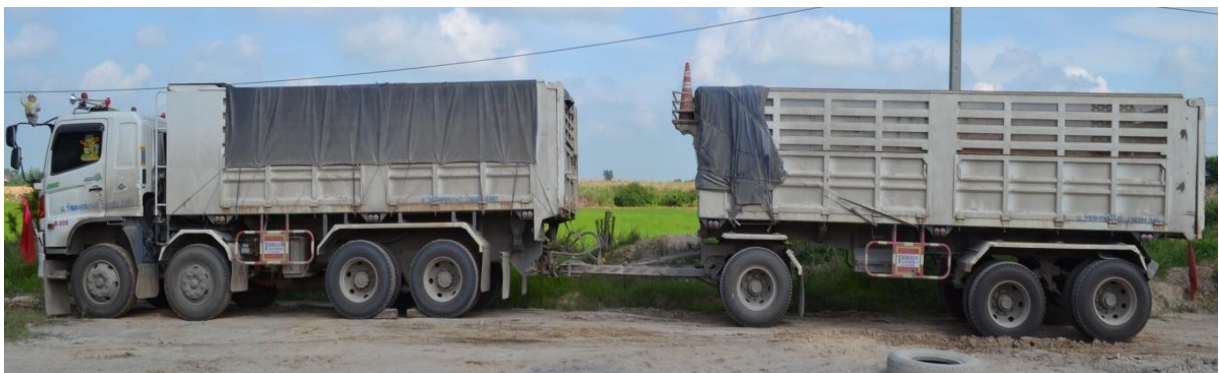
Figure 3 Dimension of Trailer-Truck

The trailer- truck involved in this crash was HINO 500 FM2P-NGV, 24 wheeled, 10520 cc, 6-cylinder diesel engine, white in color. A trailer had 3 axles, 12 wheels with the dimensions 7.05x2.4x3.0 m and had a registration number 70-6519 Ayutthaya. Similarly, truck had 4 axles, 12 wheels with the dimensions 8.37x2.4x3.0 m and had a separate registration number 70-6517. The vehicles tires brand and size were quit varied. Table 3 shows the details of the tires of trailer and trucks separately.

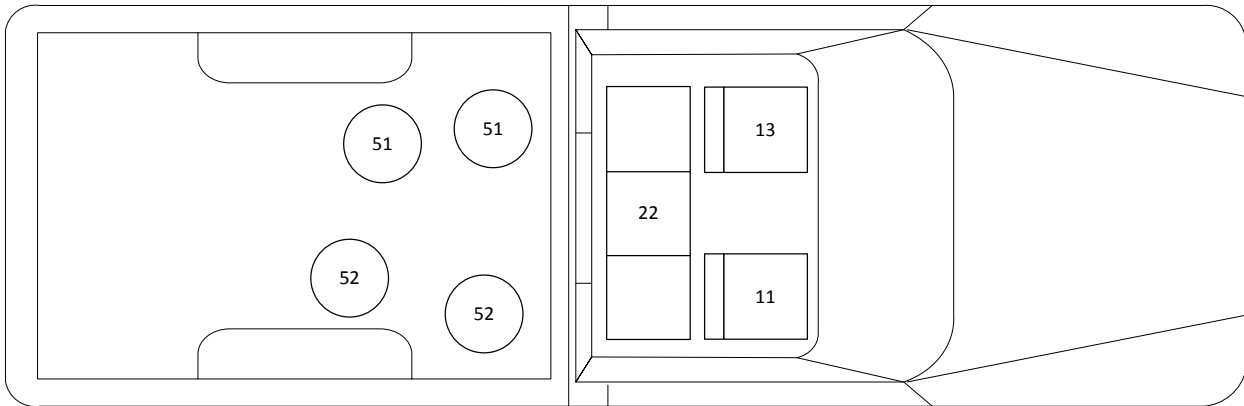
Figure 12 Occupant's Seating Position

There were 7 occupants on board at the time of the crash. 4 occupants were sitting in the loading bed while 3 were sitting inside the occupant's compartment including the driver (Figure 12, 13). 5 out of 7 occupants died at scene inside the wrecked pickup, while one occupant died on the way to hospital, and remaining one occupant was severely injured. The details of the injury information are shown in table 4.
