Case ID: 081227-01

Accident Narrative

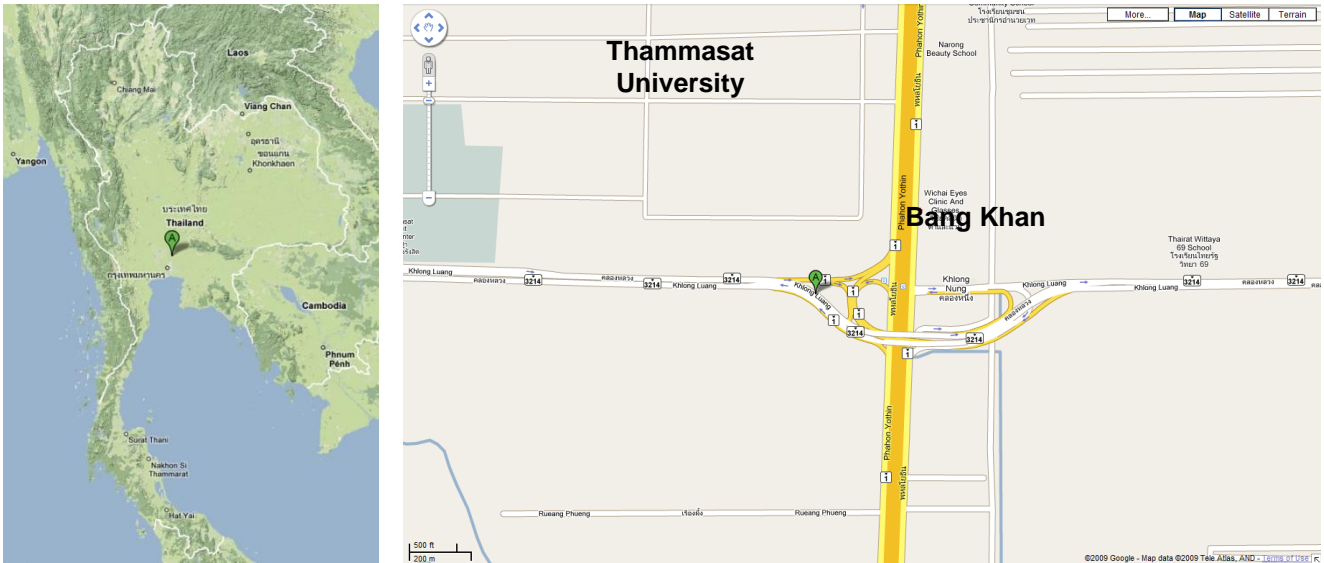
Figure 3-1: Crash Location

Late at night on 27 December 2008, a group of friends were driving back from a restaurant in Pathumthani. On the way the passenger car with six occupants on board left the travelling way before approaching the Klong Luang Interchange at KM.4+600 on Highway No. 3214 (**Figure 3-1**). The vehicle flew from a roadside concrete barrier and landed into the structure of high mast lighting. The car broke into two parts and all six occupants died instantly.

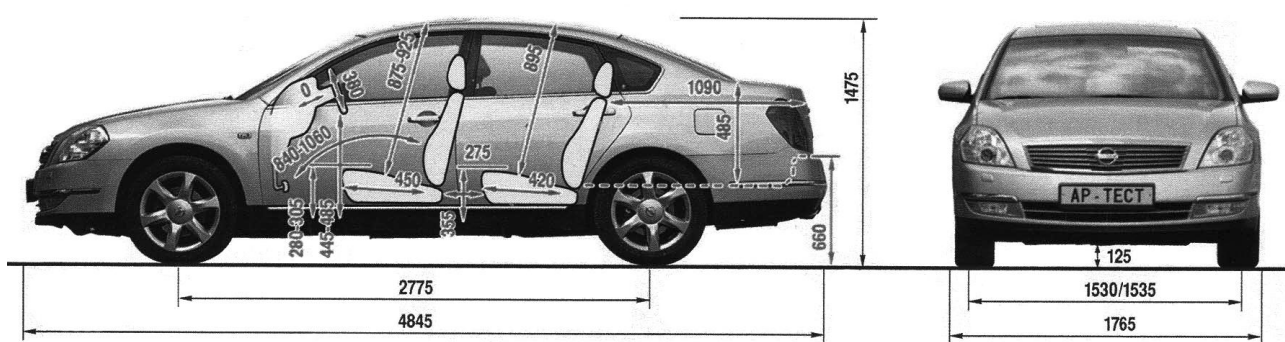
Figure 3-3: Car Dimension

The passenger car was a Nissan Teana, 2,000 CC. patrol engine with automatic speed transmission and ABS equipped (**Figure 3-3**). It was white in color. The original dimensions were 4.85 m long, 1.80 m wide, 1.49 m high, and 2.78 m wheelbase. The 3 cm diameter longitudinal safety beams were fitted on each side of the car. All tires were of size 205/65 R16, manufactured in year 2005. The details of the vehicle's tires are shown in **Table 3-1**. The driver and front passenger seats were designed as individual bench with lap-shoulder belt installed. The left and right rear seats were equipped with lap-shoulder belts while the middle seat was fitted with a lap belt.

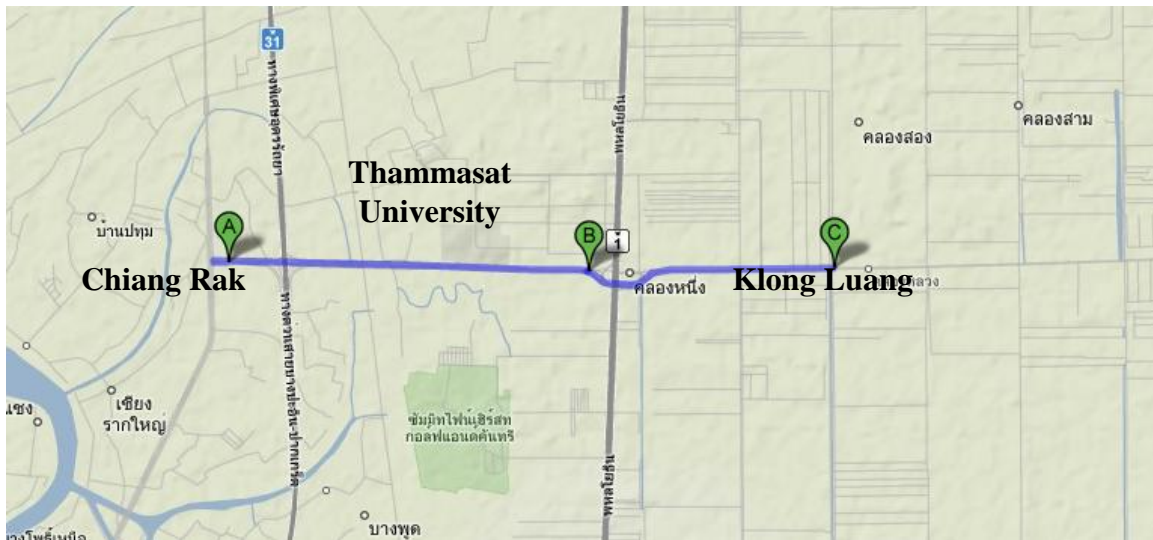
Figure 3-7: Vehicle Route

The driver was a 25 years old female. According to a witness, the driver' friend, all occupants were a group of friends. They had a party for the graduation ceremony of the driver and one passenger at a pub in Chiang Rak. The crash occurred on the way back home, which is about 3 km away from the crash scene (**Figure 3-7**).

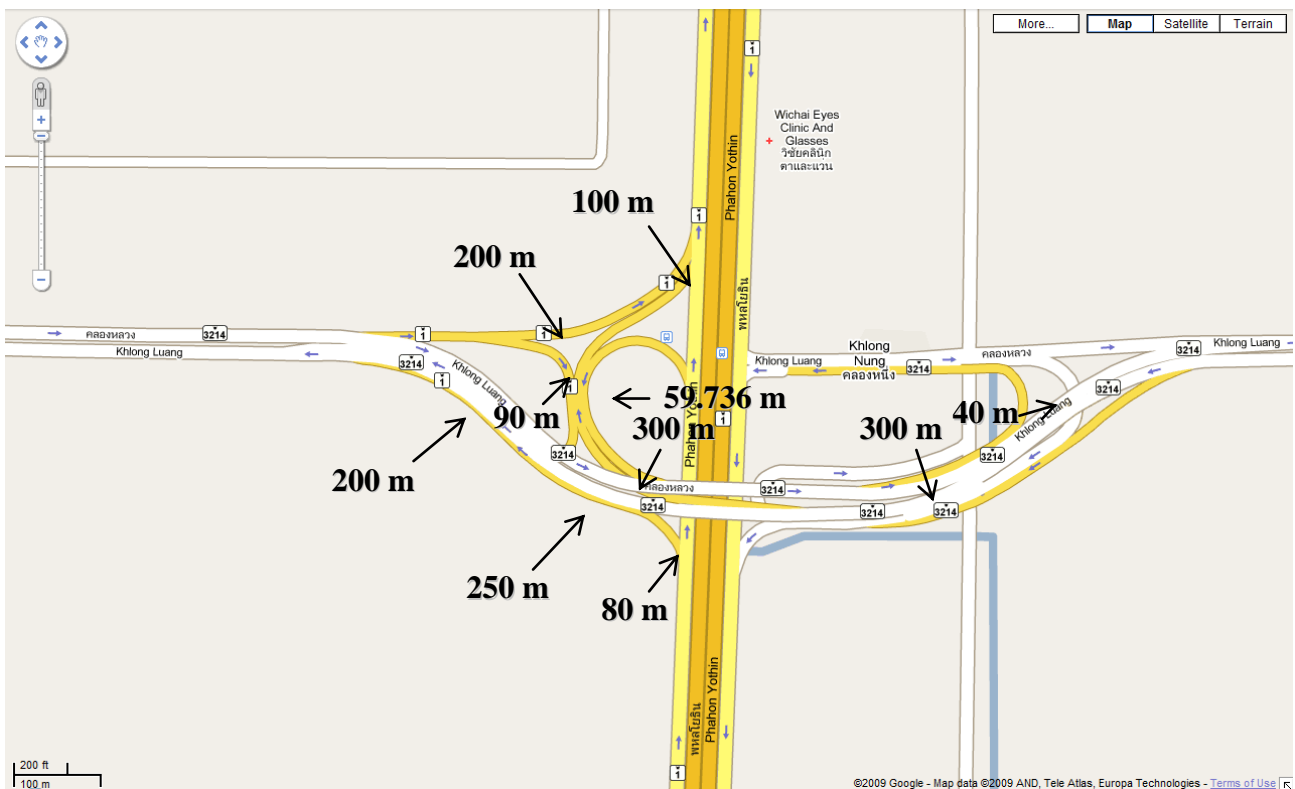
Figure 3-8: Klong Luang Interchange

Highway No.3214, 15 km long, connects the East-West corridor between Highway No.347 and Highway No.3010 in Klong Luang, Pathumthani. It is a 6-lane divided road, with a 3.7 m wide lane of concrete pavement and a 2.3 m shoulder asphaltic concrete. The diverging area is on the West approach at km.4+600 in the area of the Klong Luang Interchange. It divides the left lanes to Highway No.1 and remaining two-lane routes to the interchange. A 200 m in radius curvature connects the straight road and the overpass bridge. The details of the interchange's geometry are shown in **Figure 3-8**.

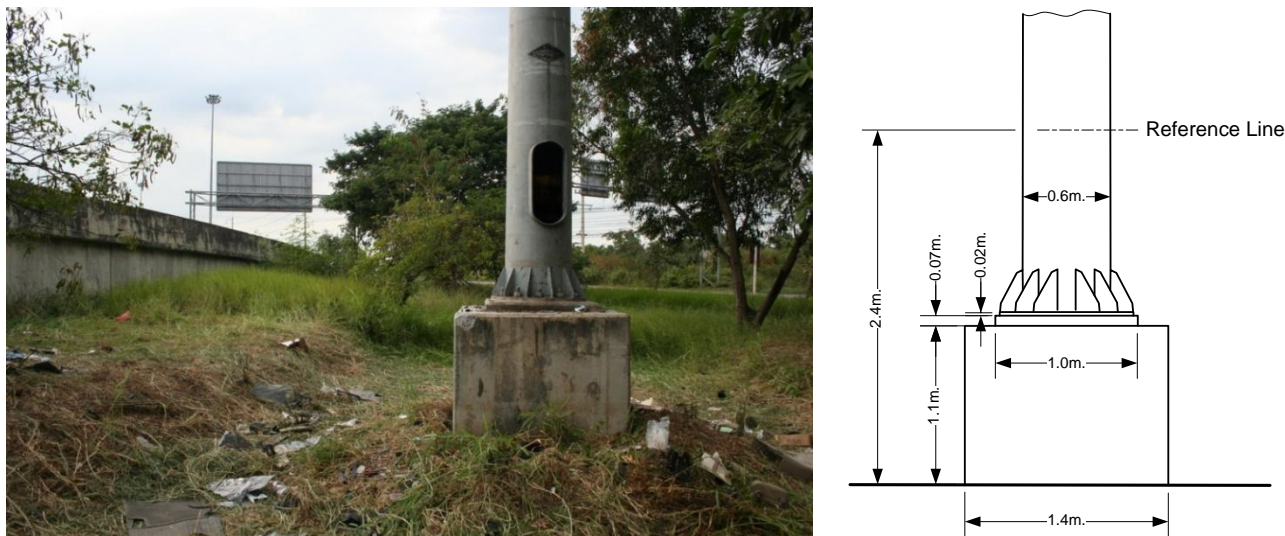
Figure 3-9: High Mast Lighting Pole

The 25 m. tall steel high mast lighting, is mainly installed every 100 m. along the route. The circumference of the pole is 190 cm. or equal to a radius of 30 cm. The steel column stands

on a 140x140 cm rectangular concrete foundation. **Figure 3-9** shows the details and dimensions of the high mast and its foundation. The reference line indicates the same level of approach concrete barrier.

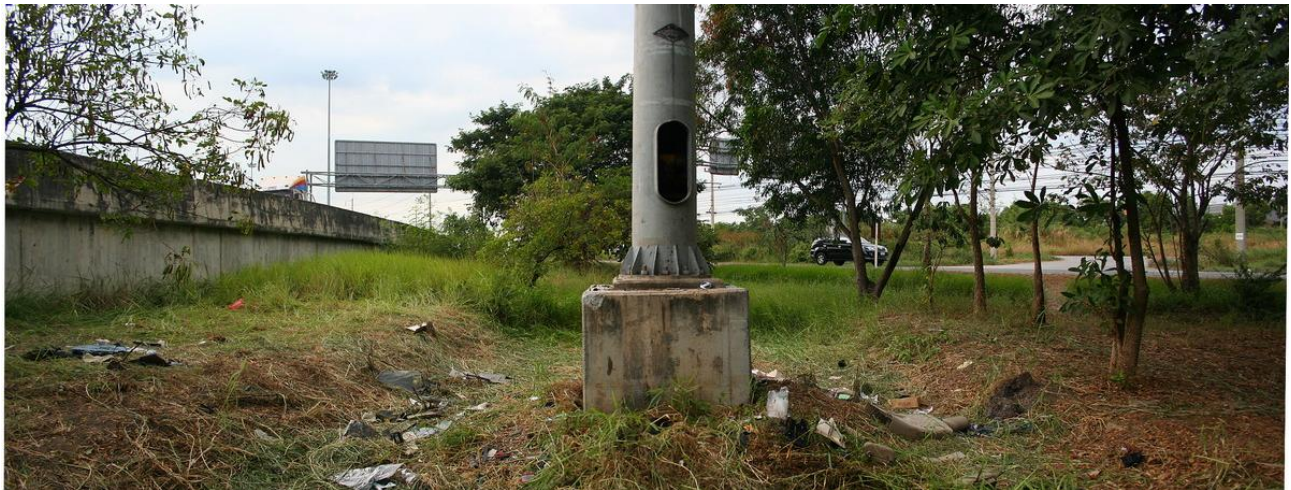
Figure 3-11: Set of Evidences Documented at the Crash Scene

The evidence found from the scene (**Figure 3-11**) began with a tire mark printed on the footing of the approach concrete barrier (**point no.1**). Within a further meter, there were plenty of scratch marks showing on the concrete surface on the top of the barrier (**point no.2**). 8.40 m from point no.1, a tire mark was printed again on the top of the barrier with 1.30 m in total length (between **points no.3** and **4**).

Another set of evidences were documented at the trees on the roadside where the branches of trees were broken. The first (**point no.5**) was found between 2.13 and 3.11 m above the ground. The next (**point no.6**), a broken branch, at a height of 2.20 m from the ground was found on the smaller tree which was located 3.03 m further away

The last evidence was located at the concrete foundation (**point no.7**) of the high mast lighting post, 46.35 m away from point no.1. It has to be noted here that there was no evidence found between point no.6 and point no.7 which means that it is highly possible that the vehicle flew from the concrete barrier at 6° over the trees and landed exactly at the concrete foundation without touching the ground.
