Accident Narrative

At about 10:00 PM, on 14 July 2013, there is a report of car crash accident at Pathumwilai Intersection across Pathumthani City Hall in Pathumthani City. The car was reported to be crash into a light pole in the raised median. Based on the evidences, the left side of the car hit into the median street light pole. The car driver was only one casualty and he has only minor injury.

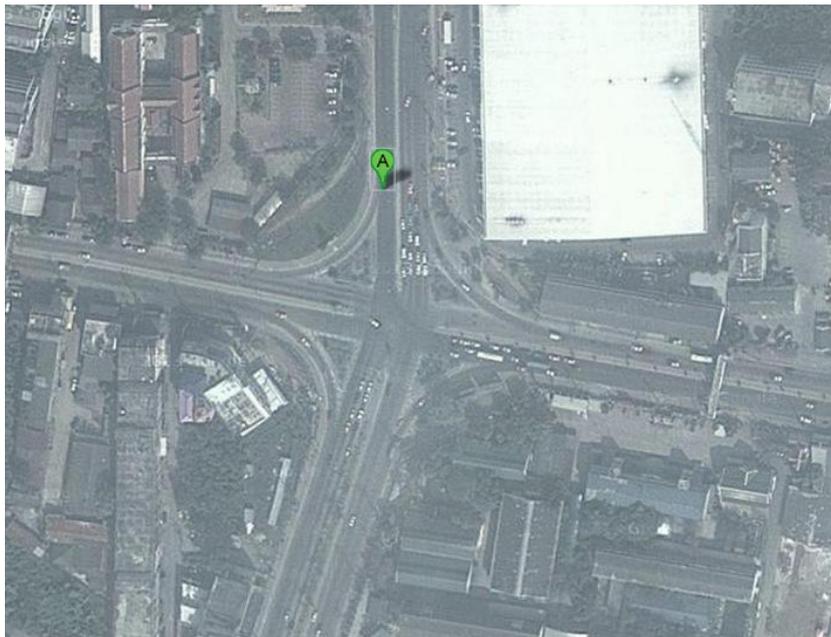
Figure 7 Satellite image of intersection

The accident occurred on the north approach of Pathumwilai Intersection which located in the center of Pathumthani City. Pathumwilai Intersection is a traffic control intersection which three roads are joined; Highway No.311 on north approach with 4 lanes in approach, Highway No.3035 on east-west approach with 3 lanes in each approach and Highway No. 307 on south approach with 3 lanes in approach. Separated left turn lane is available in every approach.

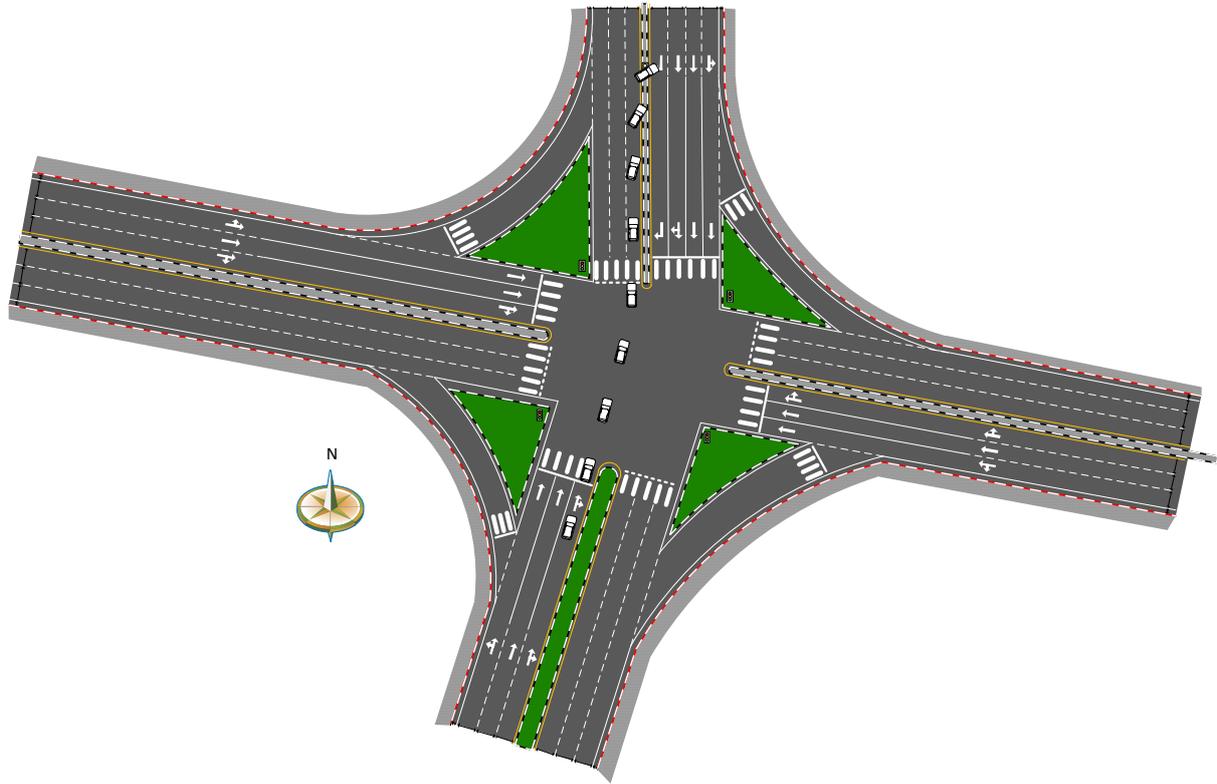
Figure 3 Schematic plan of road geometry

Before reaching the resting point of the crash, a distortion of pavement surface can be observed. According to information from the locals, that area used to be a small canal but had been filled for street widening and distortion in settlement produce uneven road surface. Suspect that the car can lose its control when running across a hump.
