Case ID: 081010-01

Accident Narrative

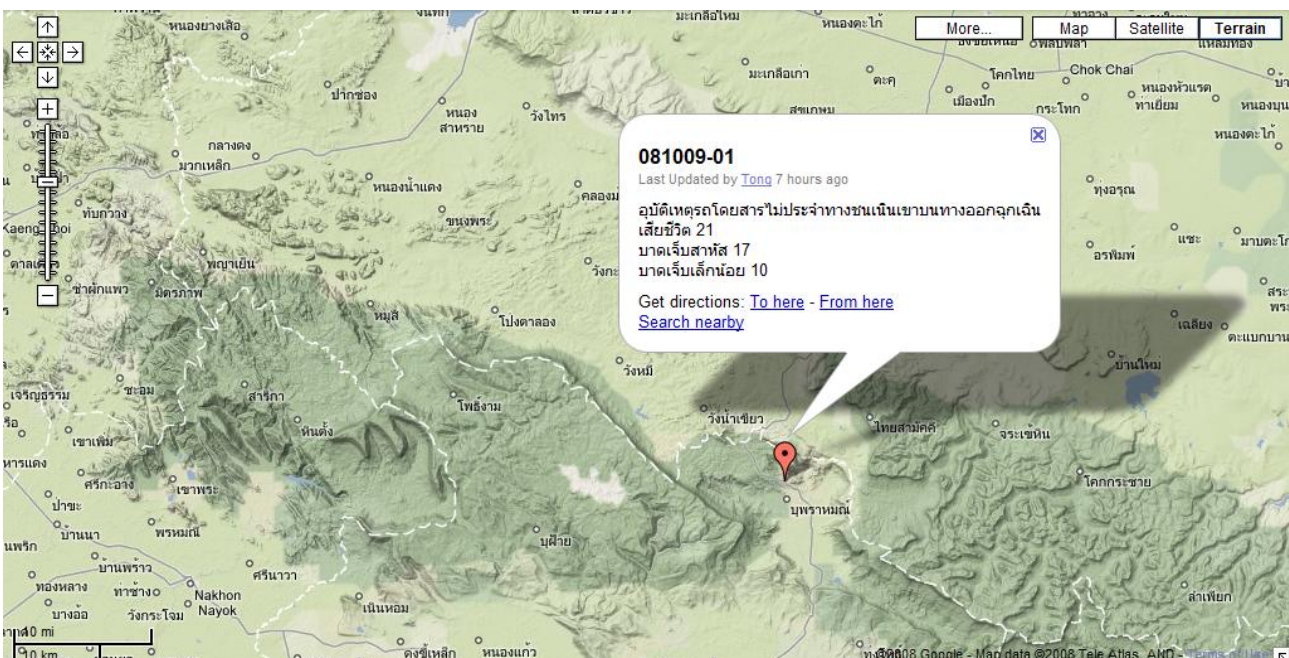
Figure 3-1: Site of the Bus Crash on a Mountainous Road between Nakhon Ratchasima and Prachinburi

The bus with 48 passengers started the trip at about 19:00 from Khon Kaen. At about midnight the bus was travelling across a mountainous area between Nakhon Ratchasima and Prachinburi (**Figure 3-1**). On a downhill section between km 42+000 to km 47+500, the driver found a malfunction of the braking system and tried to slow the vehicle down, as reported by the bus staff. At km 44+800, while traveling on a down slope the driver decided to enter an emergency exit ramp in order to stop the bus. The speed of the bus, however, was still considerably high and it failed to stop on the ramp. The bus then went over beyond the emergency ramp and plunged into a deep embankment, crushed to ground and stopped on its right side. In total, 21 persons including the driver were found dead while 17 and 10 persons suffered serious and slight injuries, respectively.

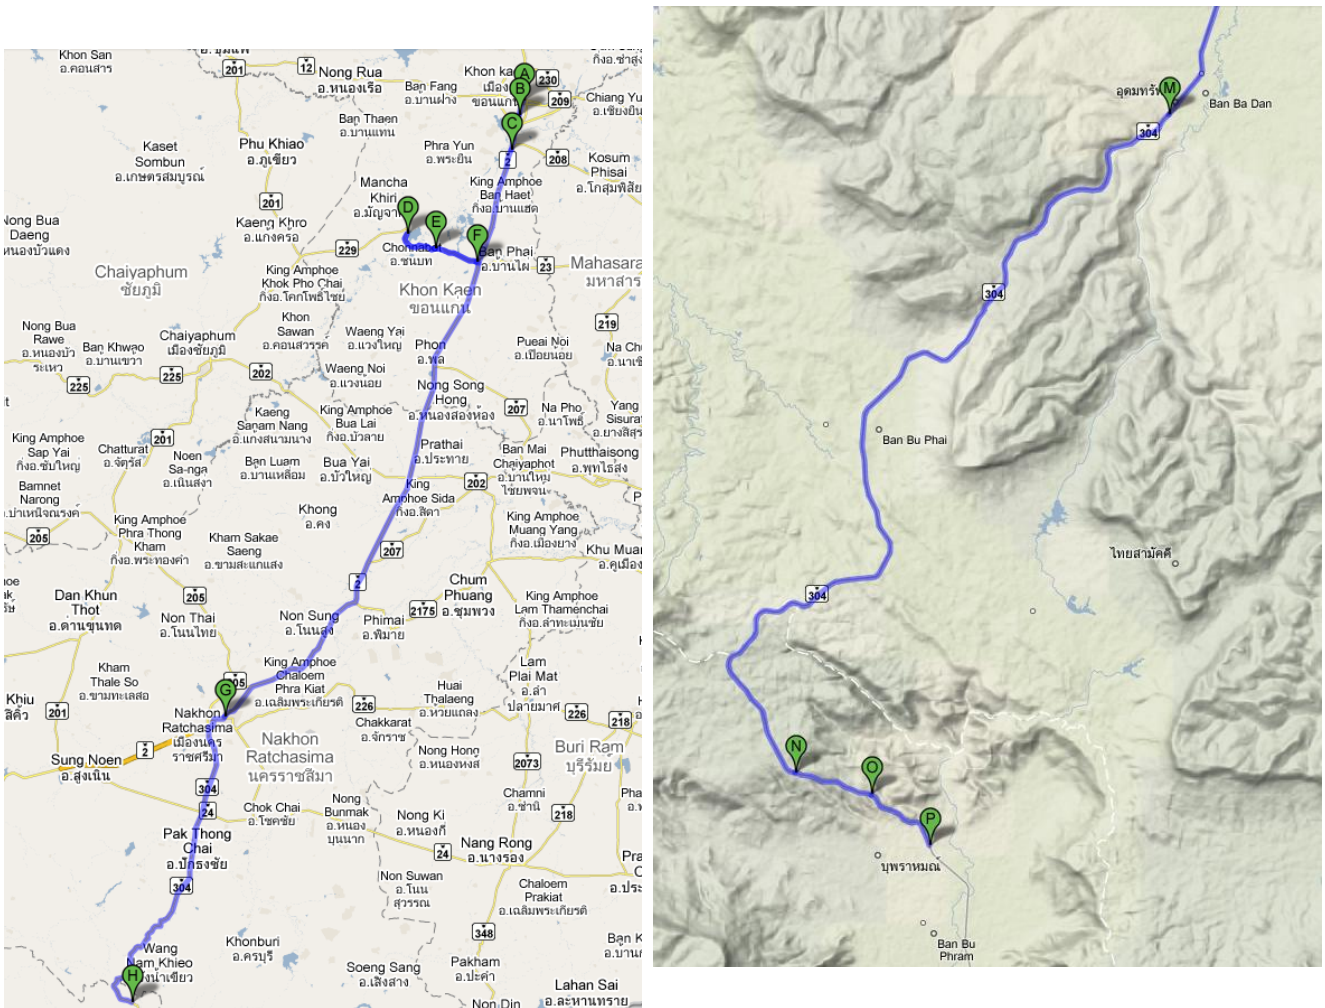
Figure 3-2: Bus Route

From 48 occupants in total, there were 44 university students, one driver and three bus staff. The trip started at 19:00 on 9 September 2008 from Khon Kaen (A). The bus stopped at Tha Pra (B) and Ban Phai (F) at about 19:30. Then, it turned right to Highway No.229, to pick up more passengers at Mancha Khiri (D) and Chonnabot (E) at 22:00 and 22:10, respectively and returned to Bang Phai (F) at about 22:30 to refill the fuel. After all passengers were on board, the bus moved forward to Nakhon Ratchasima (G), and turned left to Highway No.304 the last stop before approaching the hilly terrain during the night.

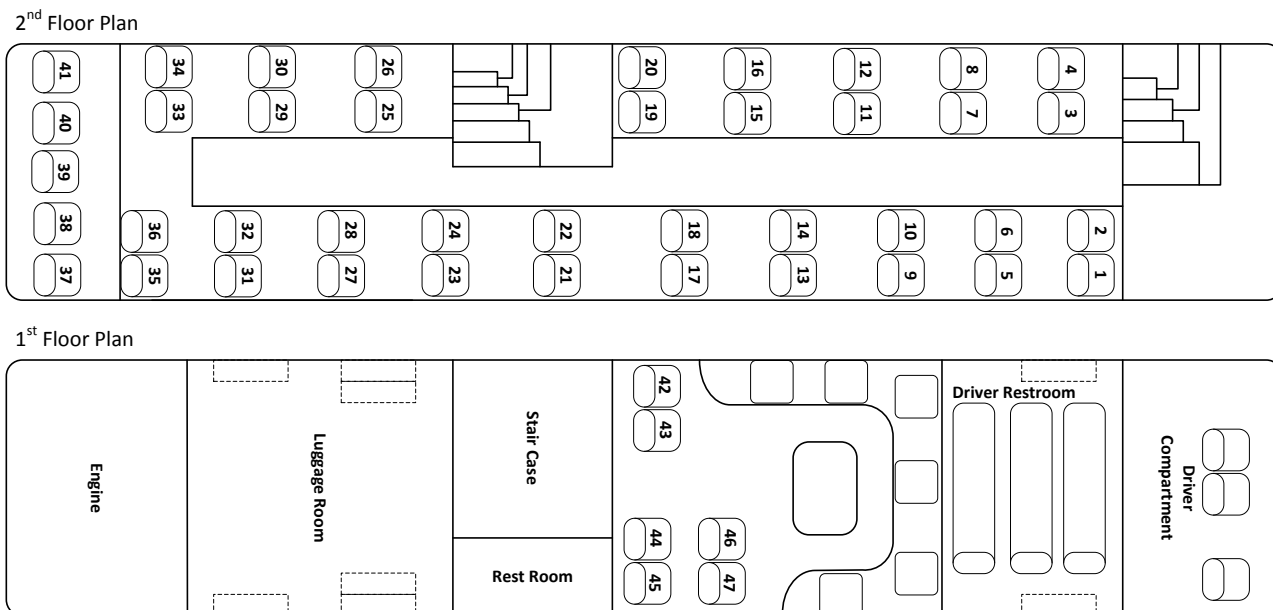
Figure 3-3: Seating Configuration

A lower deck arranged into 5 parts including the driver cab, staff room, occupants compartment, luggage room and engine box. In the occupants compartment, a u-shape bench was installed with a table in the middle, close to another three sets of passenger seats at the end. On the upper deck, the seating configuration of the bus was arranged with 18 sets, ten on the right and eight on the left. There was a stair case between the fifth and the sixth row on the left. Each set connected between two seats except for the five seats on the last row. The passenger's seats were all individual but attached tightly as a pair. The seats were connected to the bus body by a pair of steel hooks, one attached to the floor while another one was attached to a side bar (**Figure 3-3**). However, only the last row and three sets on the lower deck the seats were installed on the bus floor by connected (connecting?) bolts. No seatbelt was installed on the seats.

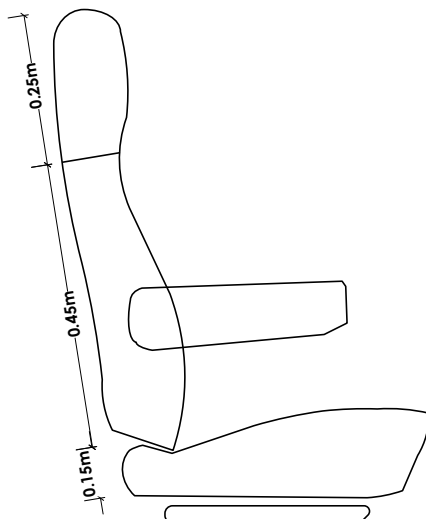
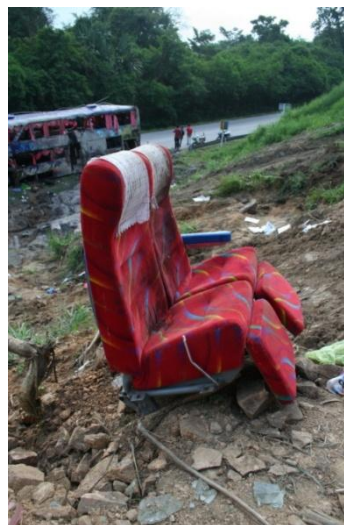
Figure 3-10: Seating Dimension

Due to major damage to the front part, the intrusion extended to the occupants compartment on the upper deck. The first and second pillars were displaced while all of the passenger seats were separated from their original position. **Figure 3-9** presents the comparison before and after the crash. **Figure 3-10** and **Figure 3-11** show the seating dimension and the hook connecting the seats and the bus body as mentioned.

People bouncing on each other and the seats detaching from their position caused harm to the occupants during the event of crash, according to victims statements. The crash consequences were reminiscent of another bus crash which happened on Highway No.304 in Doi Saket, Chiang Mai, where 17 passengers died. At that time, the seating on the upper deck detached from the body, as in this crash. It was documented that the fixing system was almost the same, where the hook fixed the seat on the bus body near the walkway, while another set of bolts was fixed into the sidebar. However, in Chiang Mai, the bus overturned more than 720 degrees, while the bus turned 90 degree after frontal impact in this crash. It was revealed from the bus manufacturer that this installation is preferred by the bus companies since it requires less time and power to rearrange the seating configuration compared to fixing the seat on the bus floor. This issue is still not addressed in the Land Traffic Act or Land Transport Act.

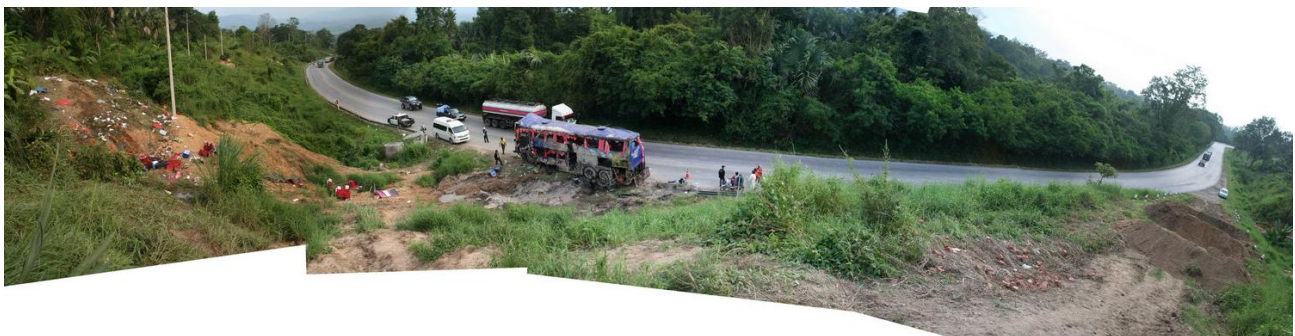
Figure 3-14: Road and Environment at the crash scene

In the mountainous area of the crash, there was a two lane undivided, asphaltic concrete road. The road is between Thap Lan National Park and Khao Yai National Park. The downhill section starts from KM.47+500 with approximately 6% grade. At KM.44+800, where the crash occurred, it composes of a 242.837 m. radius curve with a total length of 124.682 m. In addition, at the starting point of the curve, an emergency exit ramp is constructed with a 75 m. long embankment and a 6.7% uphill grade.

A speed-distance calculation was performed to determine the ability of the emergency ramp to reduce the speed. Fixing a coefficient of friction equal 0.6 on 6.7% grade uphill as measured from the scene; the speed drops only by 9-10 km/hr if entering a speed between 51-58 km/hr. The efficiency of the ramp is possibly reduced by the natural compaction of the gravel pavement over time. It was revealed from relevant agencies that this exit has been improved the roughness condition monthly. However, the soil was easily compacted again after pouring of the falling rain.

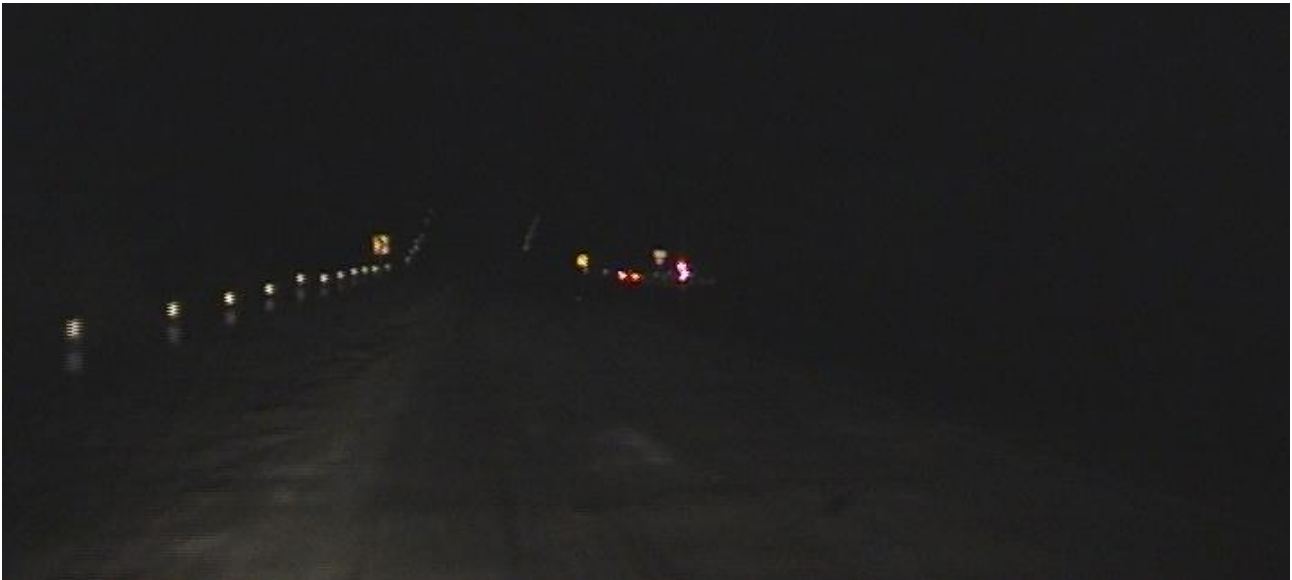
Figure 3-15: Driver’s View on the Emergency Exit Ramp

The sight distance during nighttime is limited by the lack of a road lighting system. Nevertheless, delineators are installed along the traveling way on the guiding posts, barriers or signs in order to increase the visibility during darkness (**Figure 3-15**).

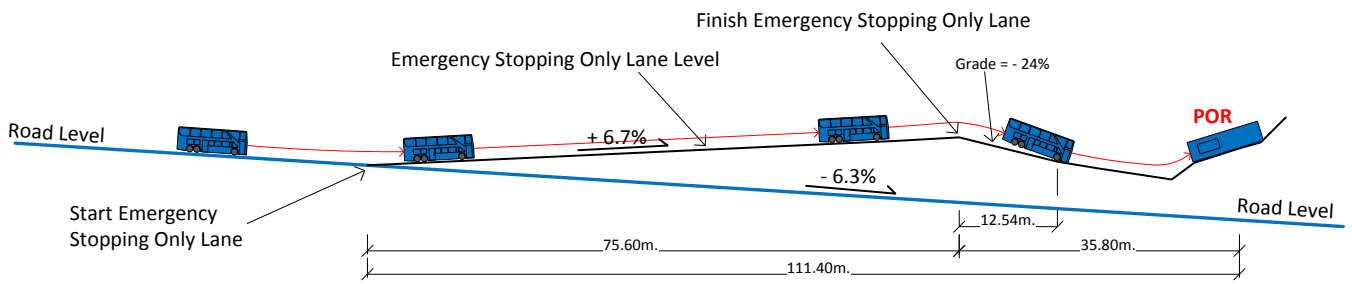
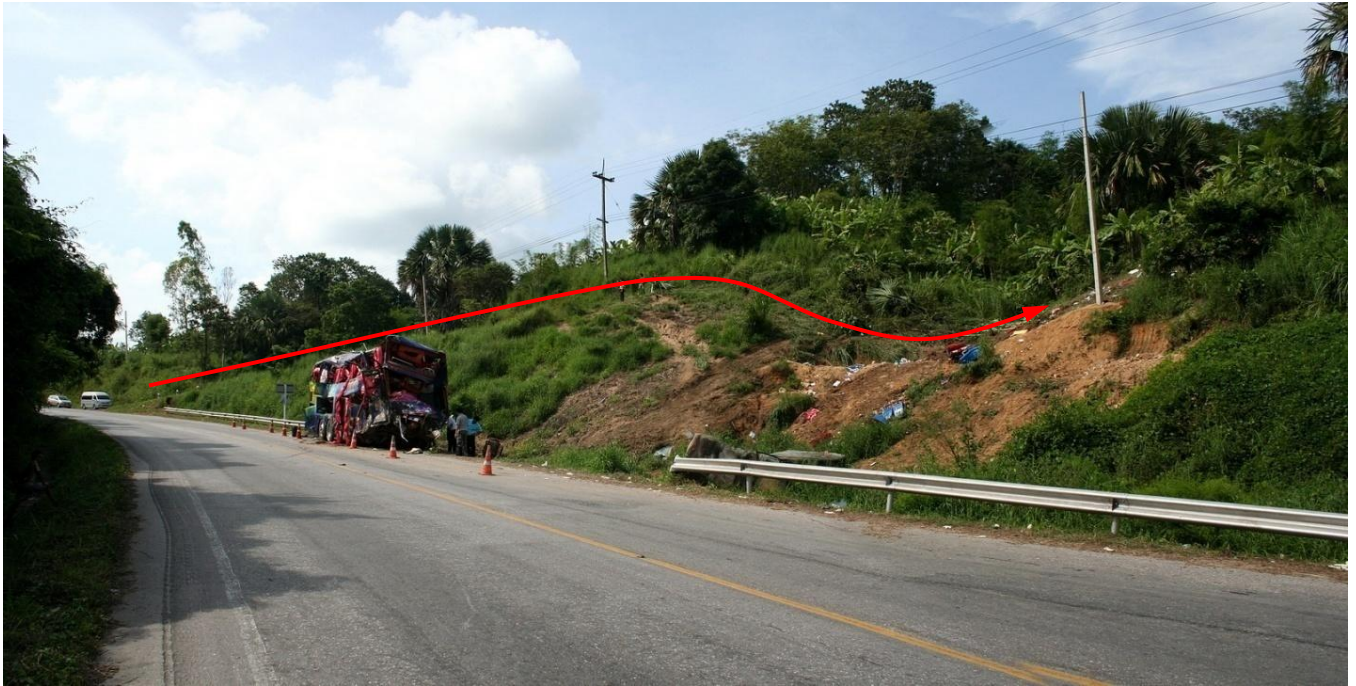
Figure 3-18: Diagram showing the bus movement

After the bus reached the top of the hill, it suddenly fell into a 24% downhill hillock and hit the embankment with its front, considered as Point of Impact (POI). The bus overturned and kept moving for some distance and stopped on its left side (**Figure 3-17**). The total distance the bus moved from the top to POR was about 40 m. (inclined distance) as shown in the moving diagram in **Figure 3-18**.
