# Case ID: 081212-01

## Accident Narrative

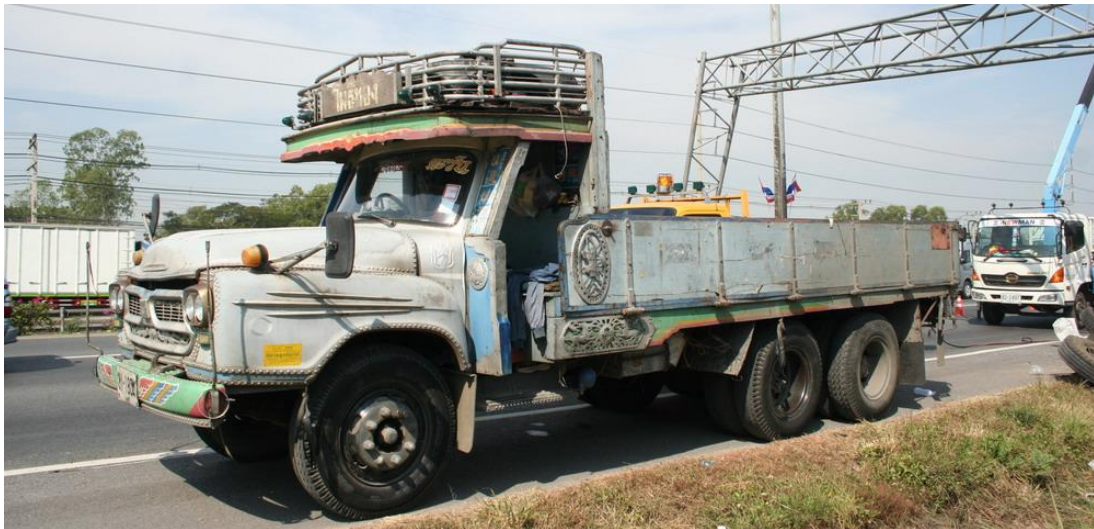
**Figure 3-3: Truck Design**

The Isuzu ten-wheel truck was a late body design truck (**Figure 3-3**), equipped with a 6-cylinder engine with 195 horse power. There were two wheels on the first axle and four wheels on the second and third axles. The dimension was 7.60 m long, 2.20 m wide, and 2.38 m high. The 19,000 kg total weight on board was the combination of 7,000 kg curb weight and 12,000 kg of cargo weight. Most of the body structures were made from wood. The cargo bed was made of wooden plates and allowed each side to be opened with several rotating hinges. Tires details are shown in **Table 3-1**.

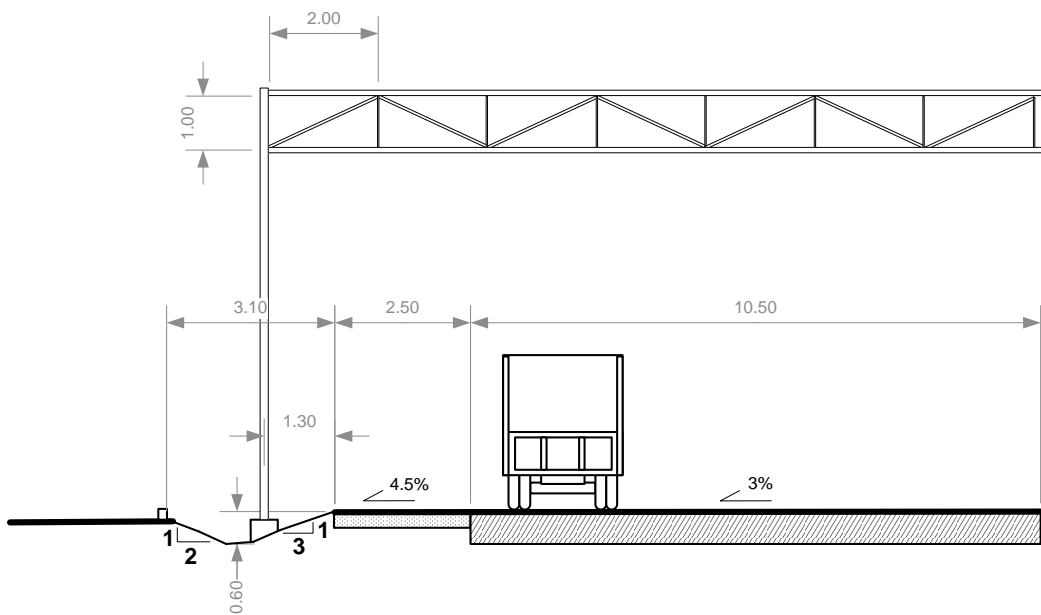
**Figure 3-7: Highway No.1 Cross Section**

In the area of the crash, the road is a straight ten-lane divided road with frontage (**Figure 3-7**). There are 3.5 m. wide three-lane on the main road and two-lane on the frontage road. The outer shoulder width is 2.5 m. There is a 3% crown slope on the traveling way and a 4.5% slope on the shoulder. The asphalt pavement had a coefficient of friction of 0.84 on the travelling lanes and shoulder.
