# Case ID: 090213-01

## Accident Narrative

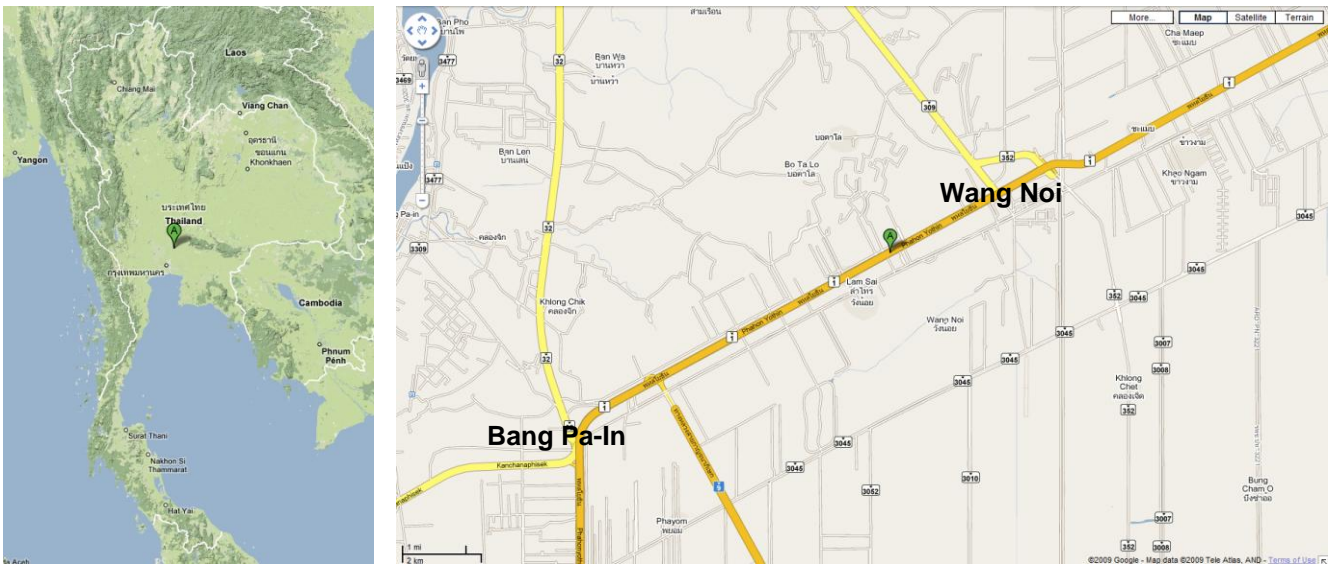
**Figure 3-1: Crash Locations**

In the early morning of 13 February 2009, a bus driver started his routine trip from Saraburi planning to take passengers, are factory workers, to Pratunam Pra-In, Ayutthya. At about 05:50, while traveling on the right lane of Highway No.1 at KM. 62+000 (**Figure 3-1**), the bus suddenly left the roadway on the right side and ran into the depressed median. The driver tried to recover the bus back into the roadway but the bus fell down on its right side after hitting the approach concrete barrier. The main impact occurred when the bus overturned and scratched the top of the barrier. It hit a pedestrian bridge column with its roof and stopped 26 meter further away on the travelling way (**Figure 3-2**).

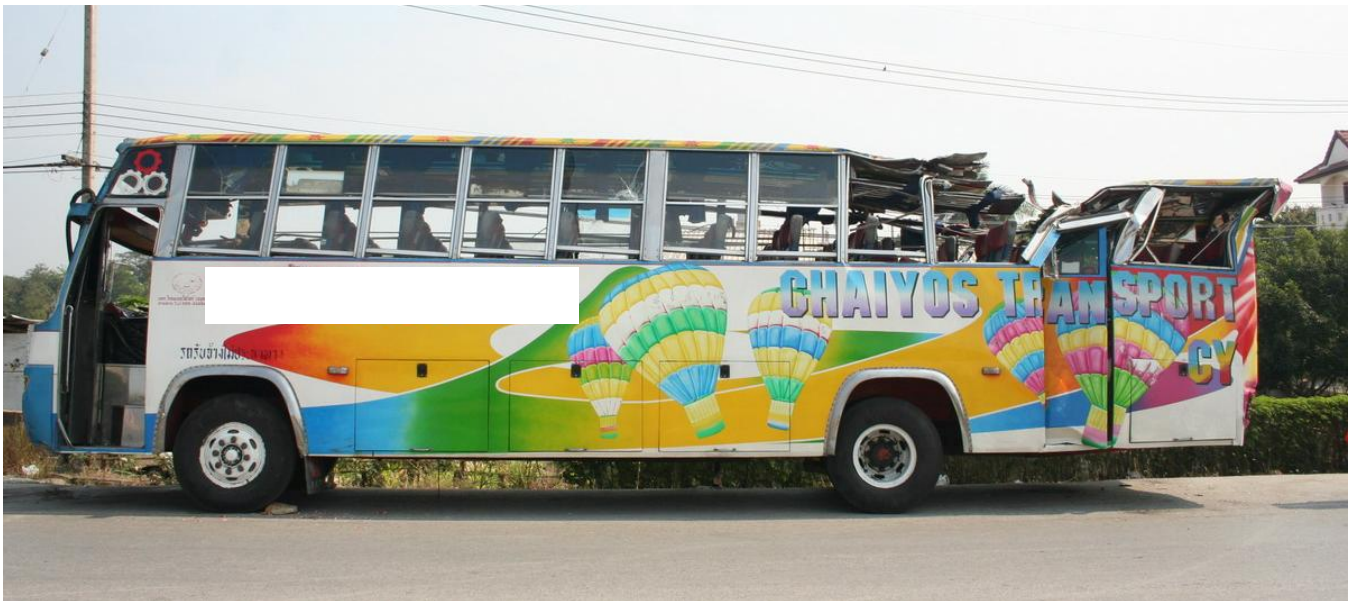
**Figure 3-3: Bus Dimension**

The bus in this single vehicle crash was a single deck bus which was locally assembled in Thailand. The body structure was emulated with a colorful artwork all around (**Figure 3-3**). The original dimensions were 3.50 m. high, 2.30 m. wide, and 11.80 m. long. The seats were arranged in 14 rows with 55 seats including the driver (**Figure 3-4**). Two seats are assembled as a pair, except for the first seat near the front stairs and another five seats on the last row. At the position of the twelfth row there is a space for the staircase on the left side.

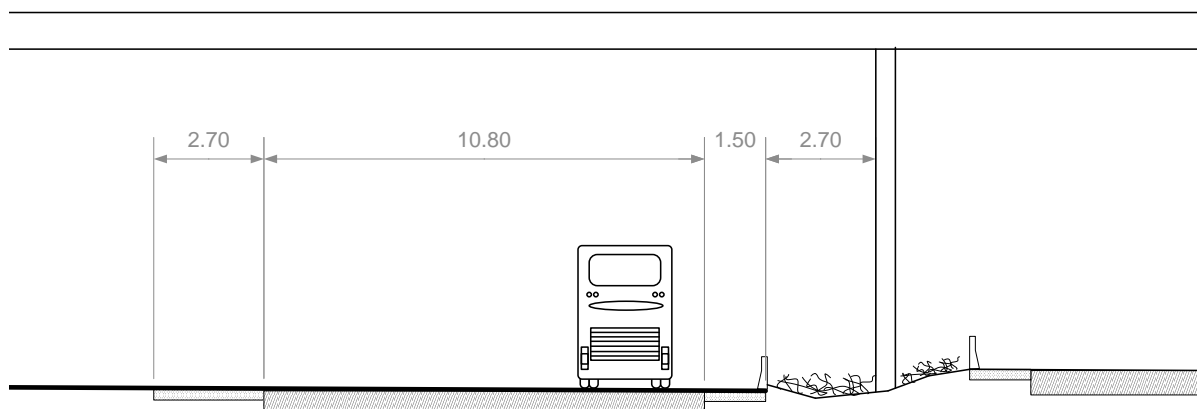
**Figure 3-8: Cross Section of Highway No.1 (Main Road)**

In the area of the crash, the road is a ten-lane divided road with frontage. There are 3.6 m. three-lane on the main road and two-lane on the frontage road with a 1.5 m. inner shoulder in each direction. The asphalt pavement had a coefficient of friction of 0.80 on the travelled lanes and shoulder. The grassy depressed median, splitting the north and south approach is 5.0 m. wide (**Figure 3-8**).
