Case ID: 060816-01

Accident Narrative

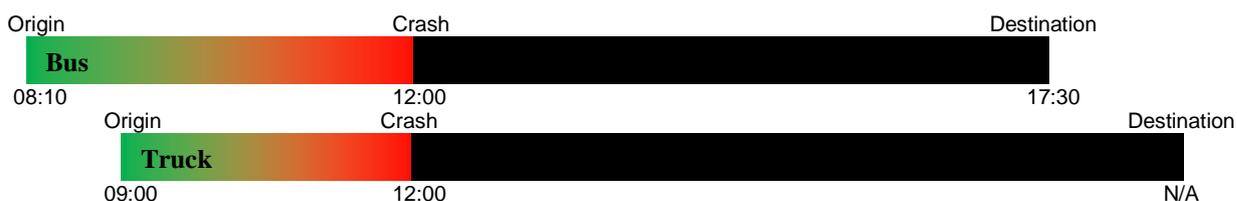
Figure 3-7: Bus and Truck Driving Hours

The truck driver, a 52 years old male, originally started the trip in Sakol Nakhon province at about 21:00 on 15 August. He stopped for sleeping along the roadside near Khon Kaen and resumed the trip at around 9:00 to Rangsit, Pathumthani as the destination. The graphic chart compares the driving hours of the two drivers, illustrated in **Figure 3-7**. According to an interview, he did not notice the rear traffic. He could not manage to control the vehicle back into the roadway after being hit.

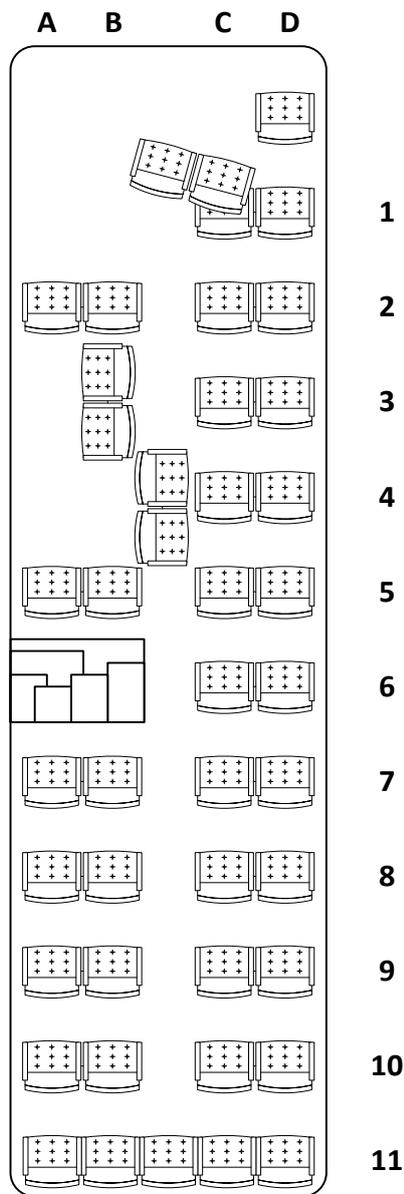
Figure 3-13: Occupant Seating Position

The other 34 victims were found slightly injured. Nine of them informed they were air borne and hit another seat in front of them. Two suffered injuries by other passenger who fell down and stepped on them, while another eight had injuries through broken windows on the ground. **Table 3-2**, with seating position in **Figure 3-13**, shows injuries were coded as ICD10 standard.
