Case ID: 080929-01

Accident Narrative

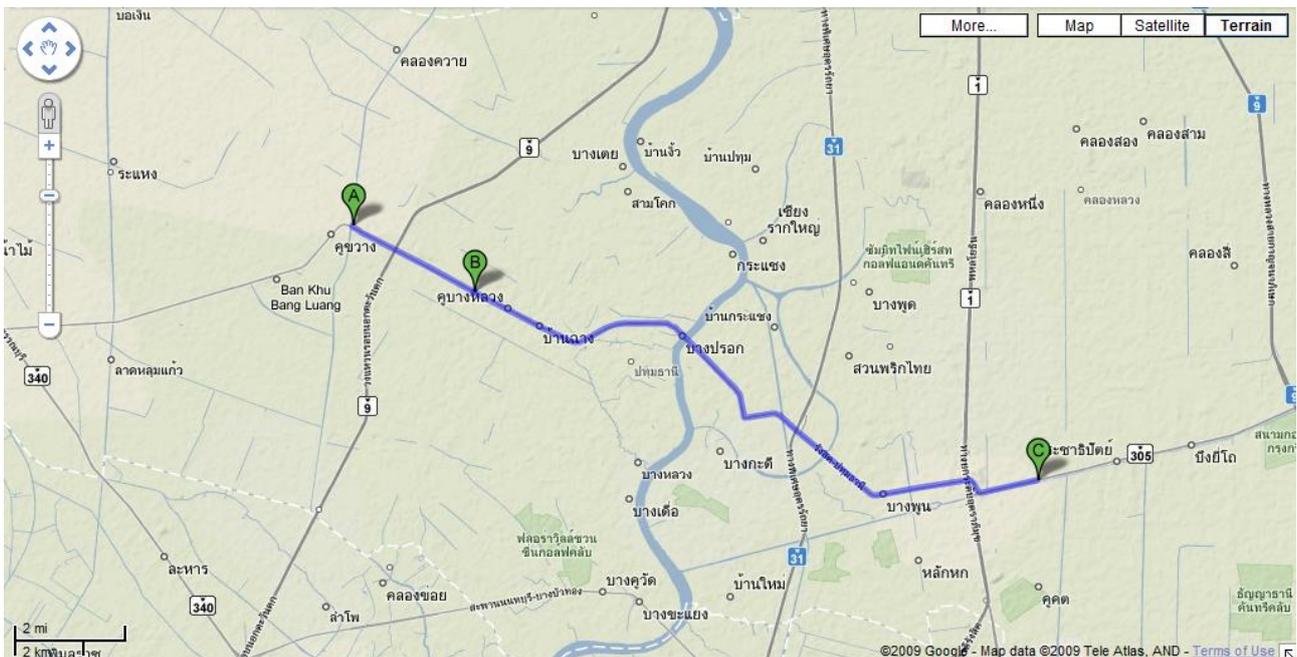
Figure 3-5: Traveled Route

The driver was a 33 years old male, the pickup's owner. He started the trip from Ku Bang Luang about 10 minutes before crash and was quite familiar with this route since this was his routine trip for the beef selling shop. He had owned this pickup for about a year. Every day, he started the trip late at night at about 01:00 to get fresh beef from Klong 1. However, there was light rain at the time of the crash. He drove on the slower outer lane. When he applied the brakes, the pickup suddenly spun and hit the tree as mentioned.

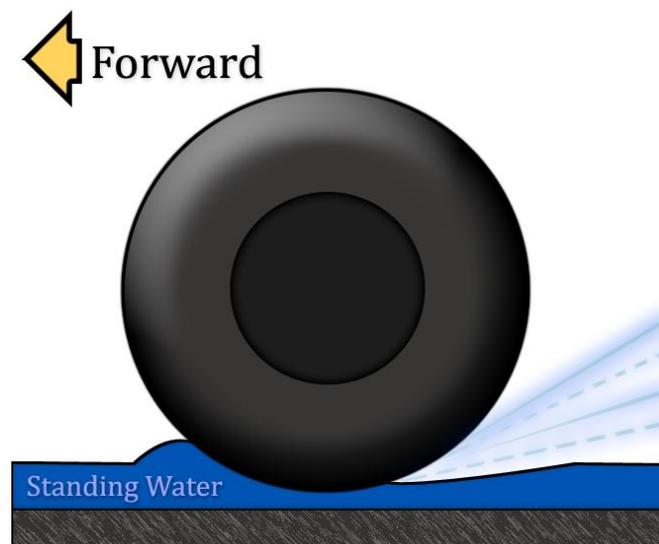
Figure 3-9: A diagram of a hydroplaning tire

At the time when the tire ran over the water film, the water pressure in front of the wheel forced water under the tire, causing it to lift from the road (**Figure 3-9**). If multiple tires hydroplaned, the vehicle may lose directional control and slide until it either collides with other obstacles or slows enough after the tires contact the road again (Wikipedia, 2009).
